# 平陆县 100MW 农光互补光伏发电项目

## 监理工程师通知单

编号: ZHJL-JLTZ-PL-061

主题: 关于东郑光伏场区巡视检查发现以下需要消缺项:

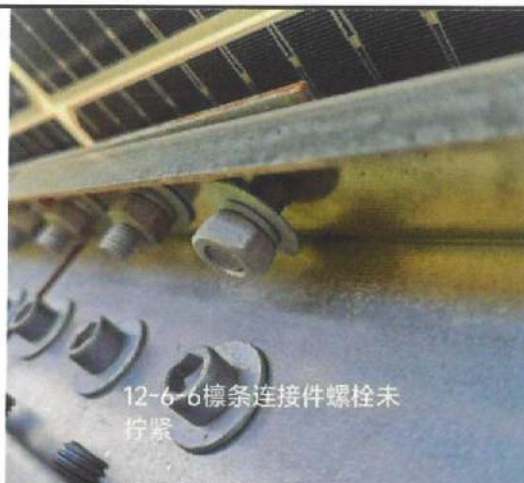
| 11 | <p>12-6-6檩条连接件螺栓未拧紧</p> | 12 | <p>12-5-28斜梁弯曲</p> |

请贵单位按照上述问题立即消缺整改。

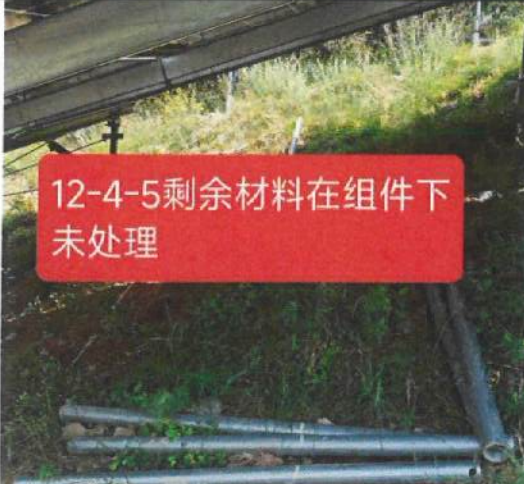
| 13 | <p>12-4-5剩余材料在组件下未处理</p> | 14 | <p>12-4-5斜撑与斜梁间角度过小</p> |

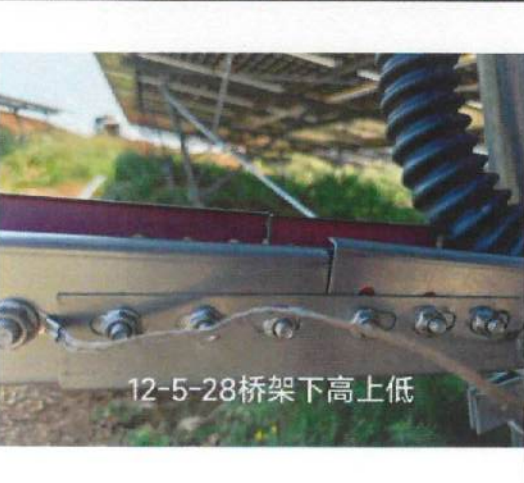
| 15 | <p>12-5-28桥架下高上低</p> | 16 | <p>12-5-28压块倾斜</p> |

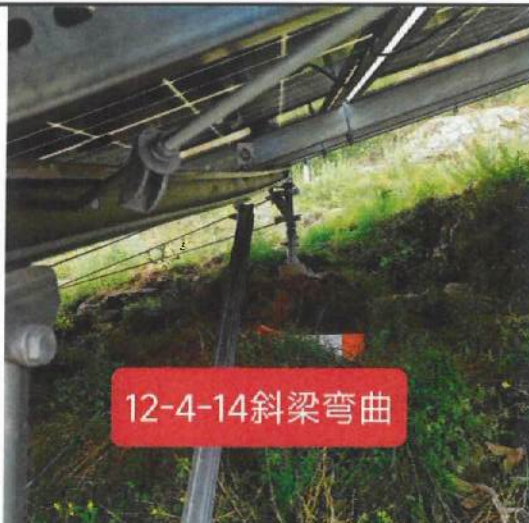
| 17 | <p>12-4-14斜梁弯曲</p> | 18 | <p>12-5-28標托螺栓未拧</p> |

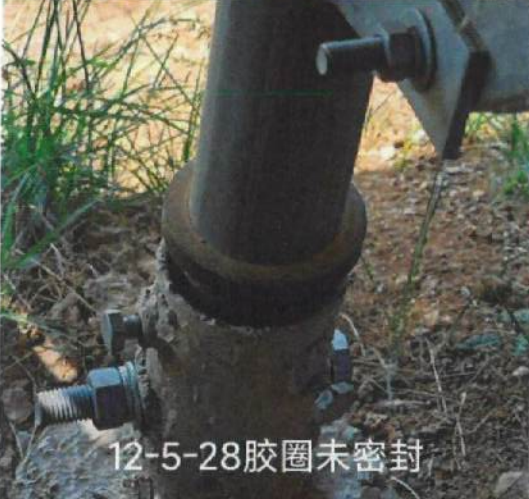
| 19 | <p>12-5-28胶圈未密封</p> | 20 | <p>12-4-14拉杆未安装</p> |

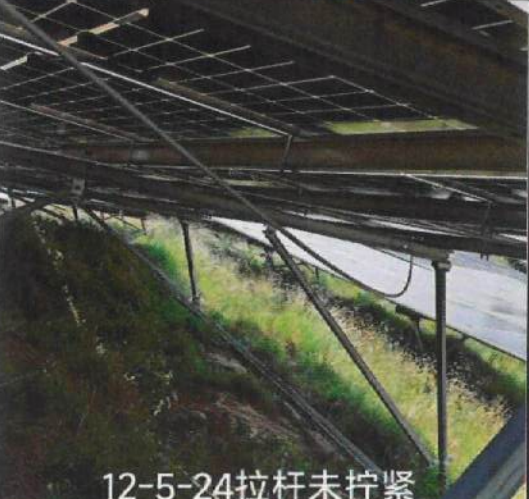
| 21 | <p>12-5-24拉杆未拧紧</p> | 22 | <p>12-4-14组件呈台阶状</p> |

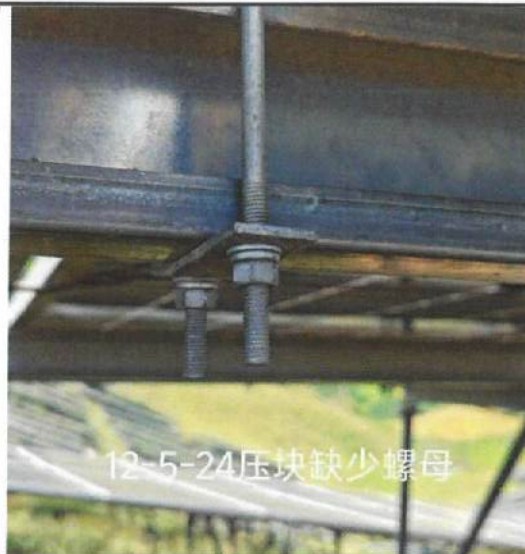
| 29 | <p>12-5-24压块缺少螺母</p> | 30 | <p>12-4-24组件呈台阶状</p> |

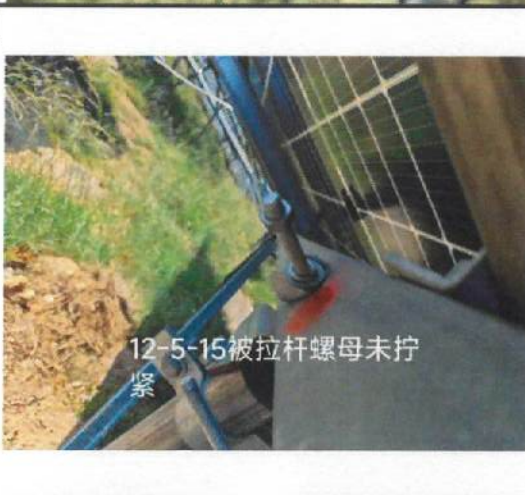
| 31 | <p>12-5-15被拉杆螺母未拧紧</p> | 32 | <p>12-4-24剩余压块未处理</p> |

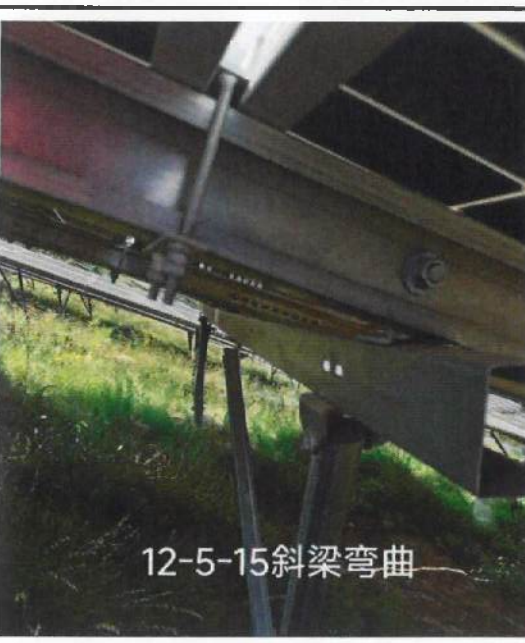
| 33 | <p>12-5-15斜梁弯曲</p> | 34 | <p>12-5-6压块缺少弹垫</p> |

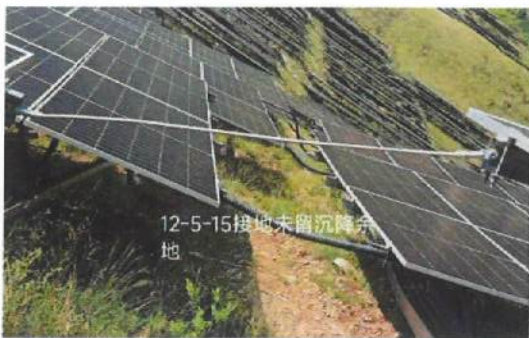
| 35 | <p>12-5-15接地未留沉降余地</p> | 36 | <p>12-5-6螺栓未按要求预留两到三丝</p> |

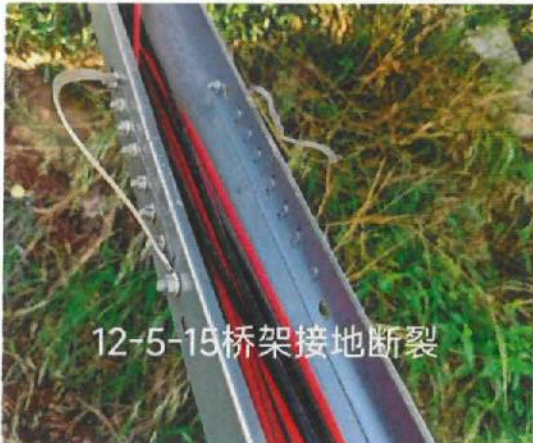
| 37 | <p>12-5-15桥架接地断裂</p> | 38 | <p>12-5-6背拉杆未安装</p> |

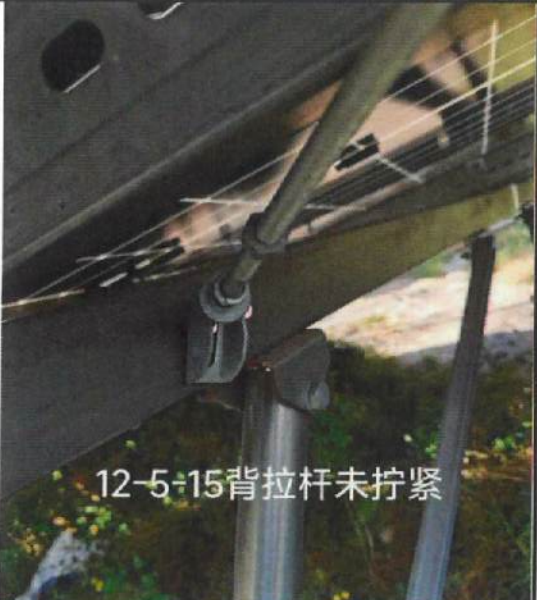
| 39 | <p>12-5-15背拉杆未拧紧</p> | 40 | <p>12-5-15压块倾斜</p> |

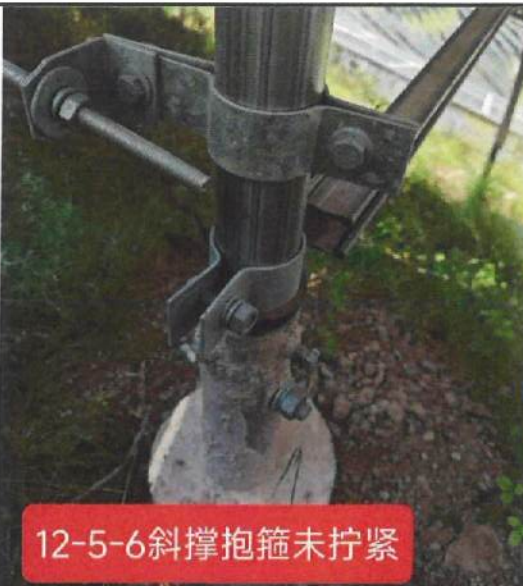
| 41 | <p>12-5-6斜撑抱箍未拧紧</p> | 42 | <p>15-5-15胶圈未密封</p> |

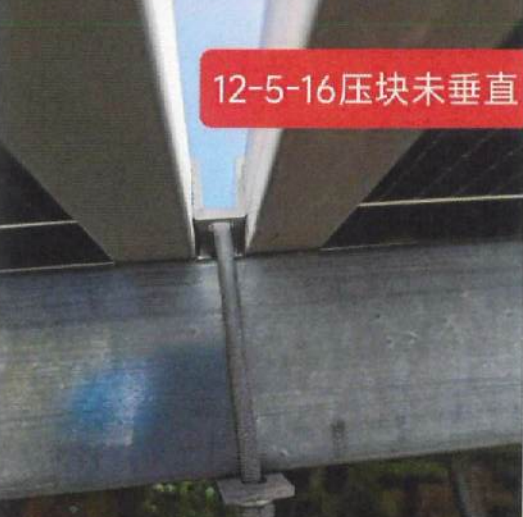
| 43 | <p>12-5-16压块未垂直</p> | 44 | <p>12-5-07桥架接地线未连接</p> |

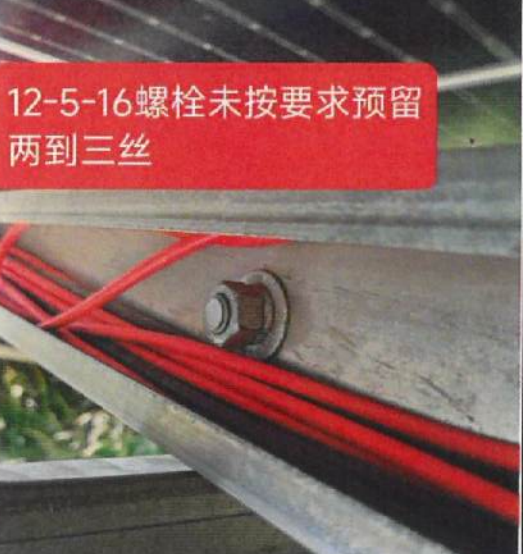
| 45 | <p>12-5-16螺栓未按要求预留两到三丝</p> | 46 | <p>15-5-19压块缺少弹垫</p> |

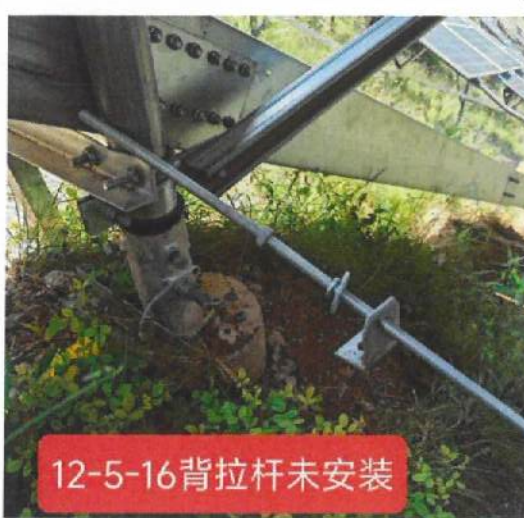
| 47 | <p>12-5-16背拉杆未安装</p> | 48 | <p>12-5-7抱箍未拧紧</p> |

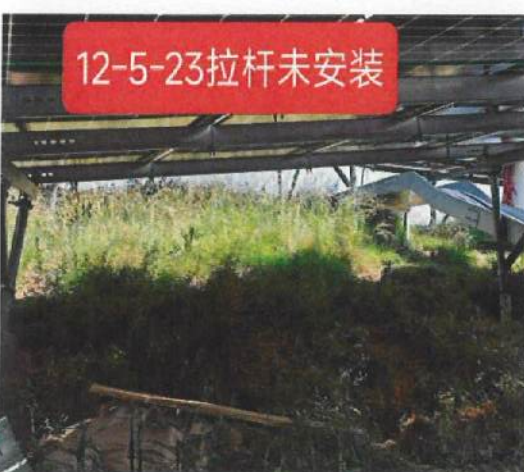
| 49 | <p>12-5-23拉杆未安装</p> | 50 | <p>12-5-7背拉杆未拧紧</p> |

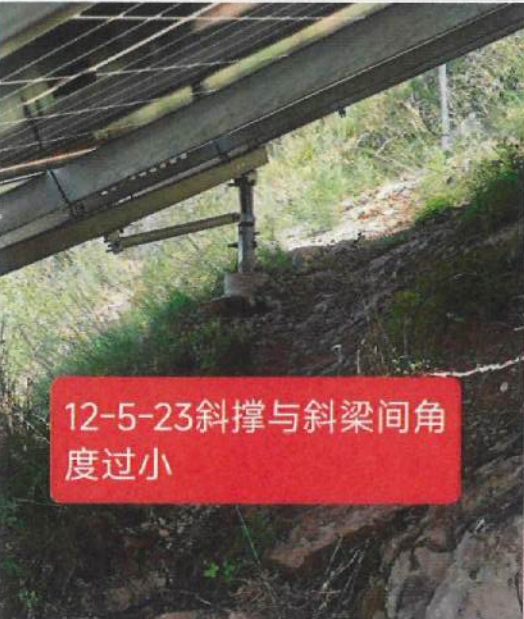
| 51 | <p>12-5-23斜撑与斜梁间角度过小</p> | 52 | <p>12-5-7背拉杆未连接</p> |

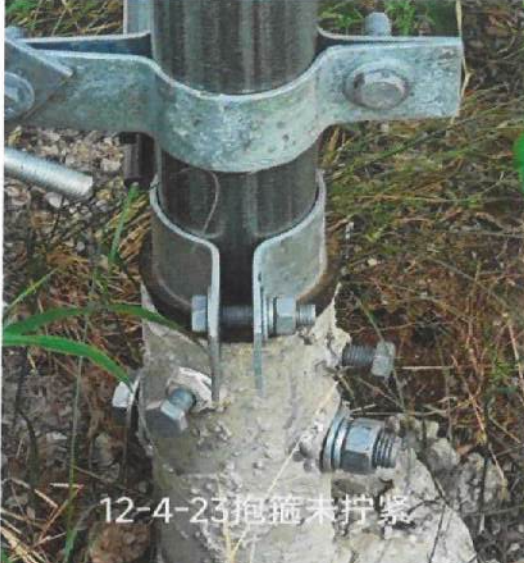
| 53 | <p>12-4-23抱箍未拧紧</p> | 54 | <p>12-4-23桥架变形，未接地</p> |

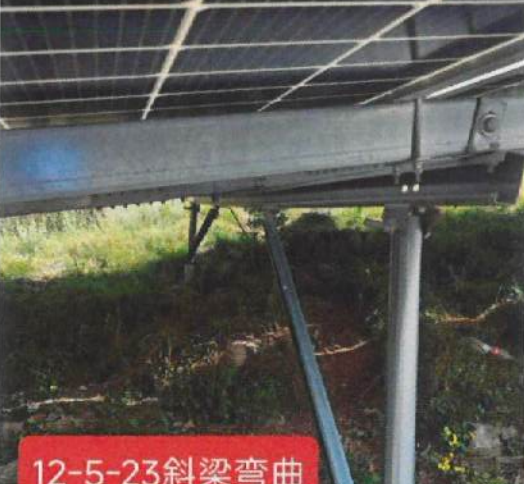
| 55 | <p>12-5-23斜梁弯曲</p> | 56 | <p>12-4-23胶圈未密封</p> |

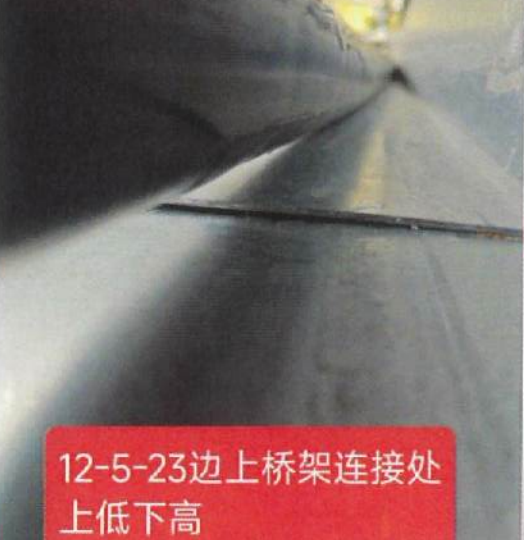
| 57 | <p>12-5-23边上桥架连接处<br/>上低下高</p> | 58 | <p>12-4-23背拉杆未连接</p> |

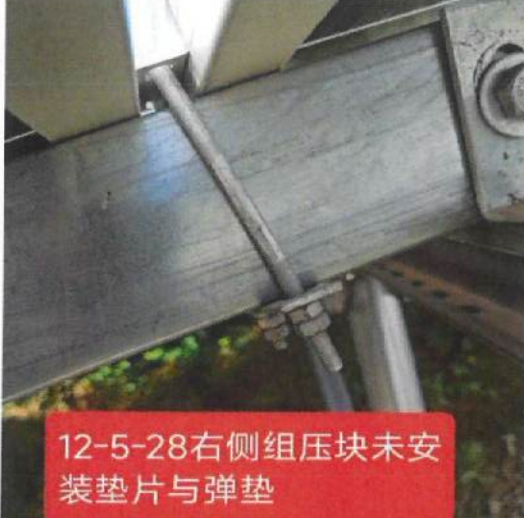
| 59 | <p>12-5-28右侧组压块未安装垫片与弹垫</p> | 60 | <p>12-4-23背拉杆螺母未拧紧</p> |

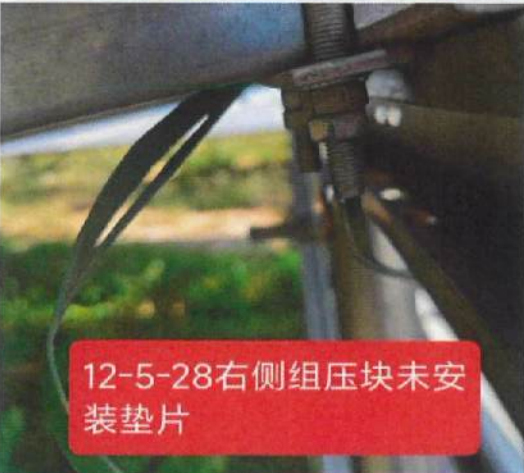
| 61 | <p>12-5-28右侧组压块未安装垫片</p> | 62 | <p>12-6-7与12-6-22间压块螺母未拧紧</p> |

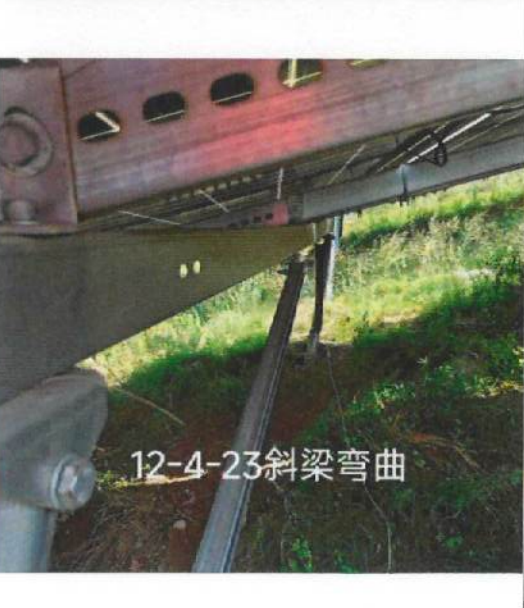
| 63 | <p>12-4-23斜梁弯曲</p> | 64 | <p>12-6-7与12-6-22间立柱安装处无灌注桩</p> |

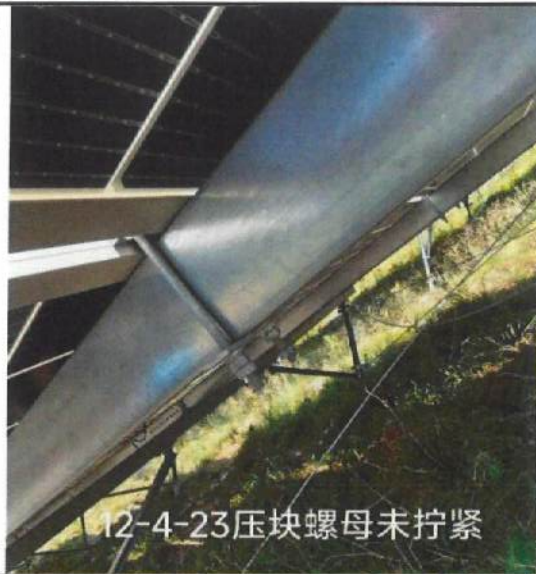
| 65 | <p>12-4-23压块螺母未拧紧</p> | 66 | <p>12-4-23贯穿螺栓生锈</p> |

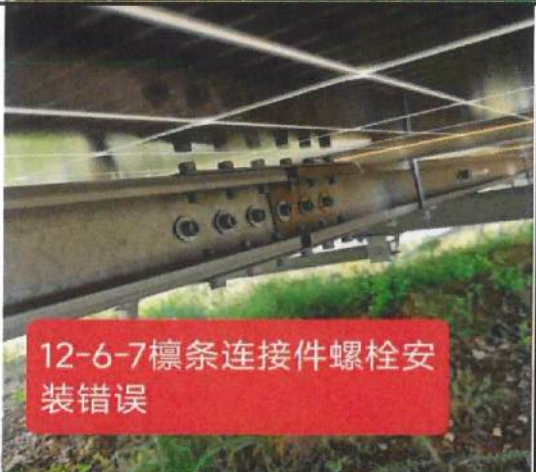
| 67 | <p>12-6-7檩条连接件螺栓安装错误</p> | 68 | <p>12-6-7斜撑与斜梁角度过小</p> |

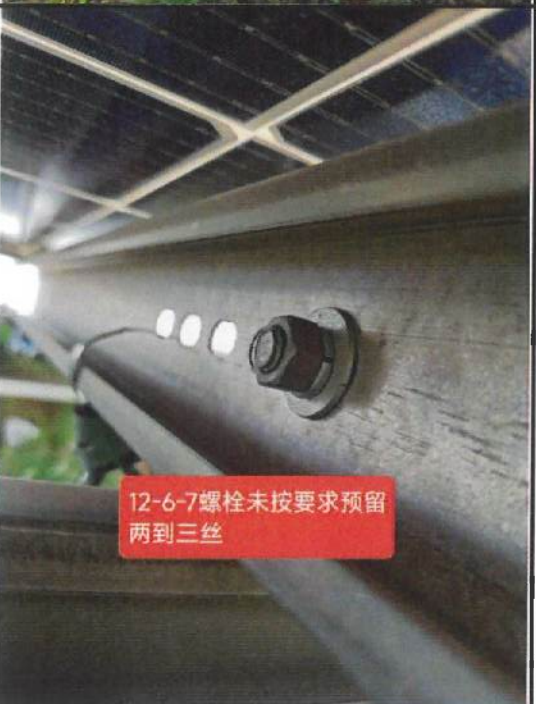
| 69 | <p>12-6-7螺栓未按要求预留两到三丝</p> | 70 | <p>12-6-7拉杆未安装</p> |

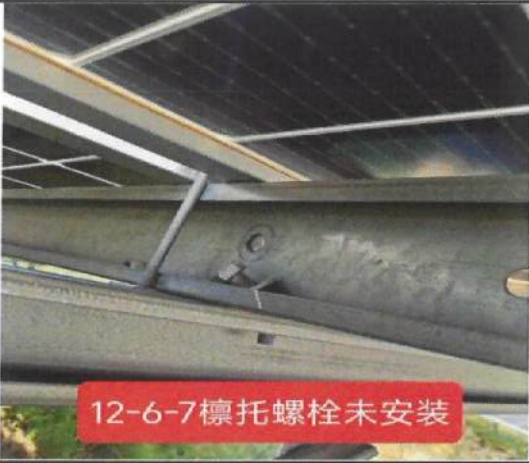
| 71 | <p>12-6-7檩托螺栓未安装</p> | 72 | <p>12-6-22组件不齐，呈台阶状</p> |

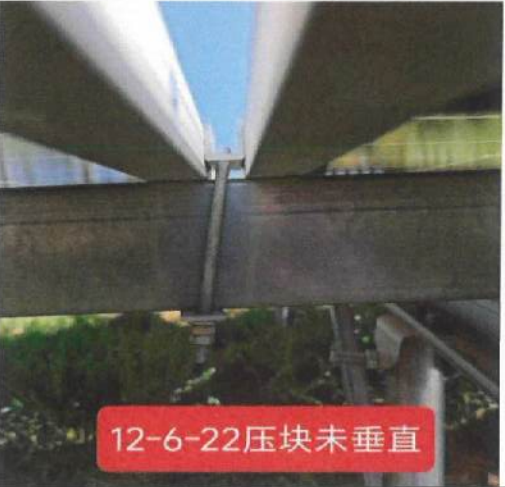
| 73 | <p>12-6-22压块未垂直</p> | 74 | <p>12-6-22压块螺母未拧紧</p> |

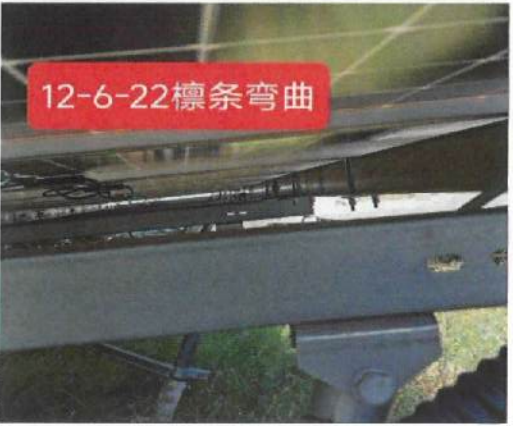
| 75 | <p>12-6-22檩条弯曲</p> | 76 | <p>12-6-22拉杆未安装</p> |

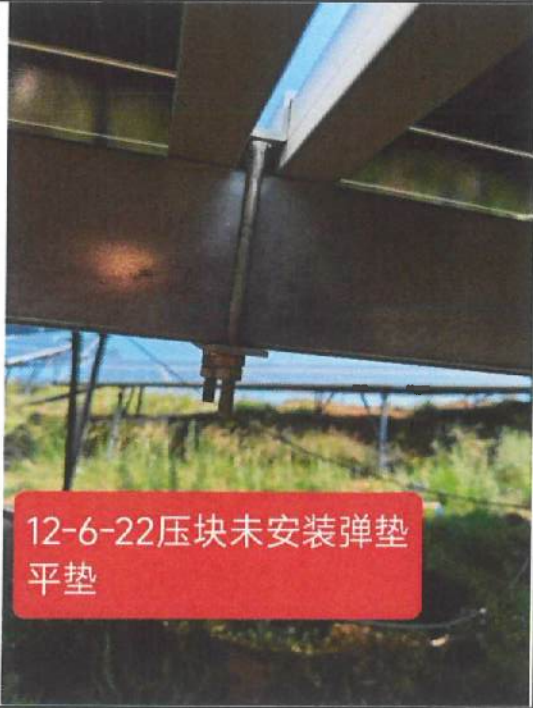
77

12-6-22压块未安装弹垫平垫
