平陆县 100MW 农光互补光伏发电项目

监理工程师通知单

编号: ZHJL-JLTZ-PL-071

主题: 关于监理、总包对东郑光伏场区初验收检查发现以下需要消缺项:

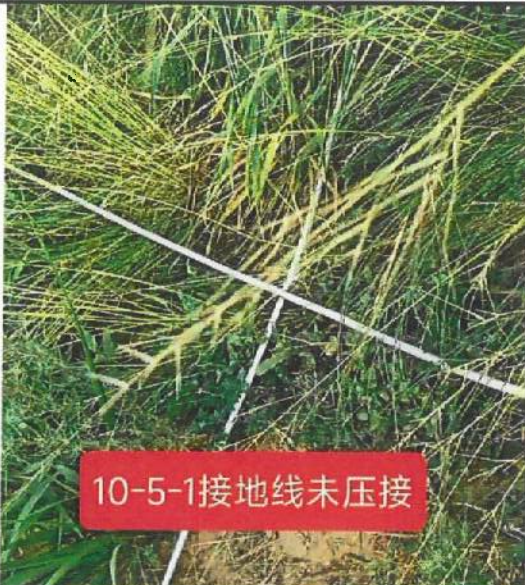
| 5 | <p>10-5-1接地线未压接</p> | 6 | <p>10-5-1压块缺少螺母</p> |

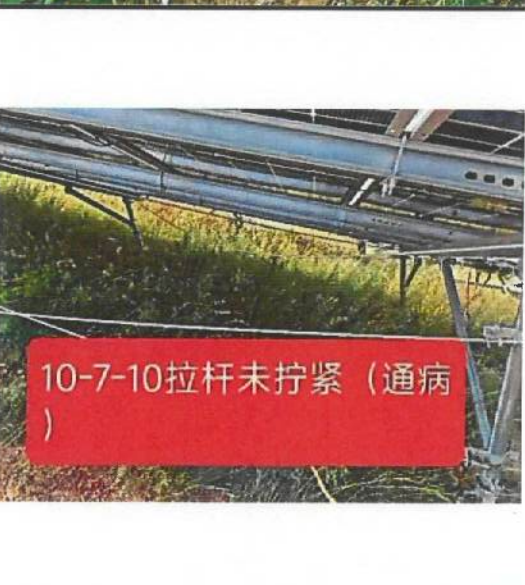
| 7 | <p>10-7-10拉杆未拧紧 (通病)</p> | 8 | <p>10-6-27组件下沉</p> |

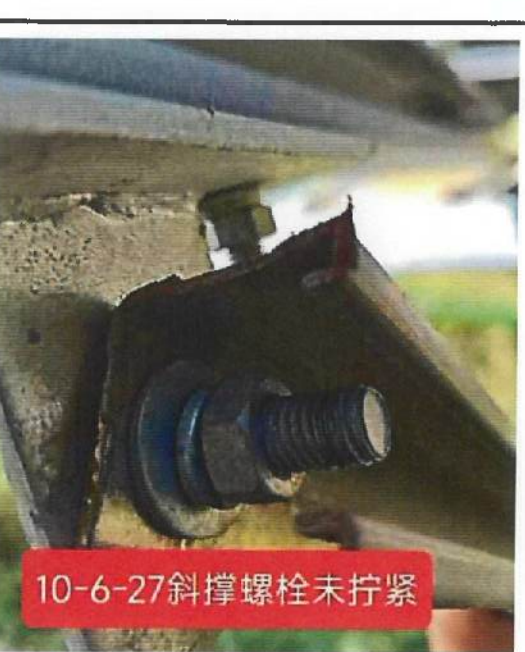
| 9 | <p>10-6-27斜撑螺栓未拧紧</p> | 10 | <p>10-6-27组件下有小树苗需清理 (通病)</p> |

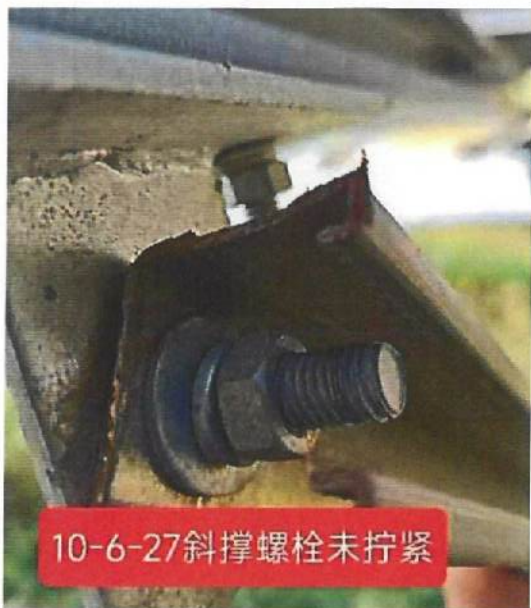
11

10-6-27斜撑螺栓未拧紧

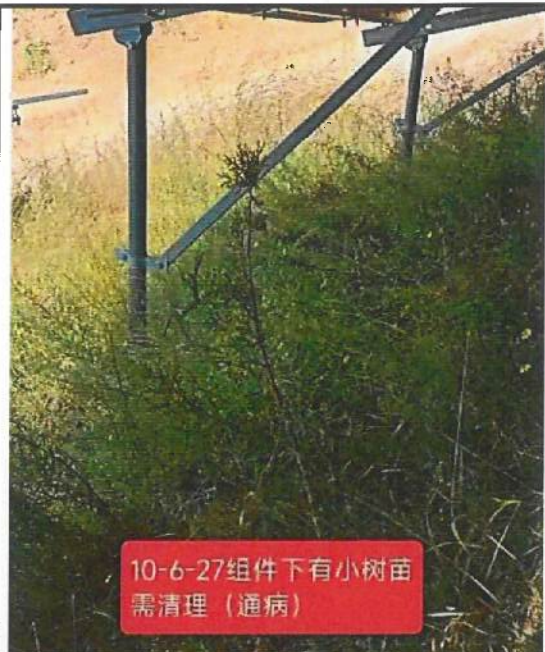
12

10-6-27组件下有小树苗  
需清理 (通病)

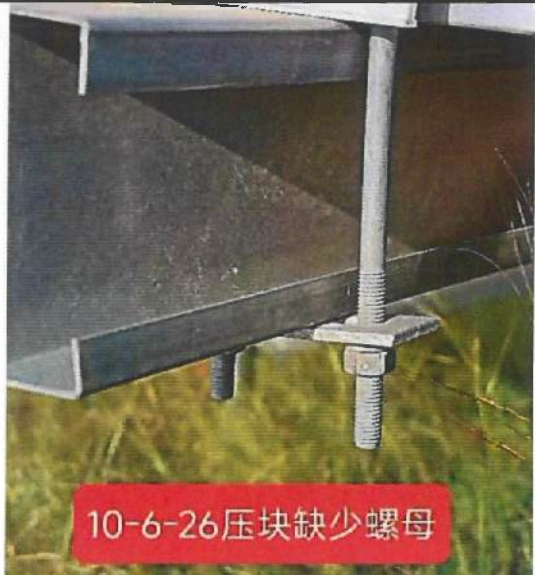
13

10-6-26压块缺少螺母

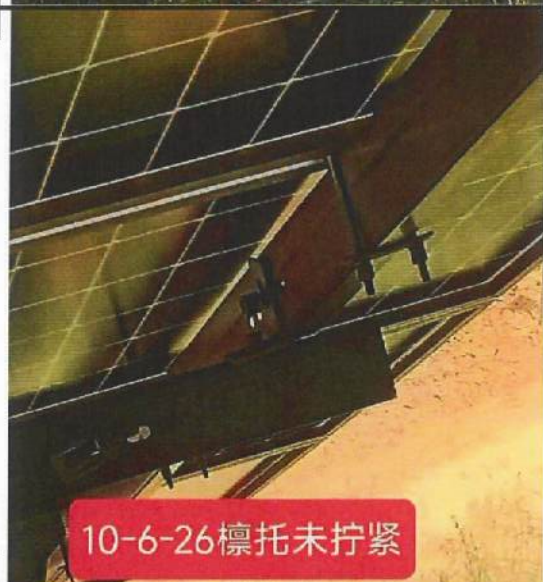
14

10-6-26檩托未拧紧

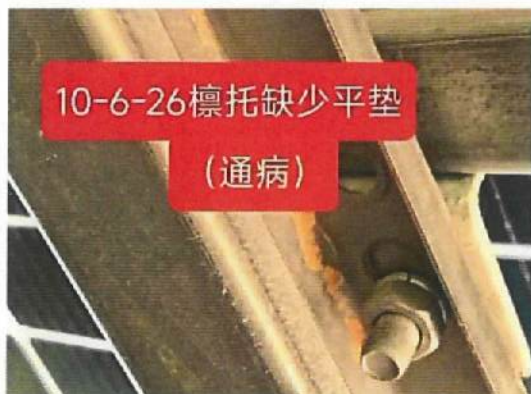
15

10-6-26檩托缺少平垫  
(通病)

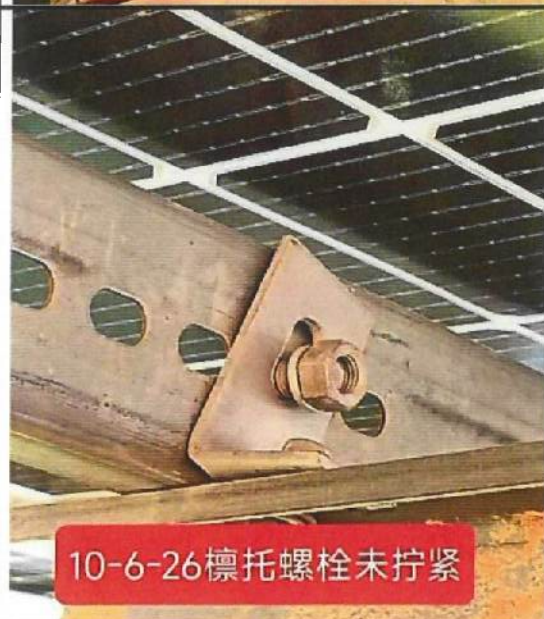
16

10-6-26檩托螺栓未拧紧

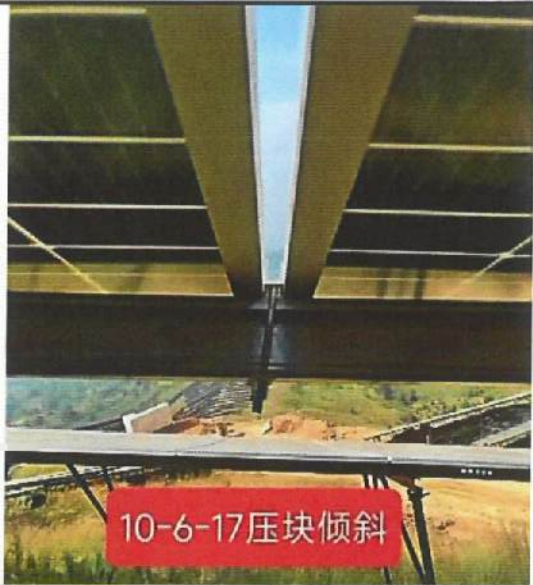
| 23 | <p>10-6-17压块倾斜</p> | 24 | <p>10-6-14檩条连接件缺少螺母</p> |

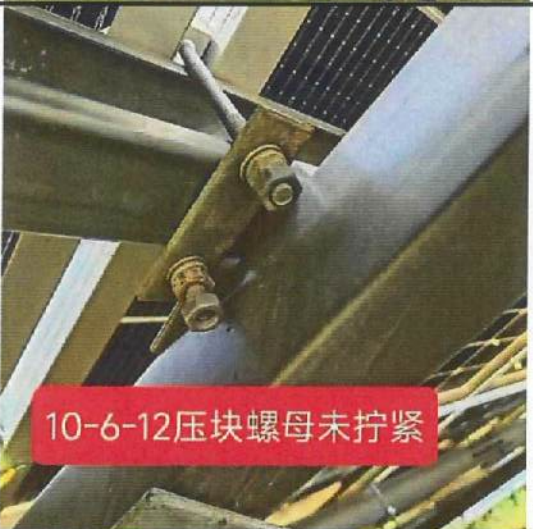
| 25 | <p>10-6-12压块螺母未拧紧</p> | 26 | <p>10-6-12檩托未拧紧</p> |

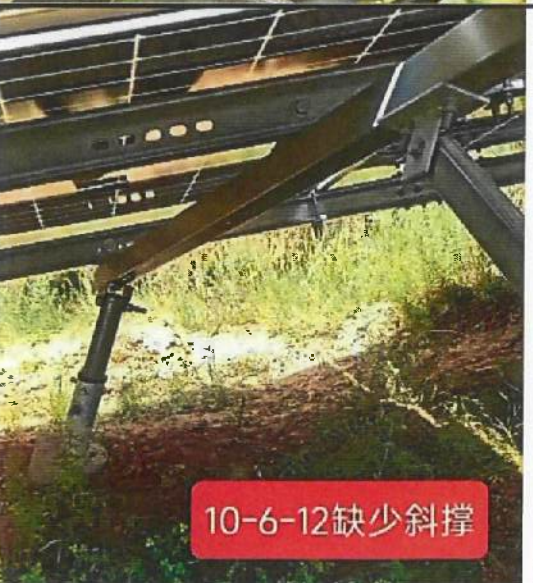
| 27 | <p>10-6-12缺少斜撑</p> | 28 | <p>10-6-9檩条连接件缺少弹垫</p> |

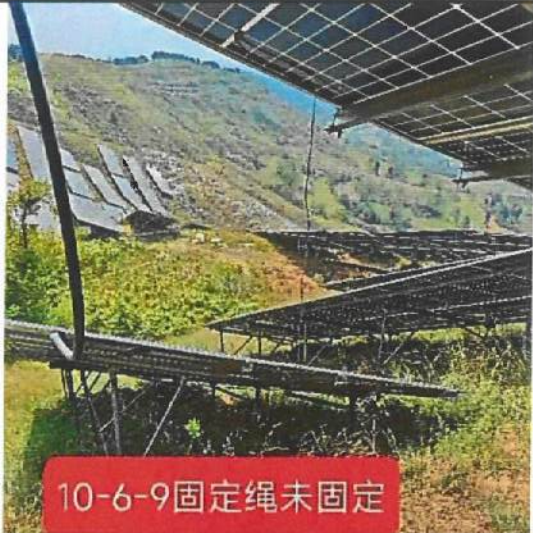
| 29 | <p>10-6-9固定绳未固定</p> | 30 | <p>10-6-13压块缺少垫片</p> |

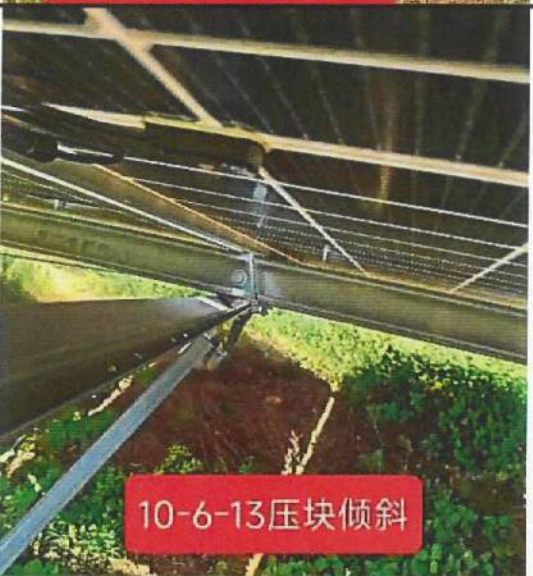
| 31 | <p>10-6-13压块倾斜</p> | 32 | <p>10-5-12压块缺少螺母</p> |

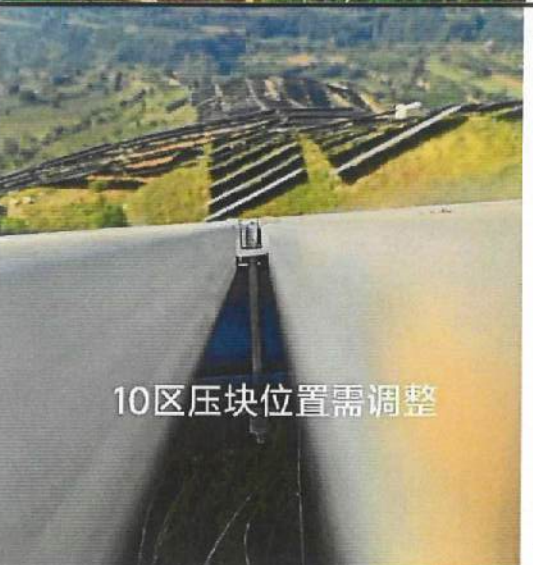
| 33 | <p>10区压块位置需调整</p> | 34 | <p>10区地锚桩未浇筑</p> |

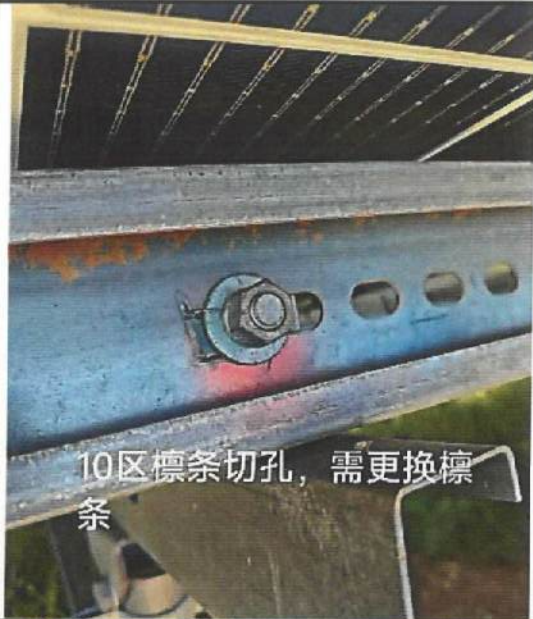
| 35 | <p>10区檩条切孔，需更换檩条</p> | 36 | <p>10-5-11压块缺少螺栓</p> |

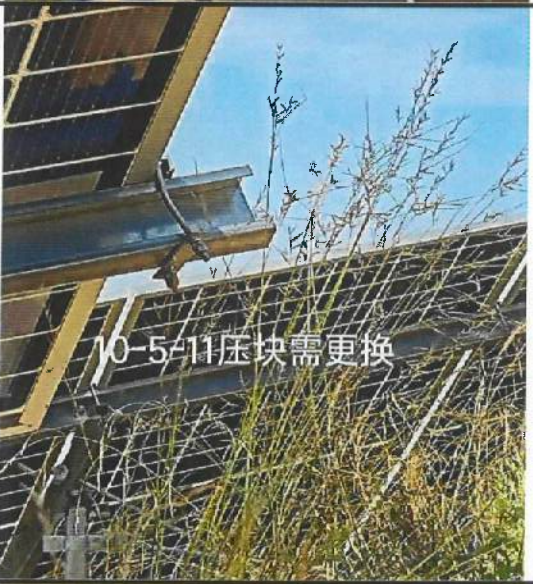
| 37 | <p>10-5-11压块需更换</p> | 38 | <p>10-5-13垫片安装位置错误</p> |

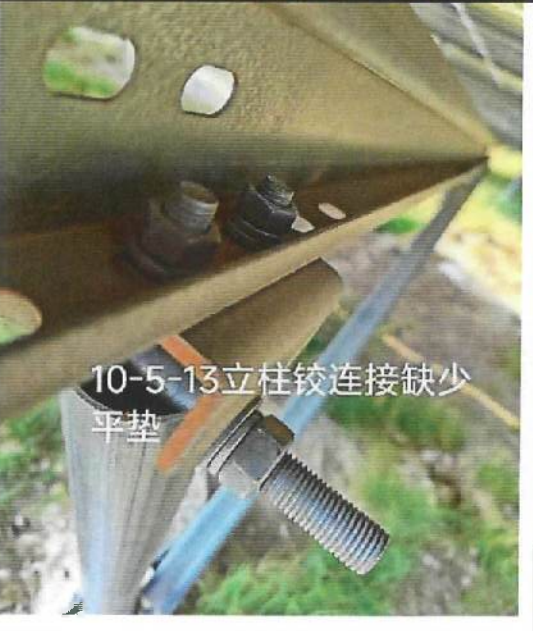
| 39 | <p>10-5-13立柱铰连接缺少平垫</p> | 40 | <p>10-5-14檩条连接件缺少平垫</p> |

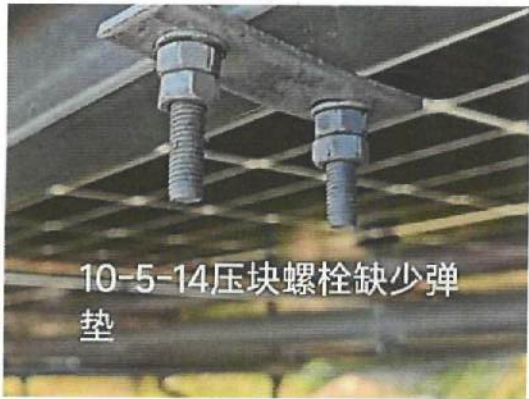
| 41 | <p>10-5-14压块螺栓缺少弹垫</p> | 42 | <p>10-5-12檩托螺栓缺少垫片</p> |

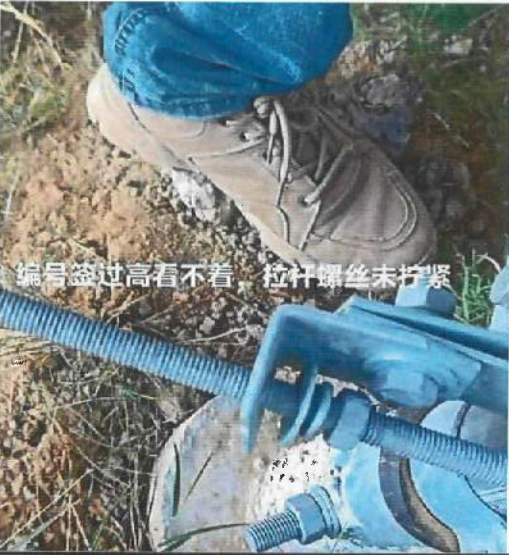
| 43 | <p>编号签过高看不见 拉杆螺丝未拧紧</p> | 44 | <p>10-15-2 拉杆螺丝未拧紧</p> |

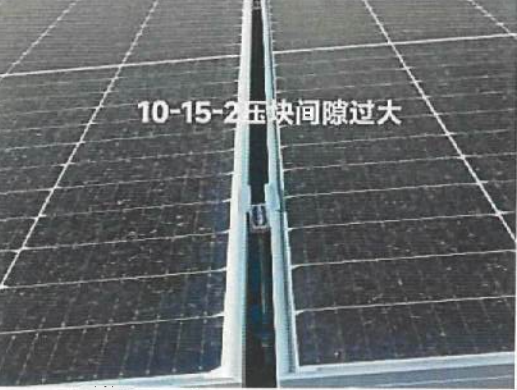
| 45 | <p>10-15-2压块间隙过大</p> | 46 | <p>10-15-2斜撑未受力</p> |

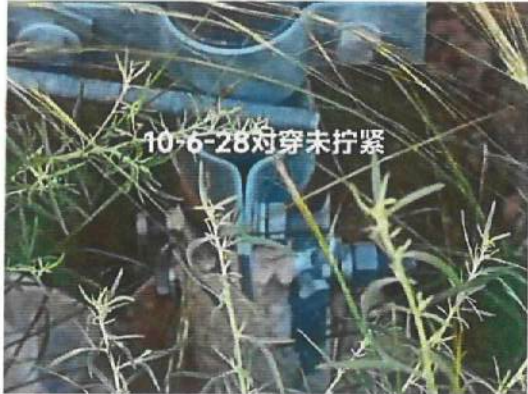
| 47 | <p>10-6-28对穿未拧紧</p> | 48 | <p>10-6-20斜撑螺丝未拧紧</p> |

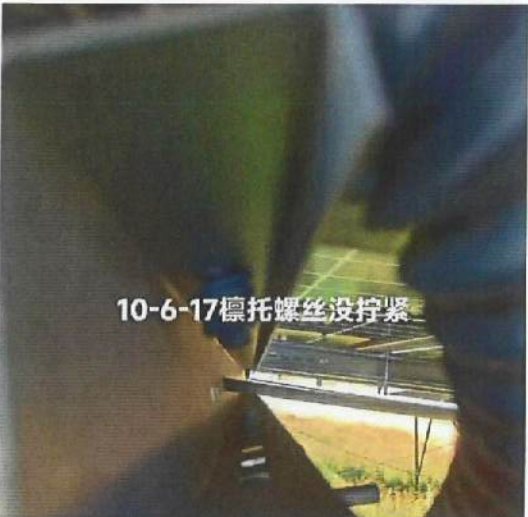
| 49 | <p>10-6-17檩托螺丝没拧紧</p> | 50 | <p>10-6-17抱箍未紧</p> |

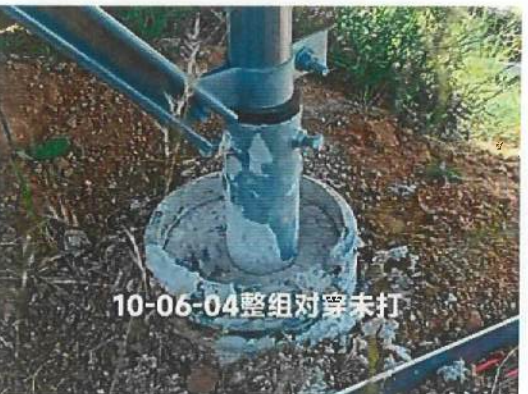
| 51 | <p>10-06-04整组对穿未打</p> | 52 | <p>10-06-04缺少平垫</p> |

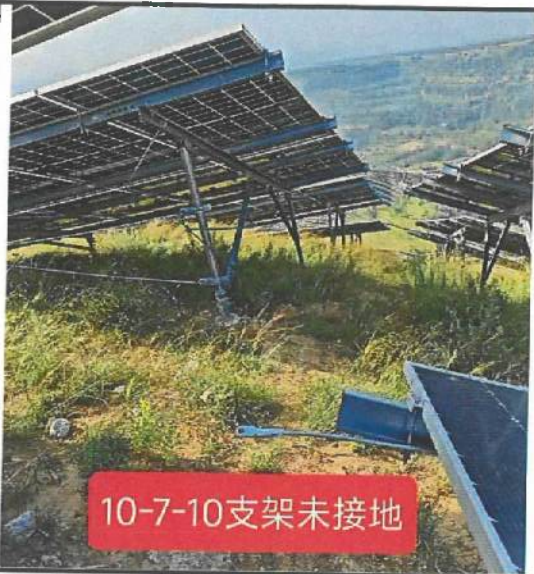
| 59 | <br>10-7-10支架未接地 | 60 | <br>10-7-16斜梁弯曲 |
