# 平陆县 100MW 农光互补光伏发电项目

## 监理工程师通知单

编号: ZHJL-JLTZ-PL-147

2024 年 10 月 28、10 月 29 日建设单位、监理单位及总包单位对东郑 11、10 区光伏区验收过程中发现以下问题:

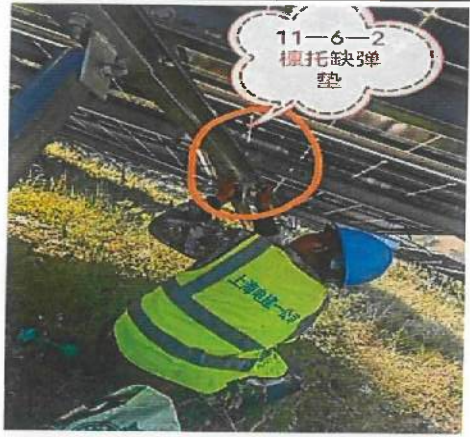
| 5 | <p>11-6-2<br/>撑托缺弹<br/>垫</p> | 6 | <p>11-4-22<br/>地埋桩没有<br/>浇筑桩帽</p> |

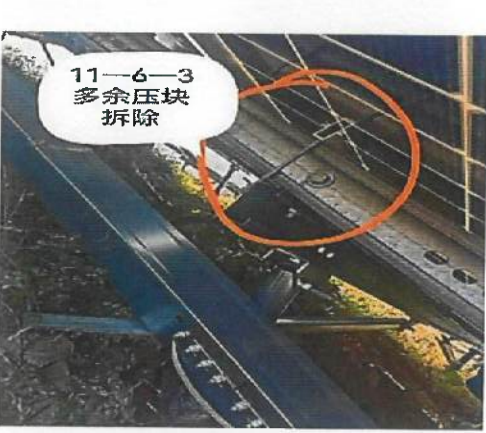
| 7 | <p>11-6-3<br/>多余压块<br/>拆除</p> | 8 | <p>11-4-<br/>23桥架盖<br/>板未清理</p> |

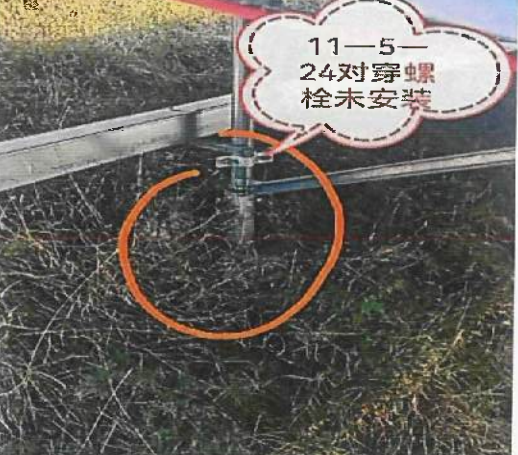
| 9 | <p>11-5-<br/>24对穿螺<br/>栓未安装</p> | 10 | <p>11-5-<br/>24压块滑<br/>丝需更换</p> |

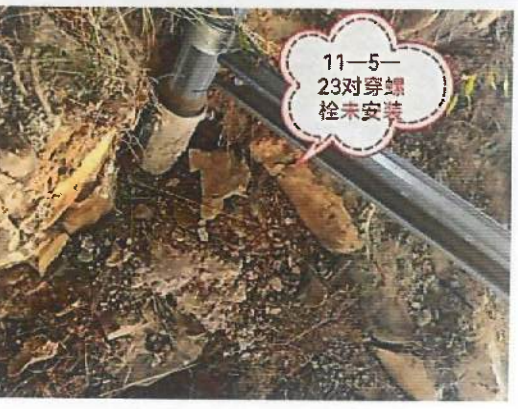
| 11 | <p>11-5-<br/>23对穿螺<br/>栓未安装</p> | 12 | <p>11-6-3<br/>对穿螺栓<br/>未安装</p> |

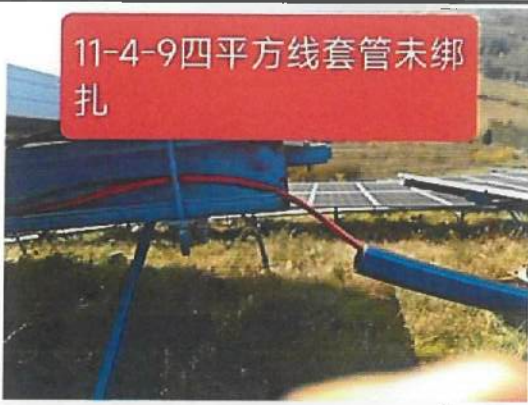
| 19 | <p>11-4-9四平方线套管未绑扎</p> | 20 | <p>11-4-13拉杆安装不规范</p> |

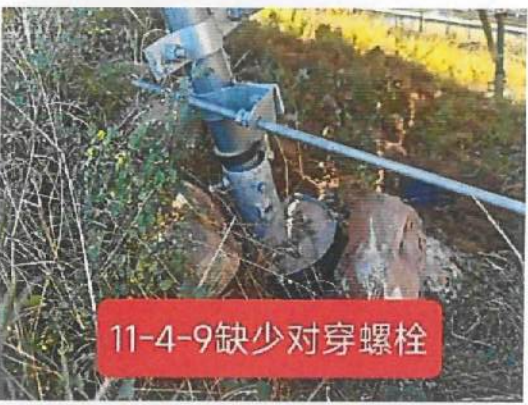
| 21 | <p>11-4-9缺少对穿螺栓</p> | 22 | <p>11-6-18压块受力面小，需要调整</p> |

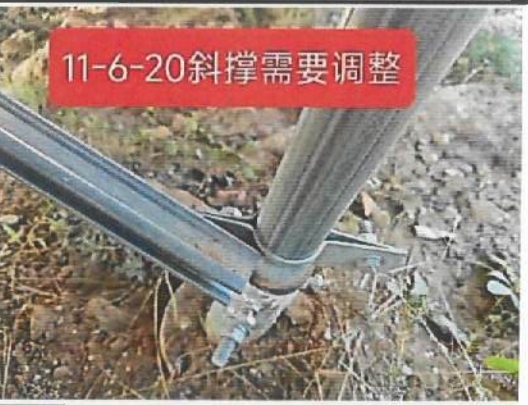
| 23 | <p>11-6-20斜撑需要调整</p> | 24 | <p>11-6-19至11-6-18间接地为连接</p> |

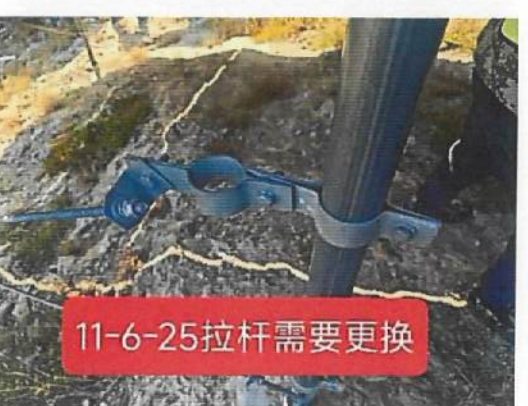
| 25 | <p>11-6-25拉杆需要更换</p> | 26 | <p>11-8-5多余压块</p> |

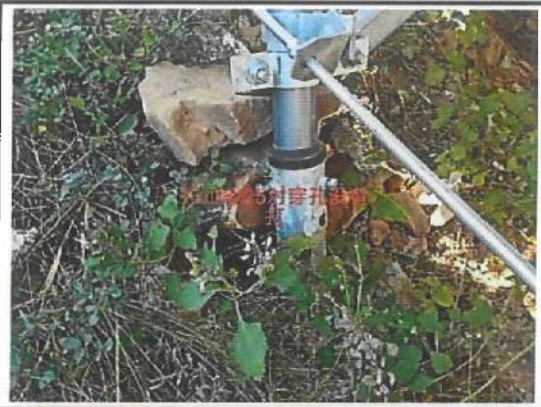
| 65 | <p>10/08/21 5吋管孔塞</p> | 66 | <p>10/08/21 5吋管孔塞</p> |

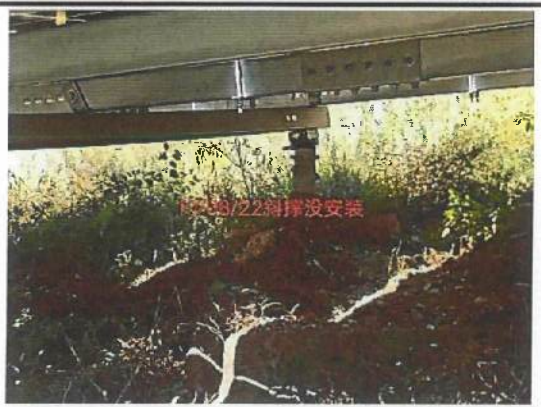
| 67 | <p>10/08/22 斜撑没安装</p> | 68 | <p>10/08/22 斜撑不受力<br/>2个</p> |

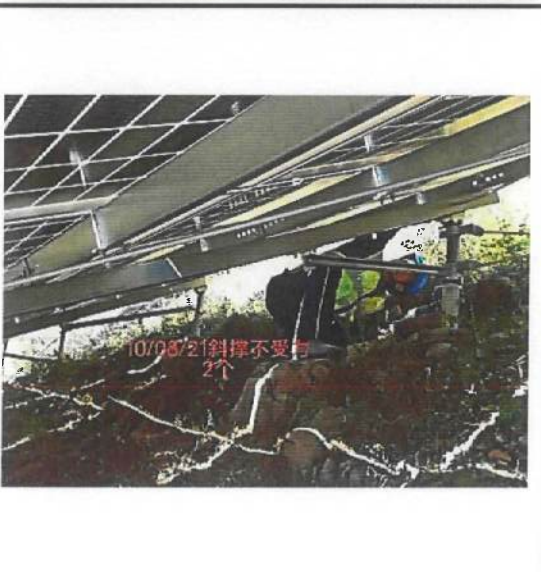
| 69 | <p>10/08/21 斜撑不受力<br/>2个</p> | 70 | <p>10/08/22 缺少对穿</p> |

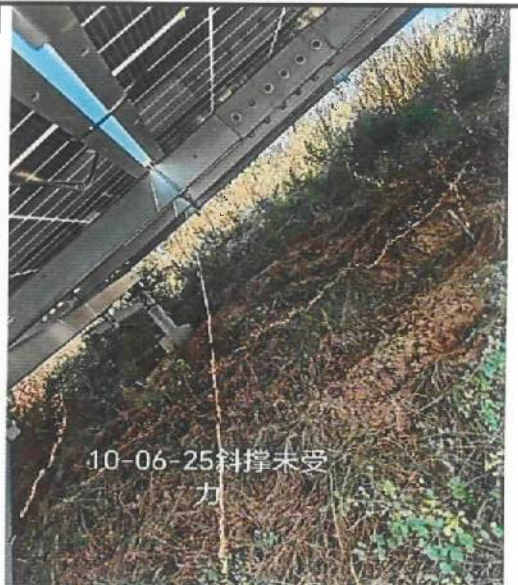
| 83 | <p>10-06-25斜撑未受力</p> | 84 | <p>10-06-29斜撑未受力</p> |

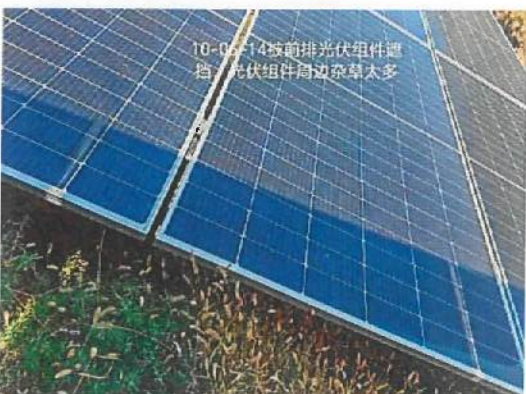
| 85 | <p>10-06-14线前排光伏组件遮挡，<br/>光伏组件周边杂草太多</p> | 86 | <p>10-06-05线前排光伏组件<br/>遮挡，周边杂草太多</p> |

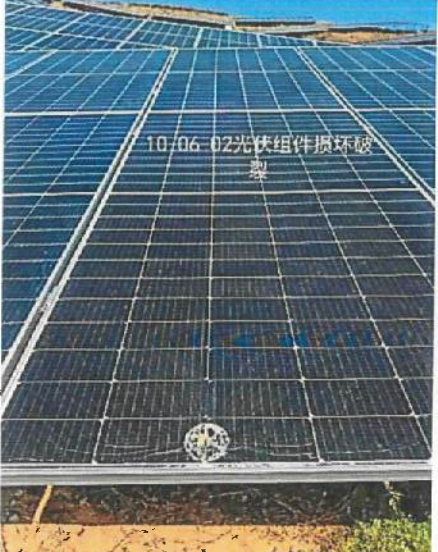
| 87 | <p>10/06-02光伏组件损坏破裂</p> | 88 | <p>10-1-4前立杆缺少对穿螺栓</p> |

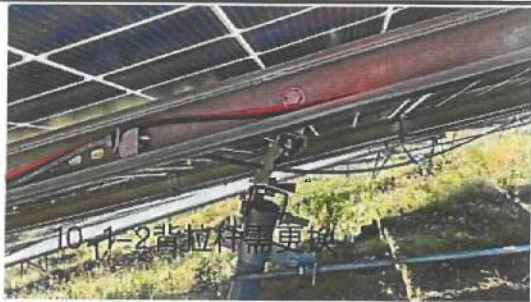
| 89 | <p>10-1-2背拉杆需更换</p> | 90 | <p>10-2-13组件装反，需调整</p> | |

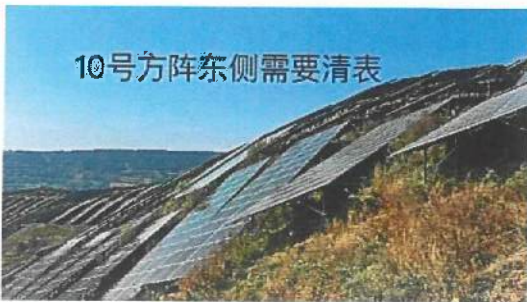
| 91 | <p>10号方阵东侧需要清表</p> | 92 | <p>10-5-16寒刺遮挡组件</p> | |

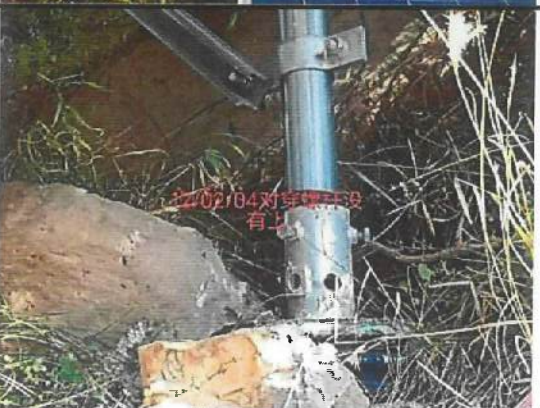
| 93 | 10-4-9, 10-4-10 组串正负极无号码管 | | 94 | <p>10-02-04对穿螺栓有上</p> |
