# 平陆县 100MW 农光互补光伏发电项目

## 监理工程师通知单

编号: ZHJL-JLTZ-PL-176

主题: 2024 年 12 月 28 日、29 日建设单位、监理单位及总包单位在西沟光伏区验收过程中发现以下问题:

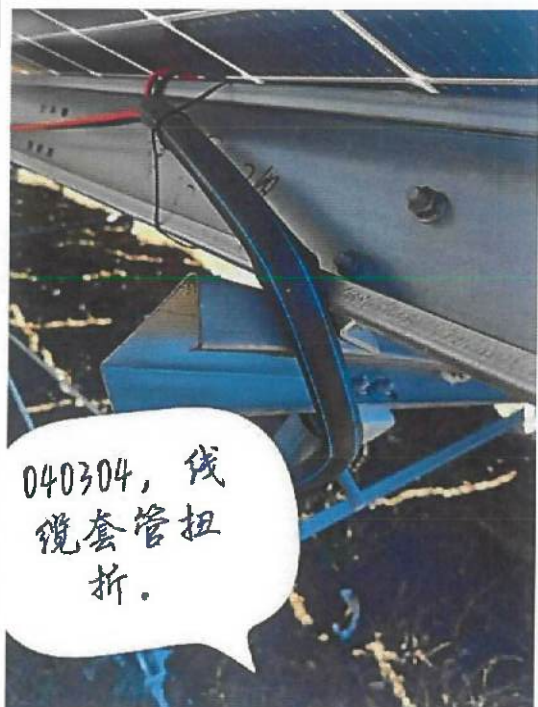
11

040304, 线  
缆套管扭  
折。

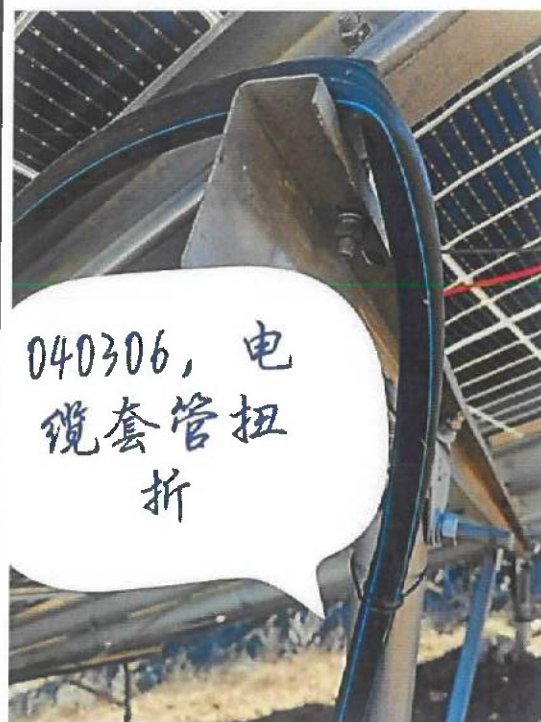
12

040306, 电  
缆套管扭  
折

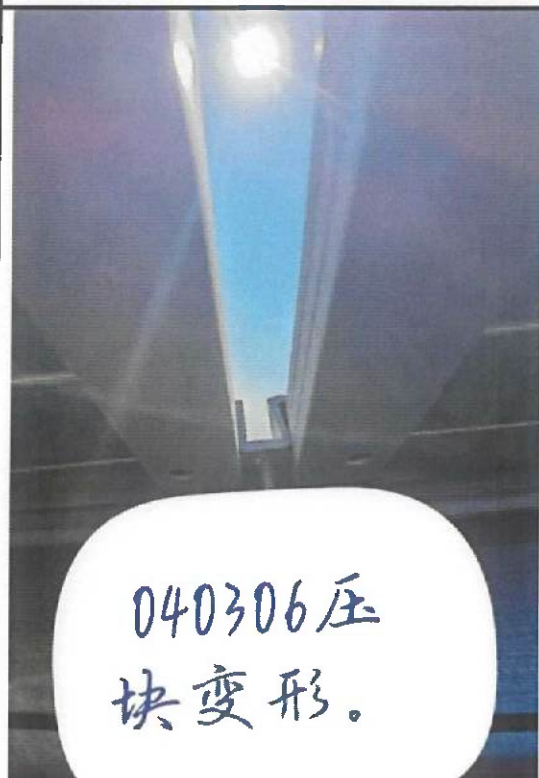
13

040306压  
块变形。

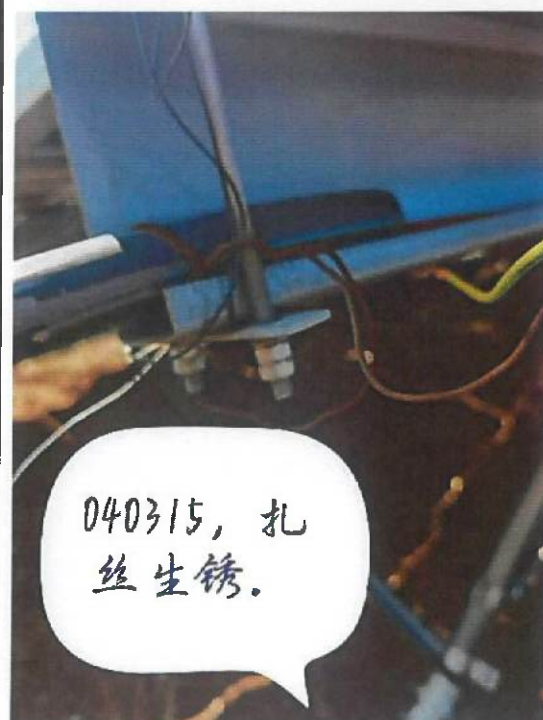
14

040315, 扎  
丝生锈。

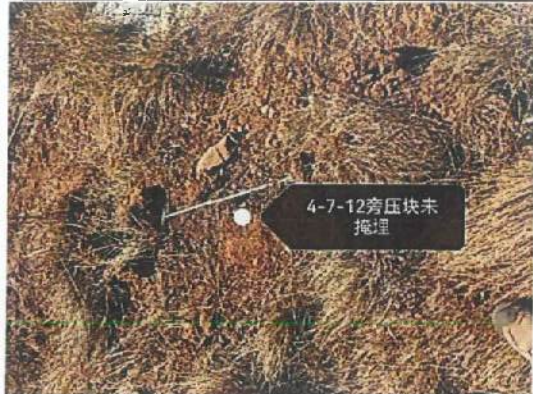
| 37 | <p>4-7-12旁压块未掩埋</p> | 38 | <p>4-7-12压块边距不够</p> |

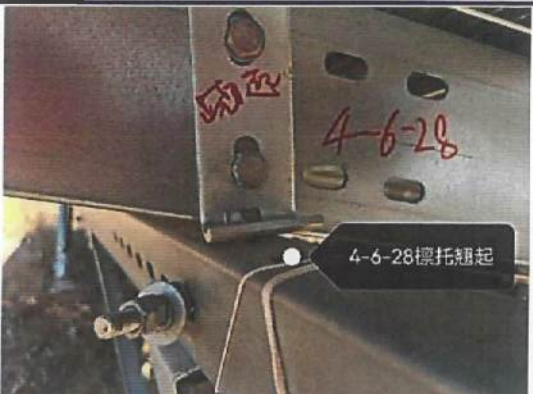
| 39 | <p>4-6-28标识翘起</p> | 40 | <p>4-6-2U型螺栓生锈</p> |

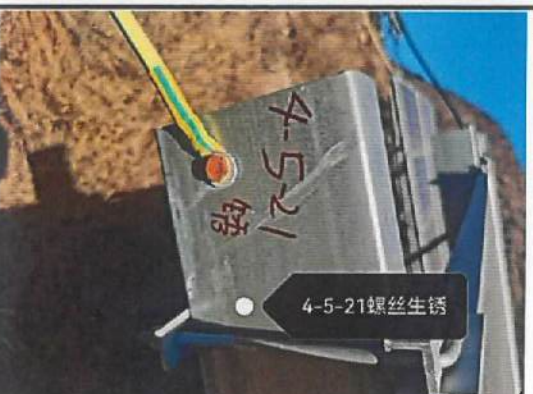
| 41 | <p>4-5-21螺丝生锈</p> | 42 | <p>4-5-20缺少螺丝</p> |

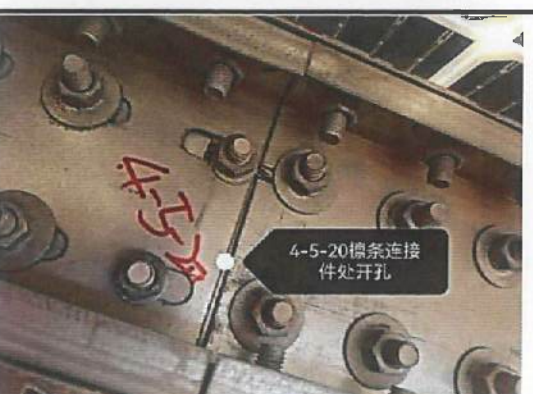
| 43 | <p>4-5-20标识条连接件处开孔</p> | 44 | <p>4-4-14跨接线生锈</p> |

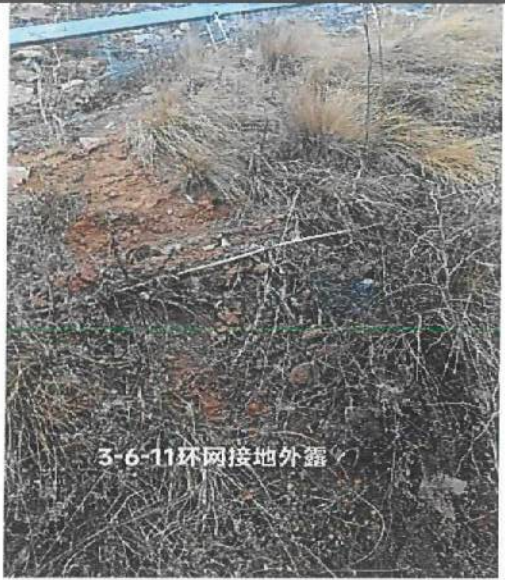
| 141 | <p>3-6-11环网接地外露</p> | 142 | <p>3-7-12环网接地深埋</p> |

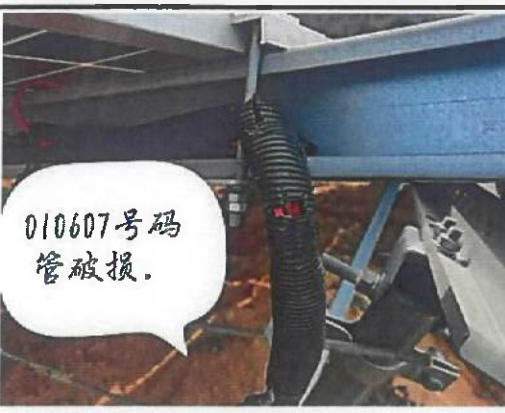
| 143 | <p>010607号码管破损。</p> | 144 | <p>010607、背拉杆生锈。</p> |

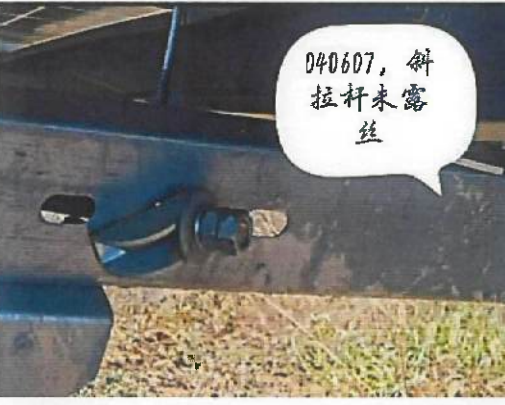
| 145 | <p>040607, 斜拉杆未露丝</p> | 146 | <p>0107逆变器防水封堵。</p> |

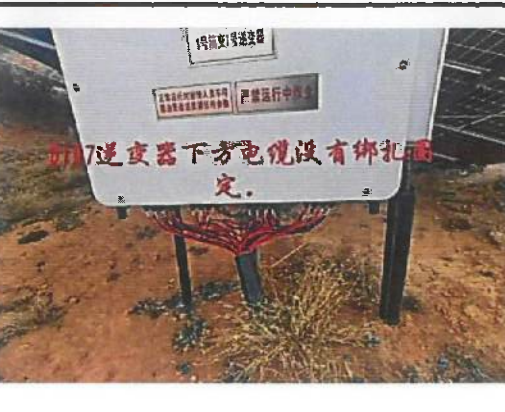
| 147 | <p>0107逆变器下方电缆没有绑扎固定。</p> | 148 | <p>010722套管不够长。</p> |

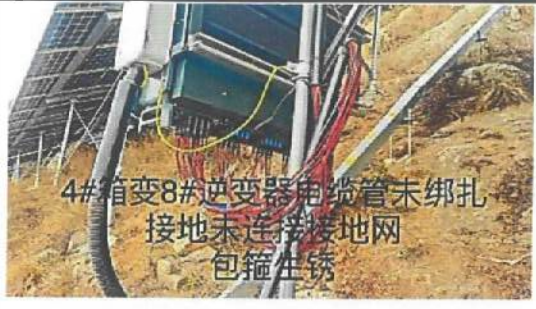
| 161 | <p>4#箱变8#逆变器电缆管未绑扎<br/>接地未连接接地网<br/>包箍生锈</p> | 162 | <p>3-8-22 3-8-28<br/>多余檩条未切割</p> |

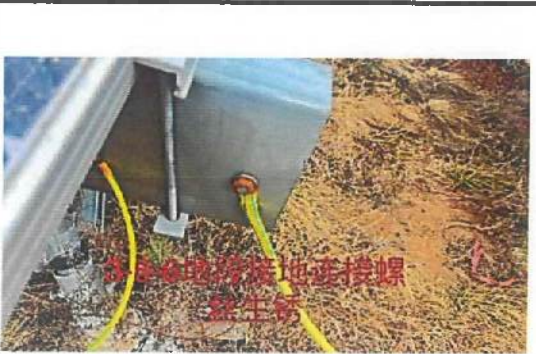
| 163 | <p>3-4-4地线接地连接螺<br/>丝生锈</p> | 164 | <p>2-5-13四平方电缆需要绑<br/>扎</p> |

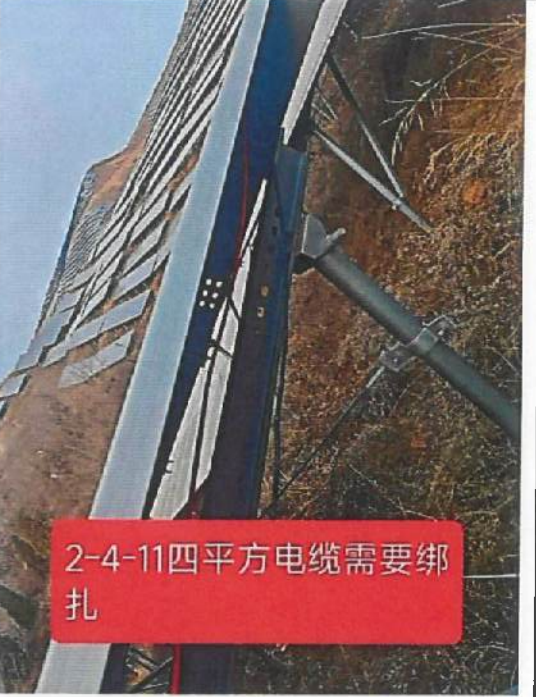
| 165 | <p>2-4-11四平方电缆需要绑<br/>扎</p> | 166 | <p>2-4-18檩条过长</p> |

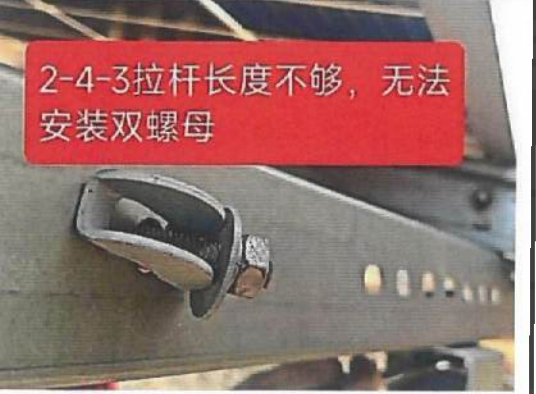
| 167 | <p>2-4-3拉杆长度不够，无法<br/>安装双螺母</p> | 168 | <p>2-4-5檩托未开孔，缺少螺<br/>栓</p> |
