# 平陆县 100MW 农光互补光伏发电项目

## 监理工程师通知单

编号: ZHJL-JLTZ-PL-192

主题: 2025 年 3 月 23 日建设单位、监理单位及总包单位在洪池地块 29 区、32 区验收过程中发现以下问题:

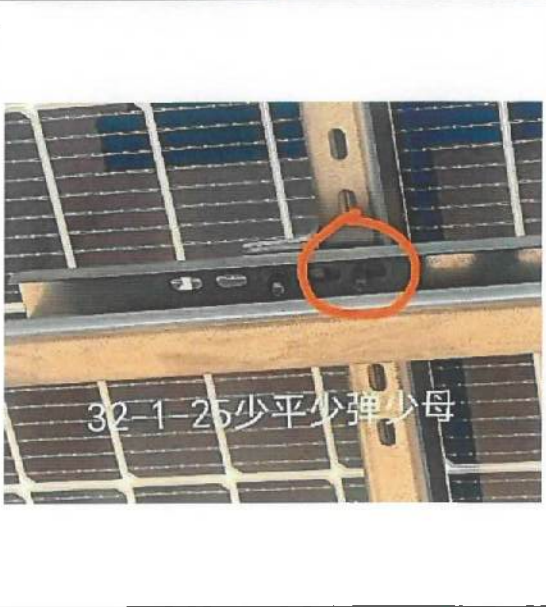
| 3 | <p>32-1-27斜槽条弯曲</p> | 4 | <p>32-1-25少平少弹少母</p> |

请贵单位按照上述问题立即消缺整改。

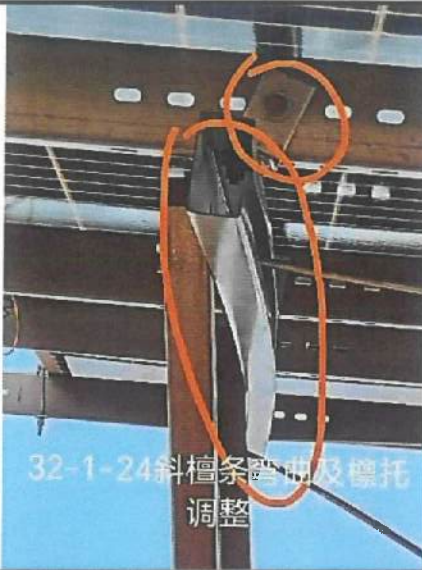
| 5 | <p>32-1-24斜槽条弯曲及撑托调整</p> | 6 | <p>32-1-28二次灌胶没做</p> |

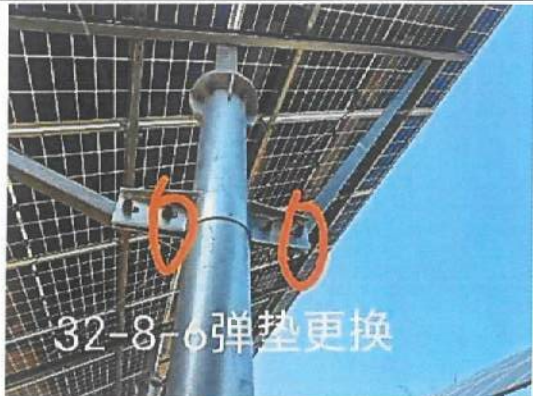
| 29 | <p>32-8-6弹垫更换</p> | 30 | <p>32-8-5少平弹母</p> |

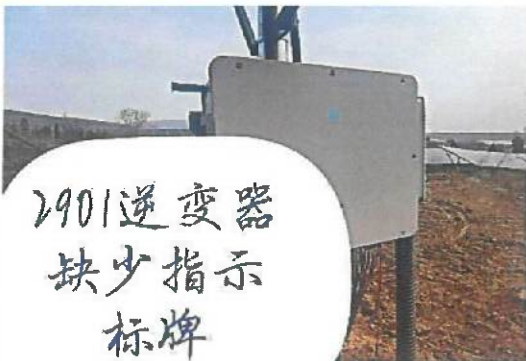
| 31 | <p>2901逆变器<br/>缺少指示<br/>标牌</p> | 32 | <p>290204斜撑<br/>螺栓未拧<br/>紧</p> |

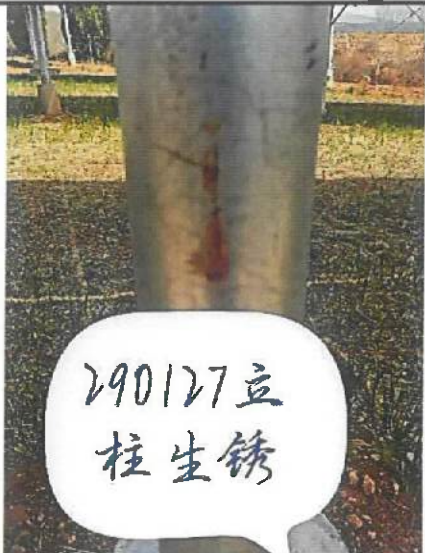
| 33 | <p>290127立<br/>柱生锈</p> | 34 | <p>290101斜撑<br/>有破损孔<br/>洞</p> |

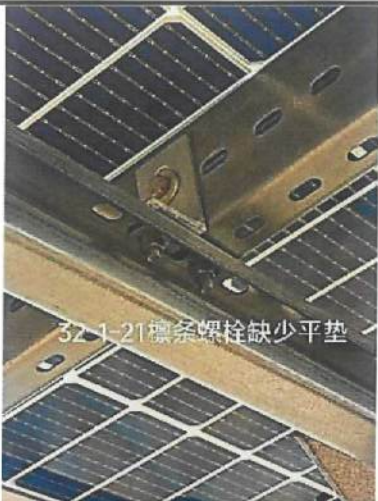
| 35 | <p>32-1-21 標条螺栓缺少平垫</p> | 36 | <p>32-1-20 標条螺栓缺少彈墊</p> |

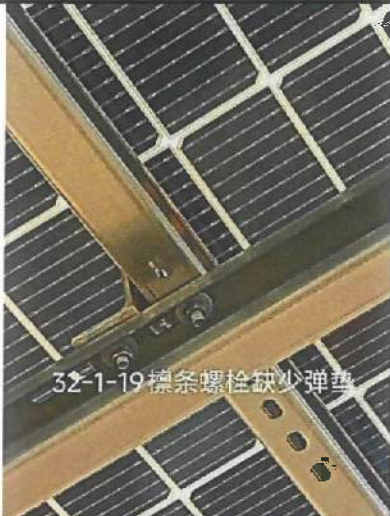
| 37 | <p>32-1-19 標条螺栓缺少彈墊</p> | 38 | <p>32-1-18 斜撐螺栓未拧紧</p> |

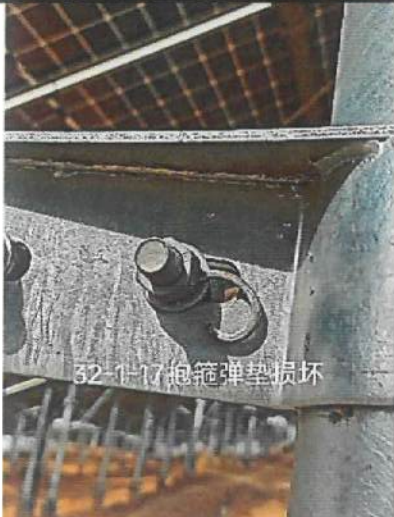
| 39 | <p>32-1-17 抱箍彈墊损坏</p> | 40 | <p>32-1-14 標托螺栓未拧紧</p> |

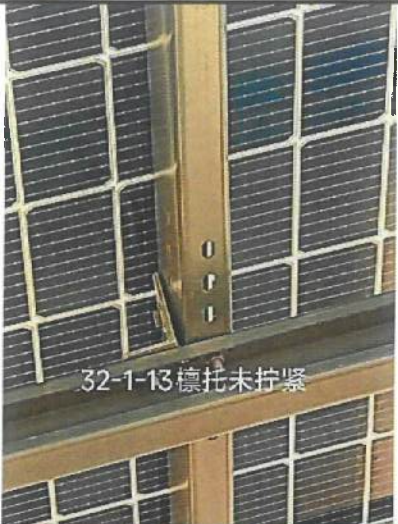
| 41 | <p>32-1-13 檩托未拧紧</p> | 42 | <p>32-1-13 檩条螺栓未拧紧</p> |

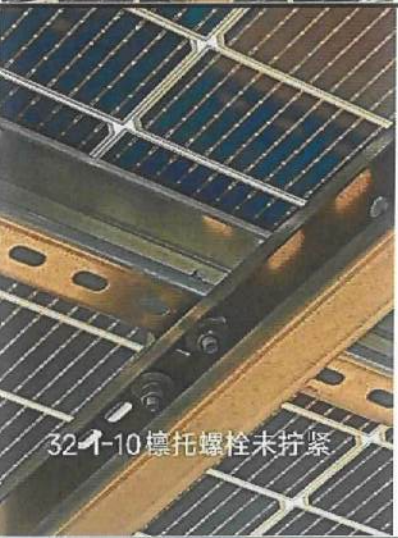
| 43 | <p>32-1-10 檩托螺栓未拧紧</p> | 44 | <p>32-1-9 檩条连接件缺少螺栓</p> |

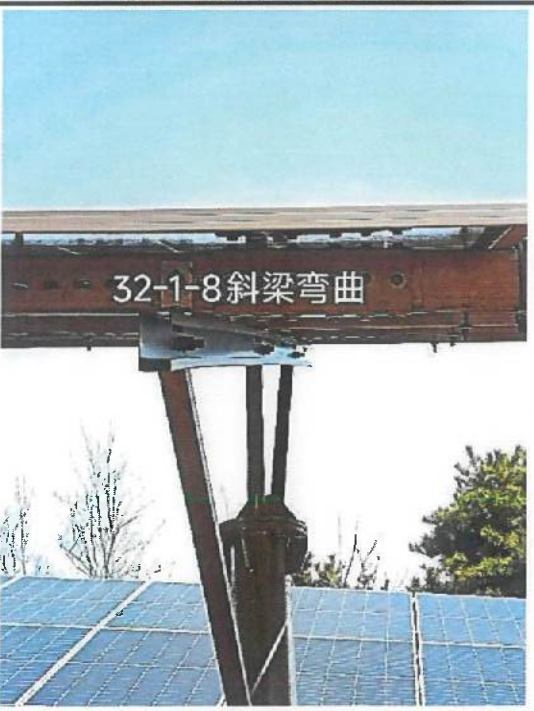
| 45 | <p>32-1-8 斜梁弯曲</p> | 46 | <p>32-1-6 檩托螺栓缺少弹垫</p> |

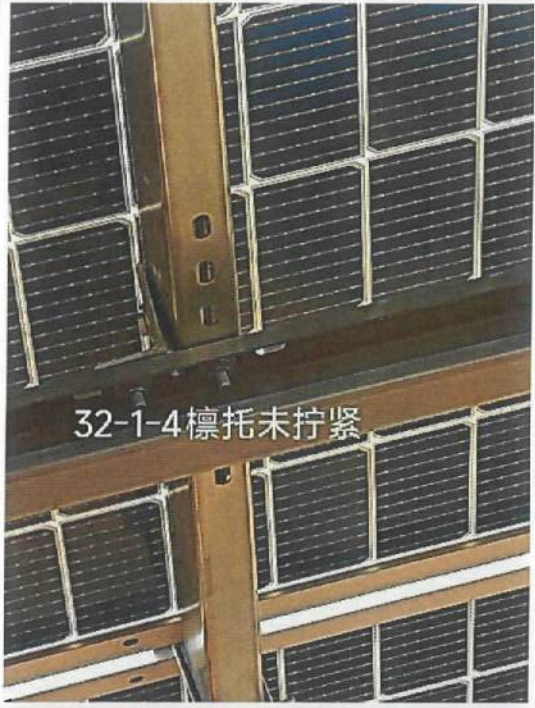
| 47 | <p>32-1-4 標托未拧紧</p> | 48 | <p>32-1-3 標条连接件未拧紧</p> |

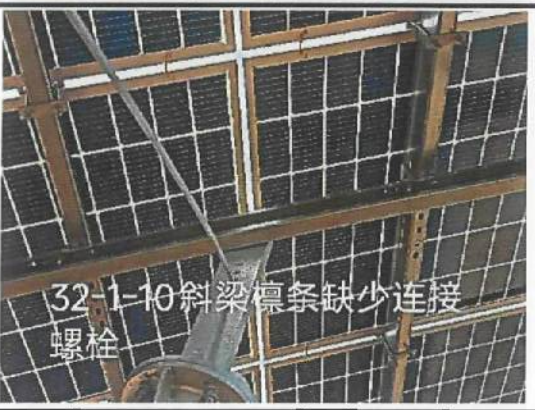
| 49 | <p>32-1-10 斜梁標条缺少连接螺栓</p> | 50 | <p>32-1-10 斜梁弯曲</p> |

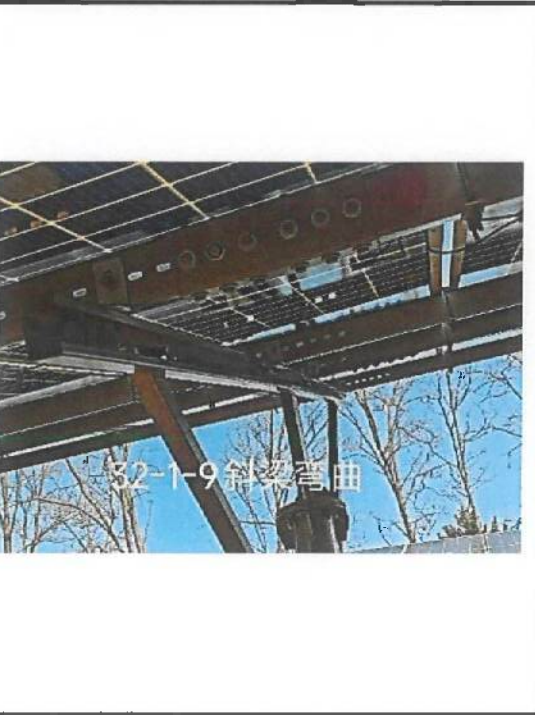
| 51 | <p>32-1-9 斜梁弯曲</p> | 52 | <p>32-1-3 斜梁弯曲</p> |

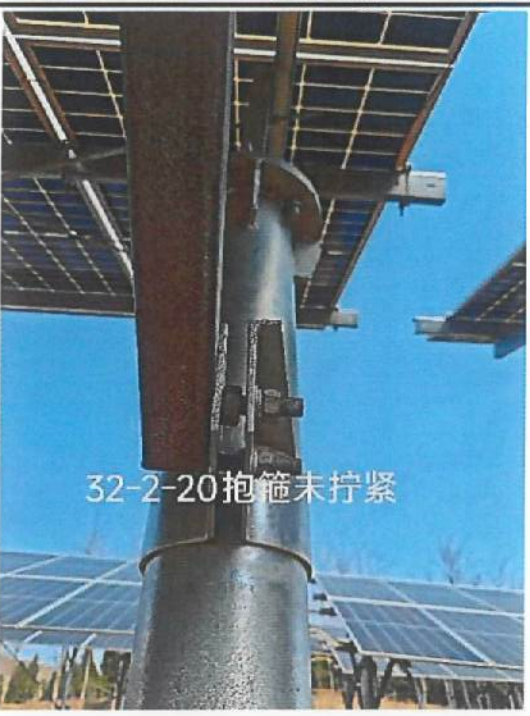
| 61 | <p>32-2-20 抱箍未拧紧</p> | 62 | <p>32-2-20 抱箍未拧紧</p> |

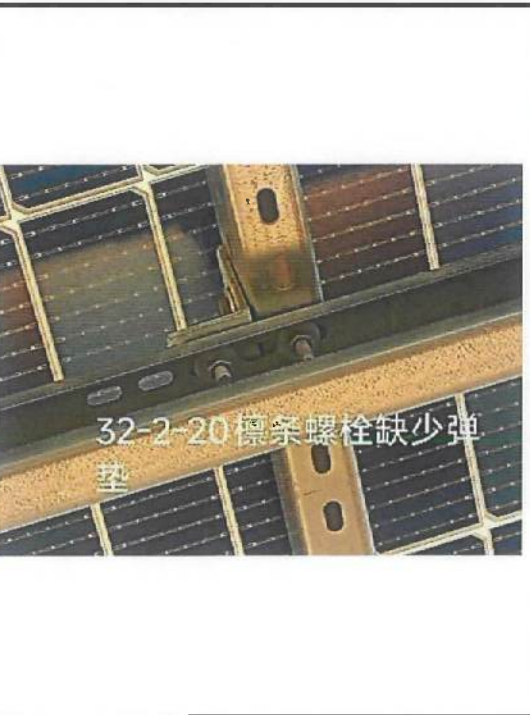
| 63 | <p>32-2-20 檩条螺栓缺少弹垫</p> | 64 | <p>32-2-19 抱箍未拧紧</p> |

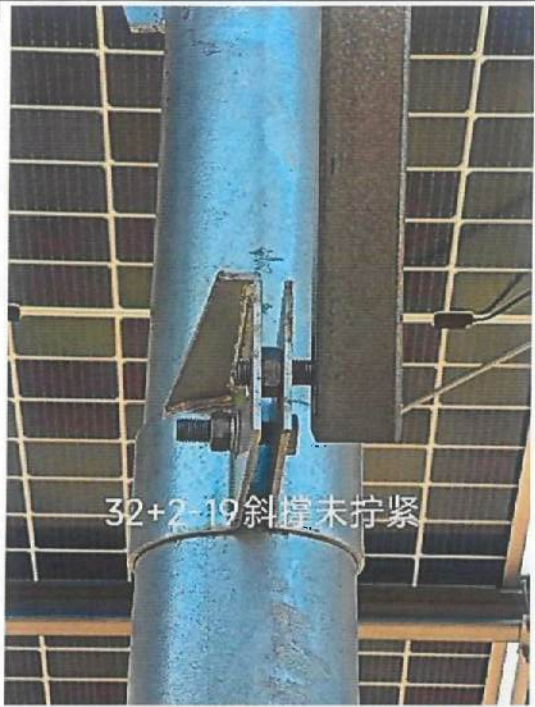
| 65 | <p>32+2-19斜撑未拧紧</p> | 66 | <p>32-8-2抱箍弹垫损坏</p> |

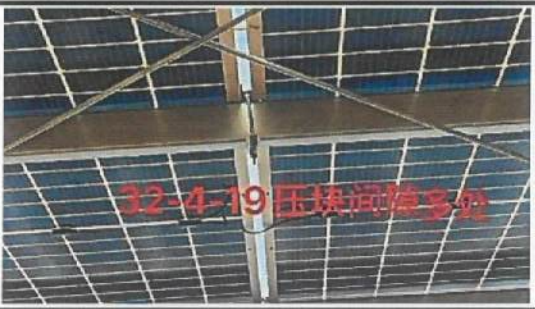
| 67 | <p>32-4-19压块间隙多处</p> | 68 | <p>32-4-20螺丝松动</p> |

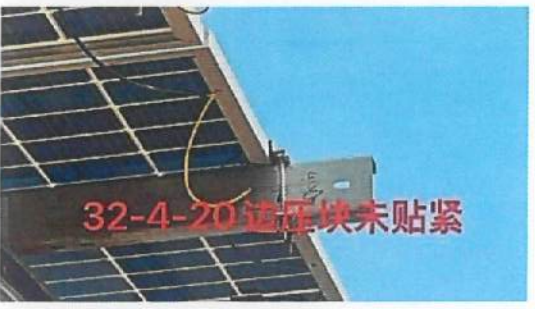
| 69 | <p>32-4-20压块未贴紧</p> | 70 | <p>32-4-26压块间隙多处</p> |

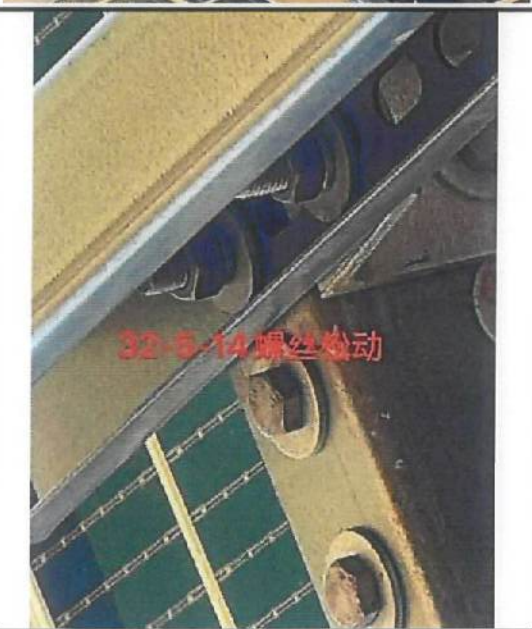
| 77 | <p>32-5-14 螺丝松动</p> | 78 | <p>32-5-23 槽托螺丝松动<br/>通病</p> |

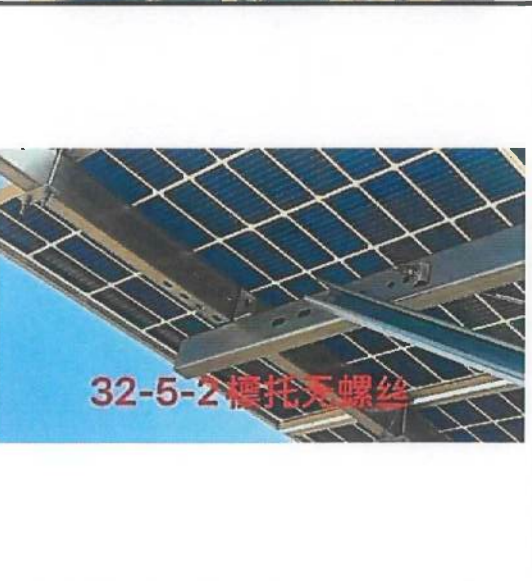
| 79 | <p>32-5-2 槽托无螺丝</p> | 80 | <p>32-2-26 槽托螺丝未紧</p> |

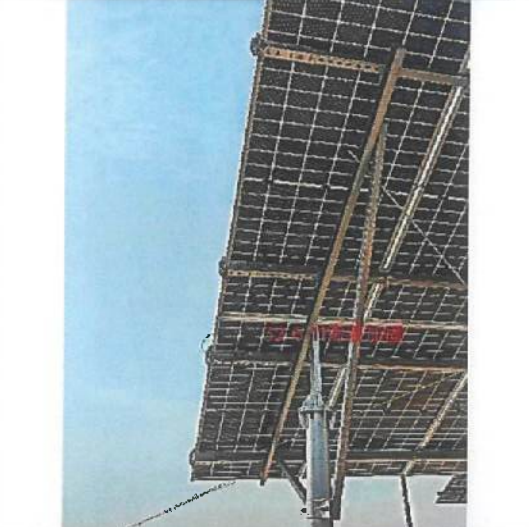
| 91 | <p>32区69号托架缺螺丝</p> | 92 | <p>52区69号托架缺螺丝</p> |

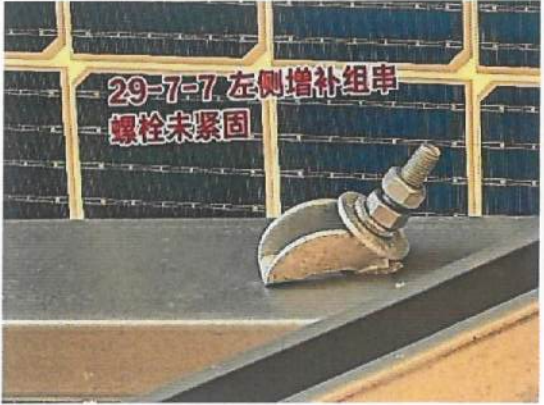
| 105 | <p>29-7-4 边压块安装不<br/>到位</p> | 106 | <p>29-7-7 左侧增补组串<br/>螺栓未紧固</p> |

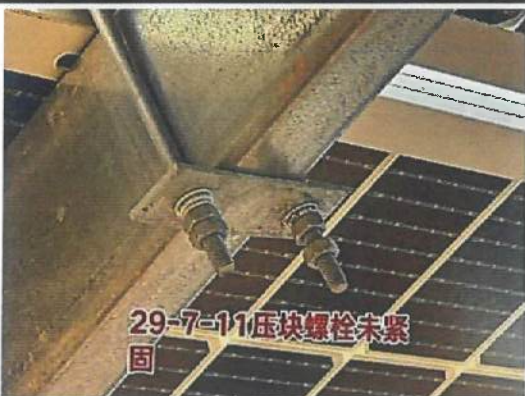
| 109 | <p>29-7-11压块螺栓未紧<br/>固</p> | 110 | <p>29-7-12 压块螺栓单<br/>螺母</p> |

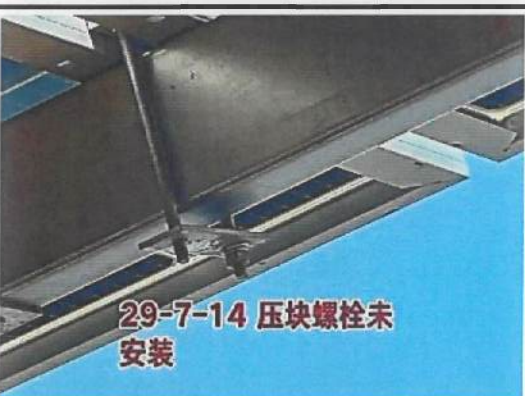
| 111 | <p>29-7-14 压块螺栓未<br/>安装</p> | 112 | <p>29-7-14 檩托螺栓未<br/>紧固</p> |

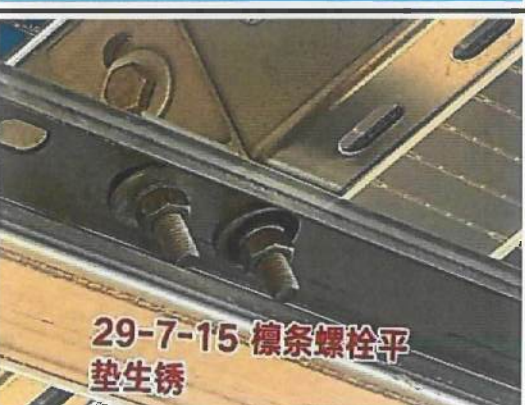
| 113 | <p>29-7-15 檩条螺栓平<br/>垫生锈</p> | 114 | <p>29-7-15边压块螺栓未<br/>紧固</p> |

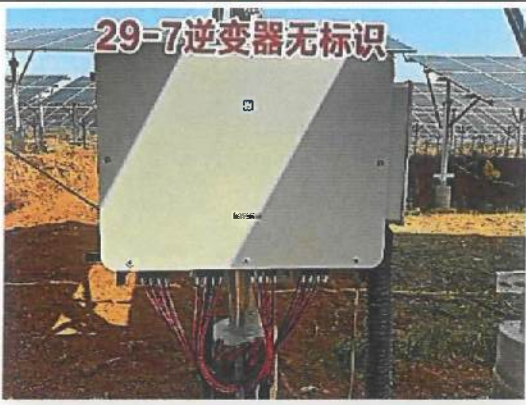
| 115 | <p>29-7逆变器无标识</p> | 116 | <p>29-7逆变器下方mc4<br/>插头未拧紧</p> |

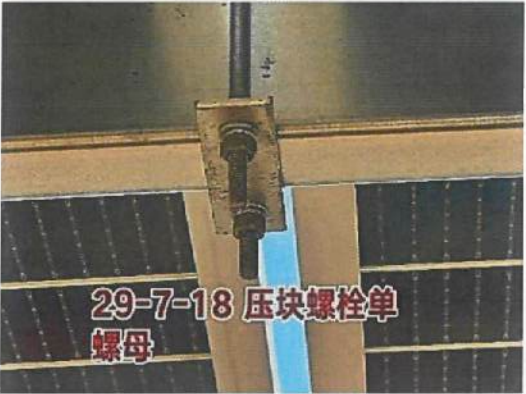
| 117 | <p>29-7-18 压块螺栓单<br/>螺母</p> | 118 | <p>29-7-23 压块螺栓未<br/>紧固</p> |

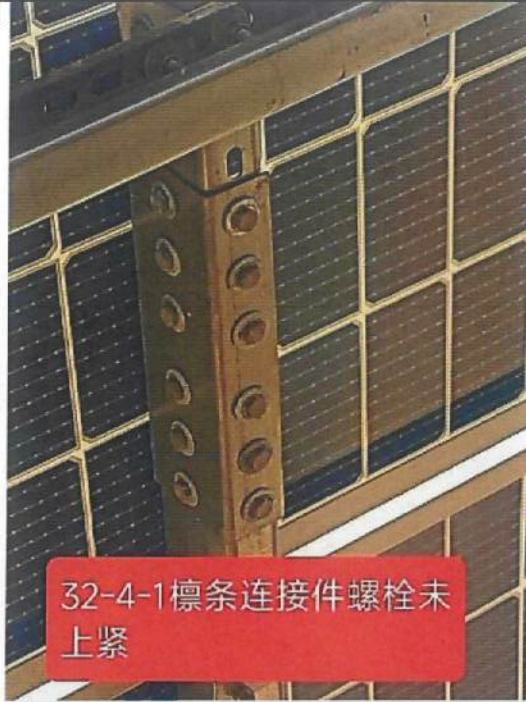
| 147 | <p>32-4-1 檩条连接件螺栓未上紧</p> | 148 | <p>32-3-29 拉杆缺少螺母</p> |

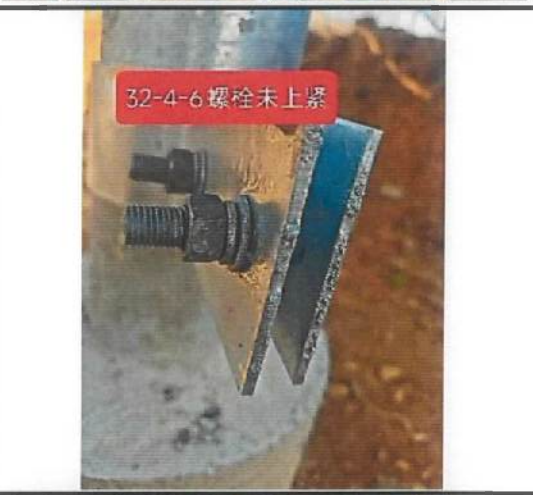
| 157 | <p>32-4-6 螺栓未上紧</p> | 158 | <p>32-4-5 螺栓松动</p> |
