# 平陆县 100MW 农光互补光伏发电项目

## 监理工程师通知单

编号: ZHJL-JLTZ-PL-153

2024年11月11日、12日建设单位、监理单位及总包单位对上苏20、24、28区光伏区验收过程中发现以下问题:

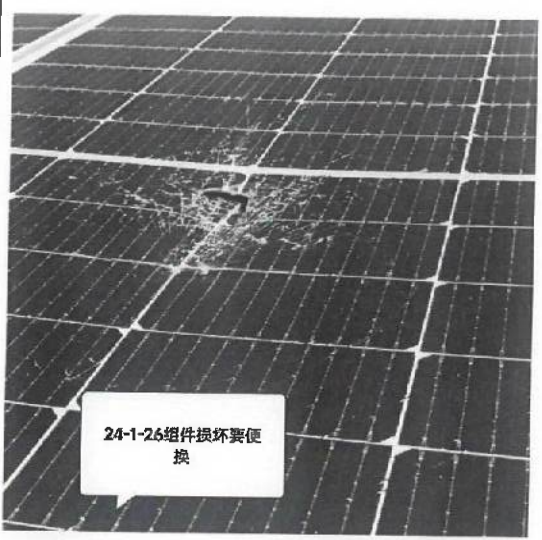
| 19 | <p>24-1-26组件损坏要便换</p> | 20 | <p>24-1-10缺少对穿螺栓</p> |

请贵单位按照上述问题立即消缺整改。

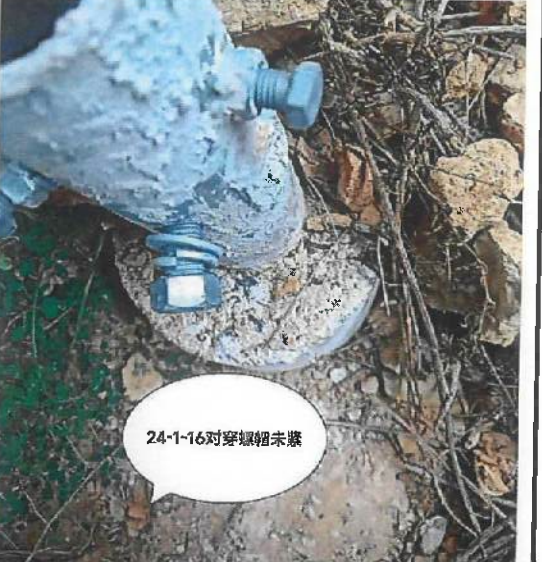
| 21 | <p>24-1-16对穿螺栓未紧</p> | 22 | <p>24-1-6缺少螺栓</p> |

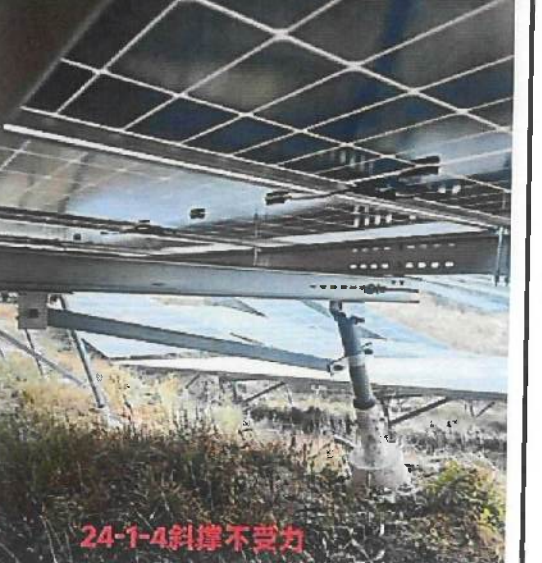
| 23 | <p>24-1-4斜撑不受力</p> | 24 | <p>20-5-20附近树枝遮挡</p> |

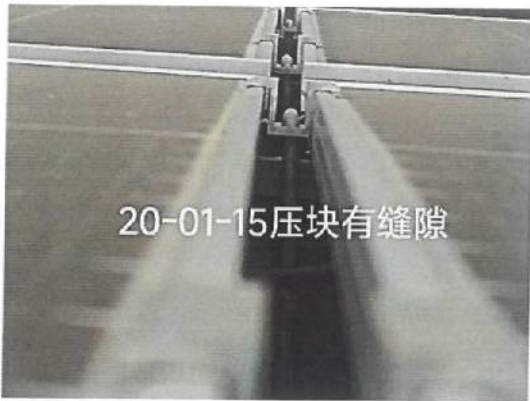
| 31 | <p>20-01-15压块有缝隙</p> | 32 | <p>20-01-16斜撑角度不够</p> |

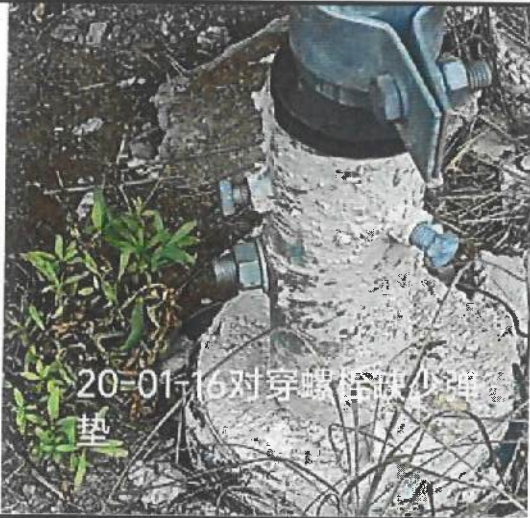
| 33 | <p>20-01-16对穿螺栓缺少弹垫</p> | 34 | <p>20-01-16立柱损坏</p> |

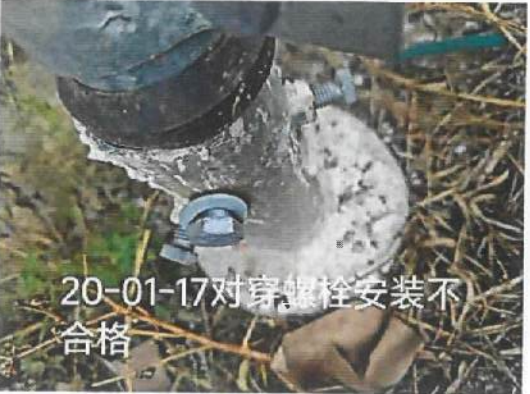
| 35 | <p>20-01-17对穿螺栓安装不合格</p> | 36 | <p>20-01-18斜撑角度不够</p> |

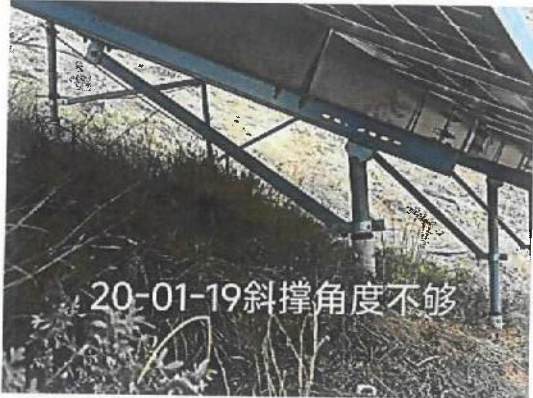
| 37 | <p>20-01-19斜撑角度不够</p> | 38 | <p>20-02-04压块有缝隙</p> |

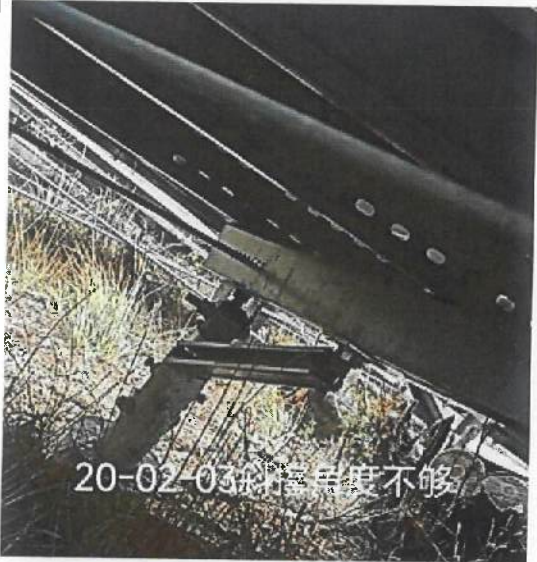
| 39 | <p>20-02-03斜撑角度不够</p> | 40 | <p>20-02-02斜梁弯曲</p> |

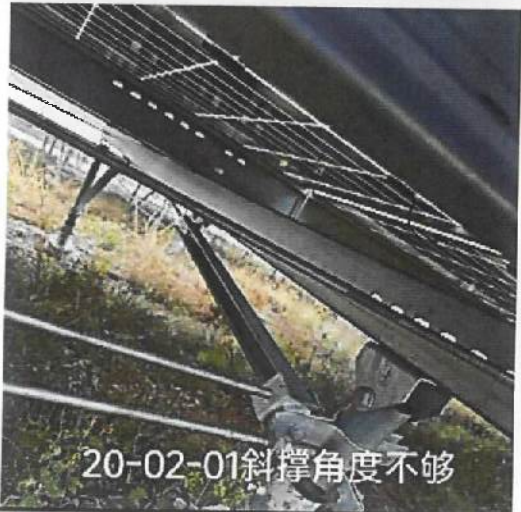
| 41 | <p>20-02-01斜撑角度不够</p> | 42 | <p>20-02-01压块有缝隙</p> |

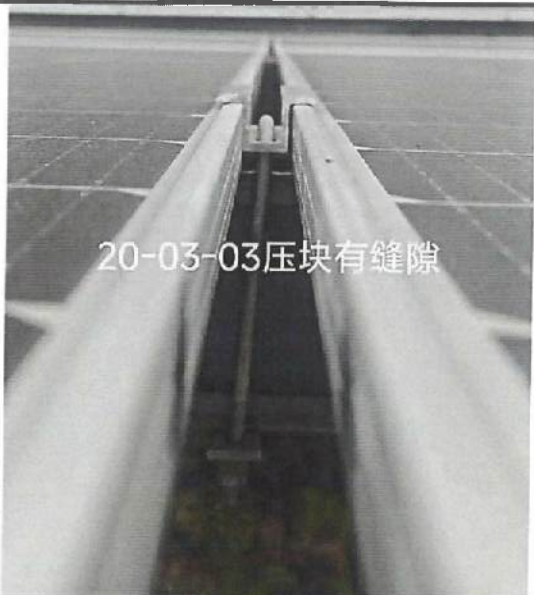
| 43 | <p>20-03-03压块有缝隙</p> | 44 | <p>20-03-03对穿螺栓安装不合格</p> |

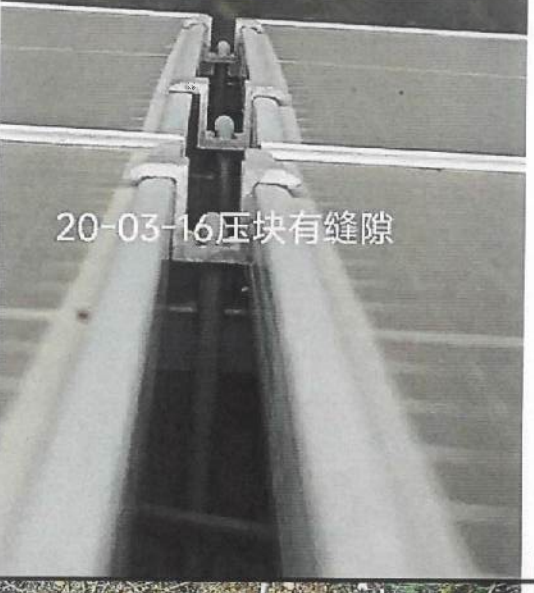
| 45 | <p>20-03-16压块有缝隙</p> | 46 | <p>20-02-19压块有缝隙</p> |

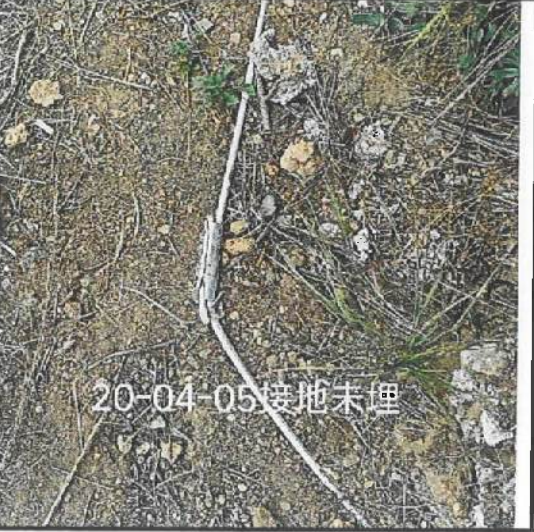
| 47 | <p>20-04-05接地未埋</p> | 48 | <p>20-04-03对穿螺栓安装不合格</p> |

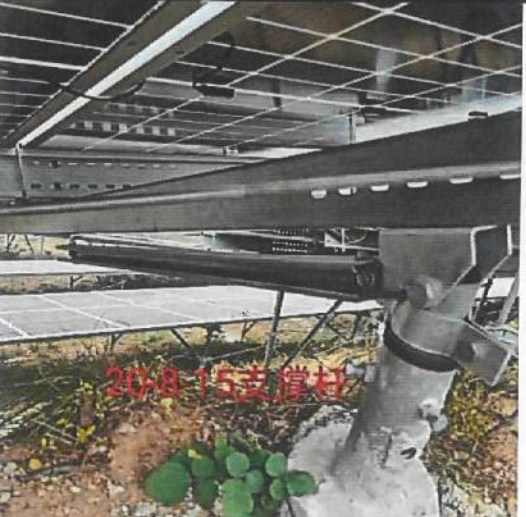
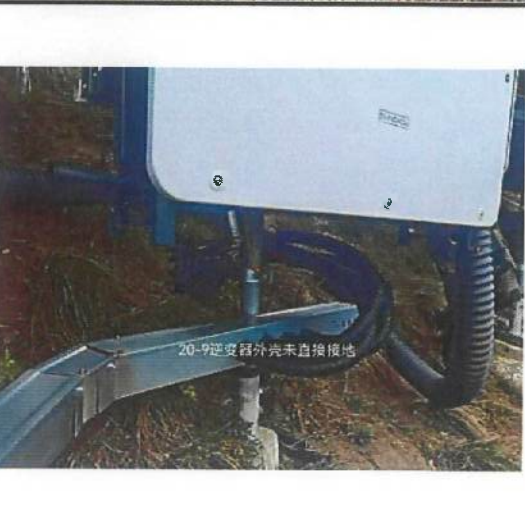
| 53 | <p>20-8-15支<br/>撑杆</p> | 54 | <p>20-9逆变器外壳未直接接地</p> |

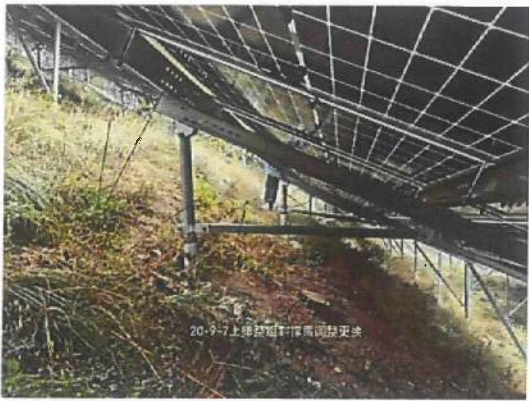
| 55 | <p>20-9-7上排斜撑杆+螺母副需更换</p> | 56 | <p>20-9-2两根斜撑需更换</p> |

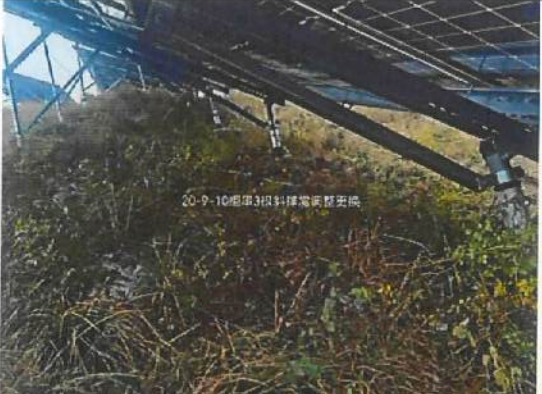
| 57 | <p>20-9-8两根斜撑需更换</p> | 58 | <p>20-9-10相串3根斜撑需更换</p> |

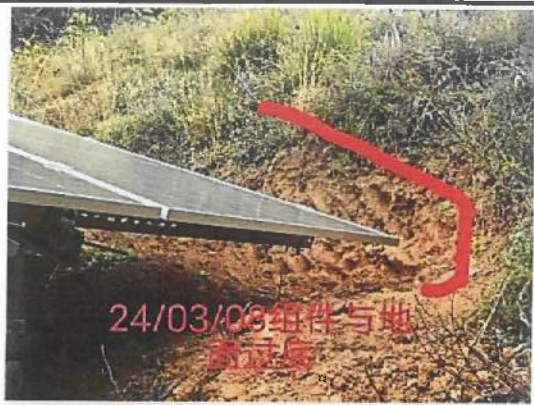
| 69 | <p>24/03/06组件与地<br/>面接触</p> | 70 | <p>24/02/18斜撑不受力</p> |

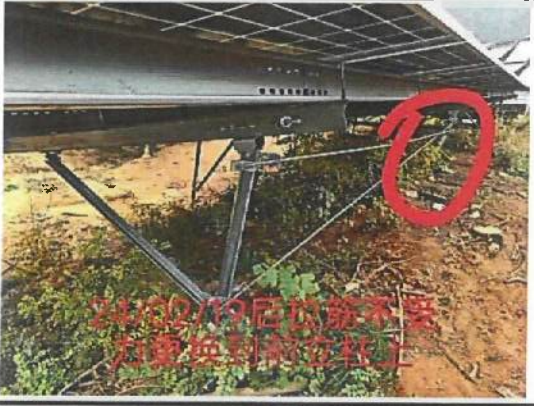
| 71 | <p>24/02/19已松脱不<br/>受力要移到前支柱上</p> | 72 | <p>24/02/14斜撑不受力<br/>2个</p> |

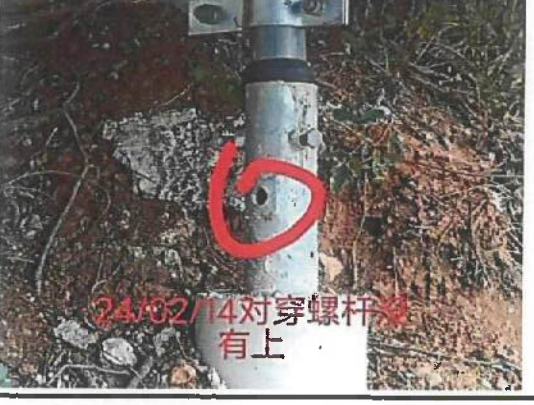
| 73 | <p>24/02/14对穿螺杆<br/>有上</p> | 74 | <p>24/03发现接地线<br/>有连接回路</p> |

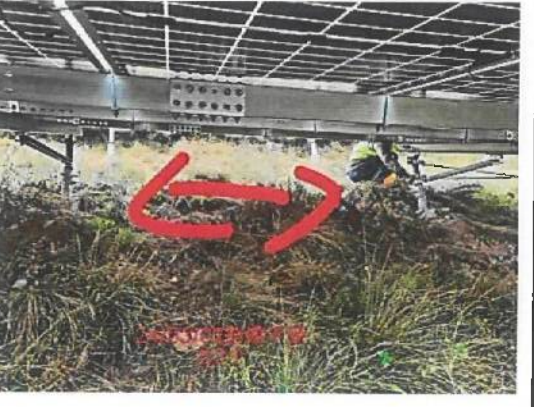
| 75 | <p>24/03/13发现不<br/>受力</p> | 76 | <p>24/04/02拉筋连接<br/>卡扣生锈</p> |

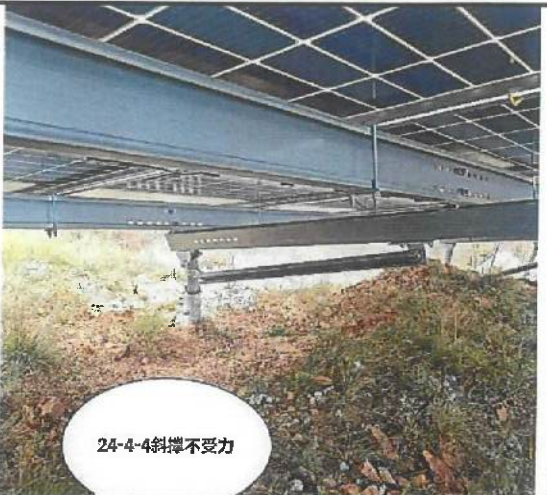
| 77 | | 78 | <p>24-4-4斜撑不受力</p> |

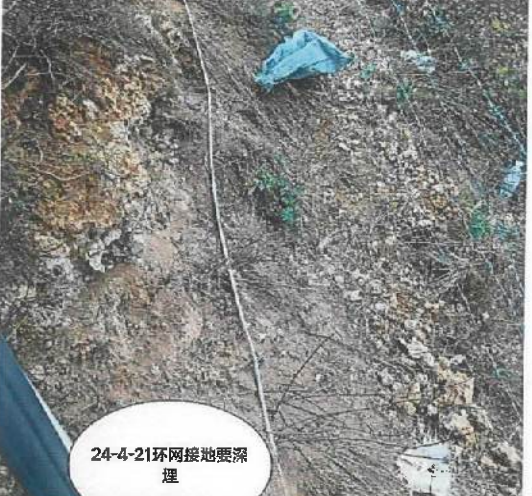
| 79 | <p>24-4-21环网接地要深埋</p> | 80 | <p>24-4-19压块未紧</p> |

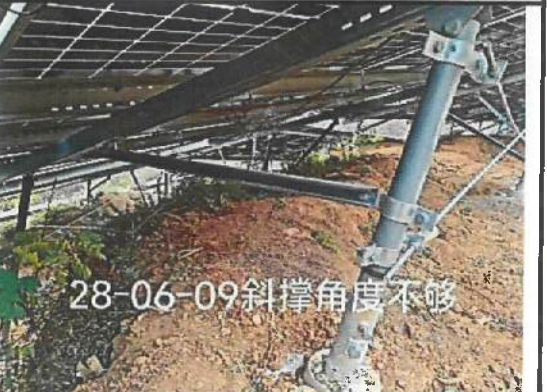
| 81 | <p>24-2-6铁对穿螺丝</p> | 82 | <p>28-06-09斜撑角度不够</p> |

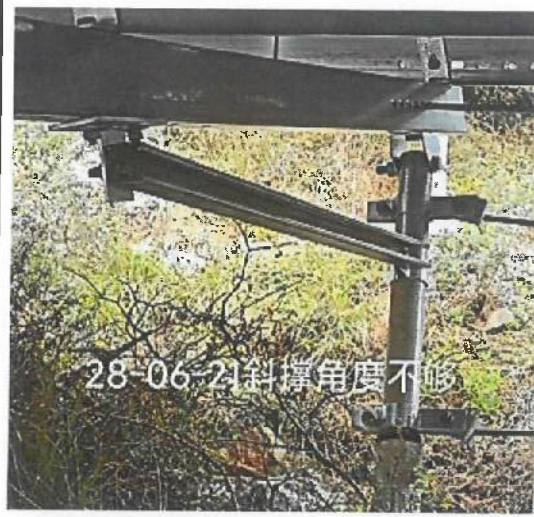
| 83 | <p>28-06-21斜撑角度不够</p> | 84 | <p>28-7-18缺少斜撑</p> |

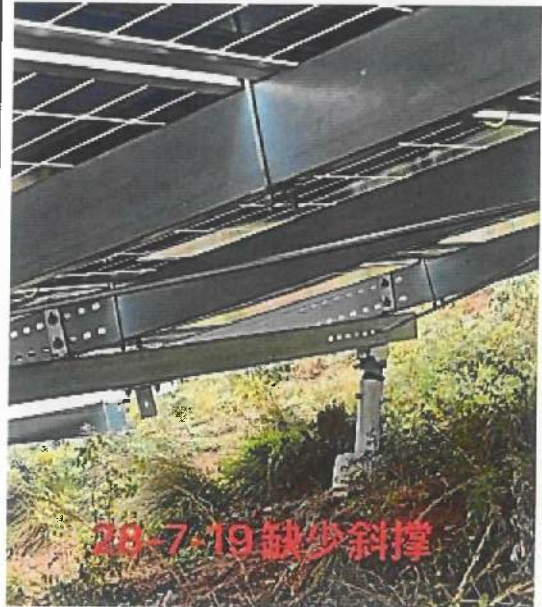
| 85 | <p>28-7-19缺少斜撑</p> | 86 | <p>28-7-20斜撑不受力需<br/>更换大抱箍</p> |

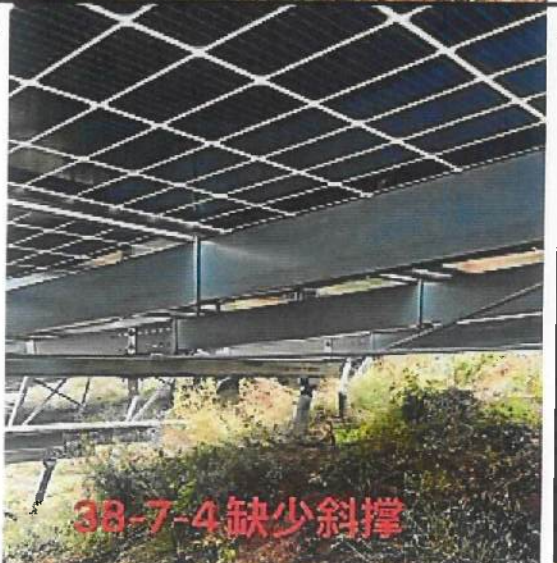
| 87 | <p>28-8-25接地线断了</p> | 88 | <p>38-7-4缺少斜撑</p> |

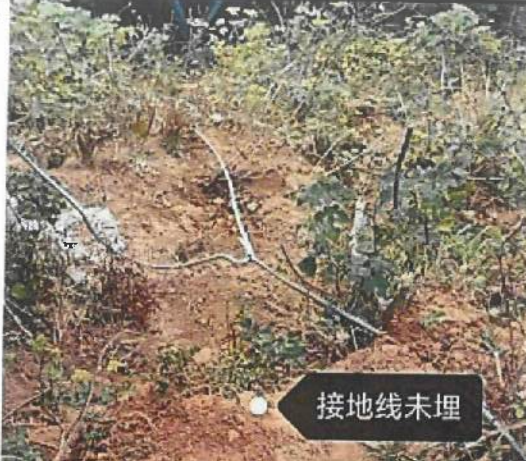
| 89 | <p>接地线未埋</p> | 90 | <p>28-5-17缺少斜撑</p> |

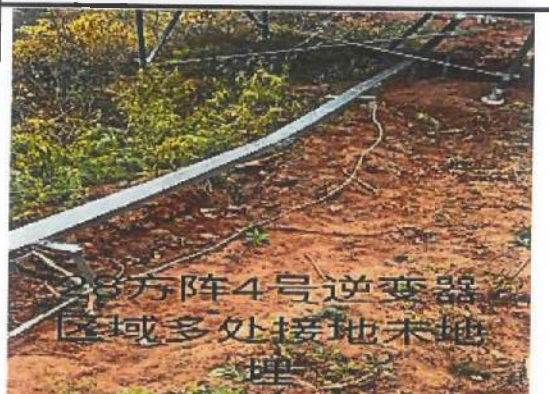
| 91 | <p>28-5-15缺少对穿</p> | 92 | <p>28方阵4号逆变器区域多处接地未地埋</p> |

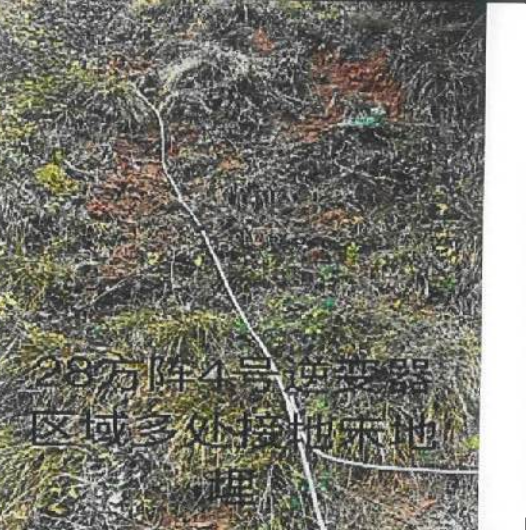
| 93 | <p>28方阵4号逆变器区域多处接地未地埋</p> | 94 | <p>28-4-4至28-4-5桥架未盖板</p> |

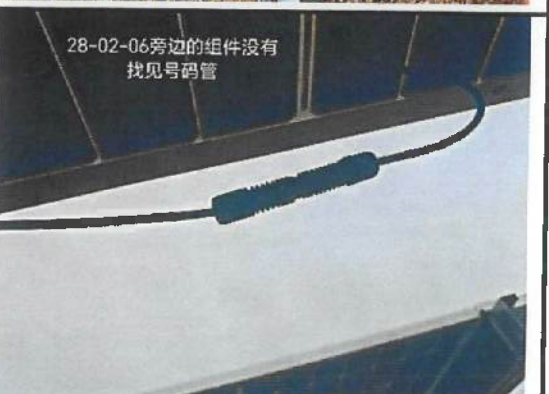
| 95 | <p>28-02逆变器外壳没有直接接地</p> | 96 | <p>28-02-06旁边的组件没有找见号码管</p> |
