# 平陆县 100MW 农光互补光伏发电项目

## 监理工程师通知单

编号: ZHJL-JLTZ-PL-147

2024 年 10 月 28、10 月 29 日建设单位、监理单位及总包单位对东郑 11、10 区光伏区验收过程中发现以下问题:

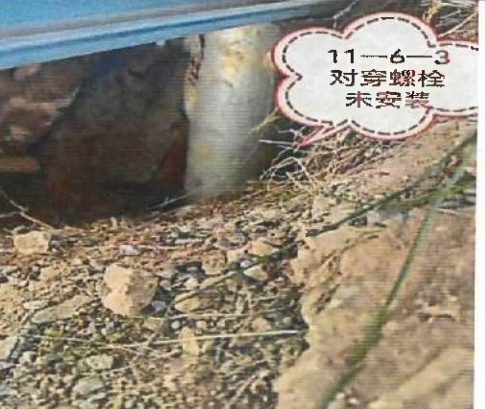
| 11 | <p>11-5-<br/>23对穿螺<br/>栓未安装</p> | 12 | <p>11-6-3<br/>对穿螺栓<br/>未安装</p> |
