# 平陆县 100MW 农光互补光伏发电项目

## 监理工程师通知单

编号: ZHJL-JLTZ-PL-176

主题: 2024 年 12 月 28 日、29 日建设单位、监理单位及总包单位在西沟光伏区验收过程中发现以下问题:

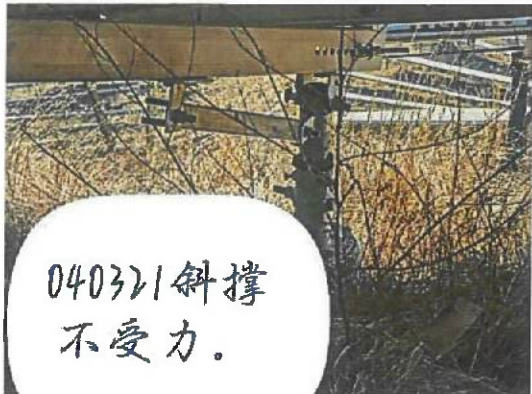
| 1 | <p>040321 斜撑<br/>不受力。</p> | 2 | <p>040325, 两处背拉杆需要交叉固定, 加延长管。</p> |

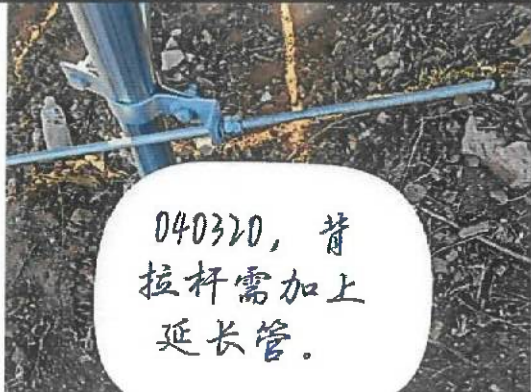
| 3 | <p>040320, 背<br/>拉杆需加上<br/>延长管。</p> | 4 | <p>040324到01, 多<br/>处背拉杆未做好<br/>交叉固定, 整改<br/>需要加长管。</p> |

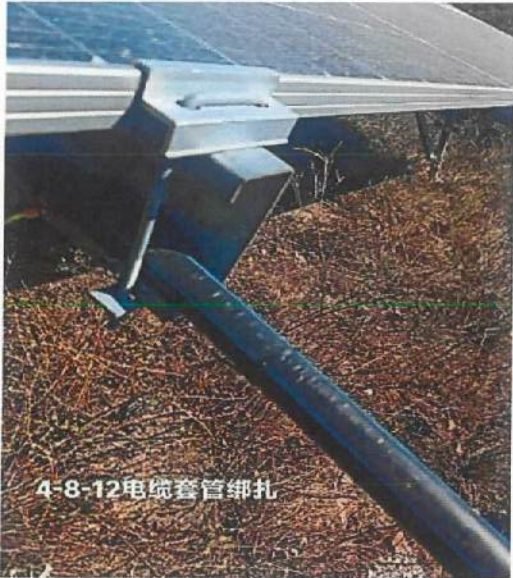
| 21 | <p>4-8-12电缆套管绑扎</p> | 22 | <p>4-8-7缺少斜撑</p> |

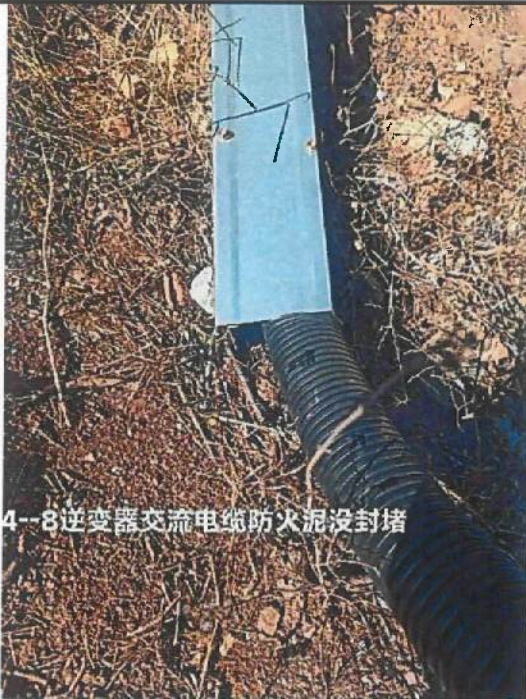
| 23 | <p>4--8逆变器交流电缆防火泥没封堵</p> | 24 | <p>4-1-1缺少元宝垫</p> |

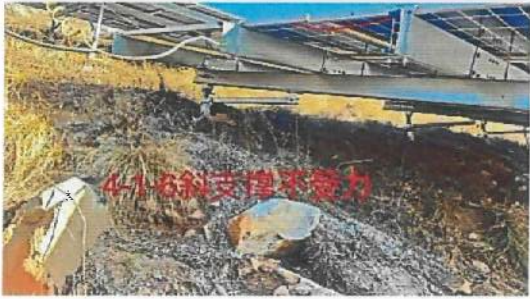
| 25 | <p>4-1-6斜支撑不紧力</p> | 26 | <p>4-1-15组件缺失</p> |

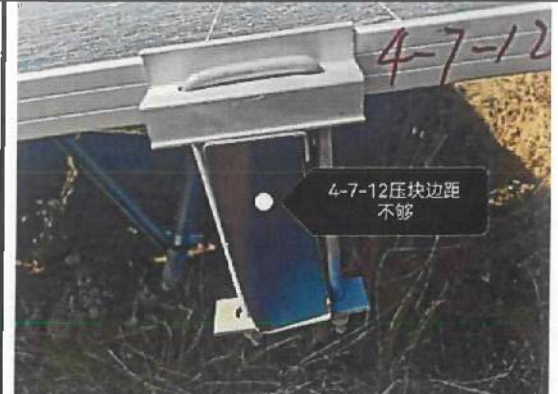
| 37 | <p>4-7-12旁压块未掩埋</p> | 38 | <p>4-7-12压块边距不够</p> |

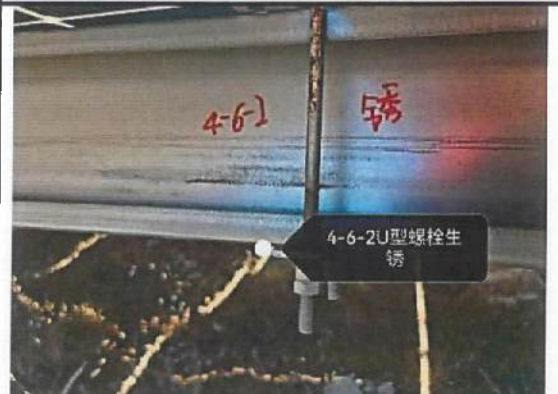
| 39 | <p>4-6-28标识翘起</p> | 40 | <p>4-6-2U型螺栓生锈</p> |

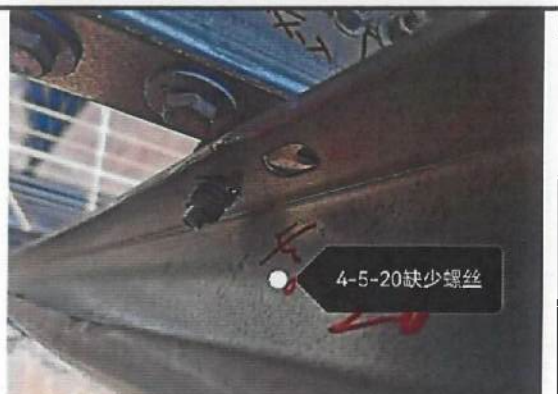
| 41 | <p>4-5-21螺丝生锈</p> | 42 | <p>4-5-20缺少螺丝</p> |

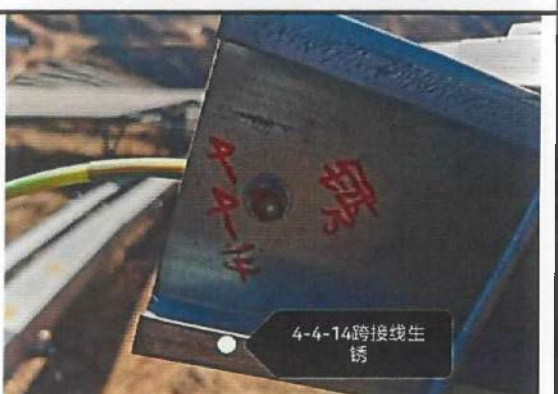
| 43 | <p>4-5-20标识条连接件处开孔</p> | 44 | <p>4-4-14跨接线生锈</p> |

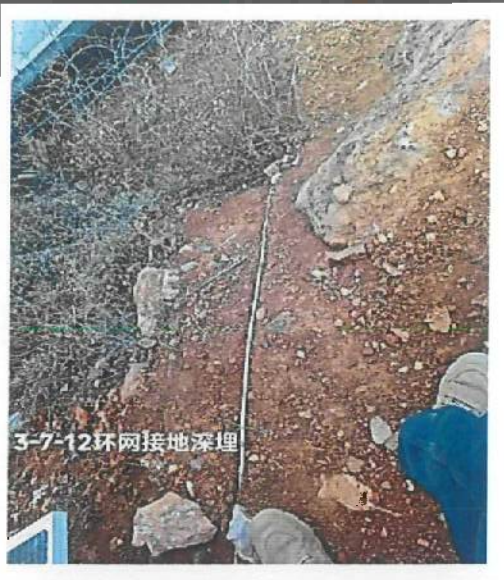
| 141 | <p>3-6-11环网接地外露</p> | 142 | <p>3-7-12环网接地深埋</p> |

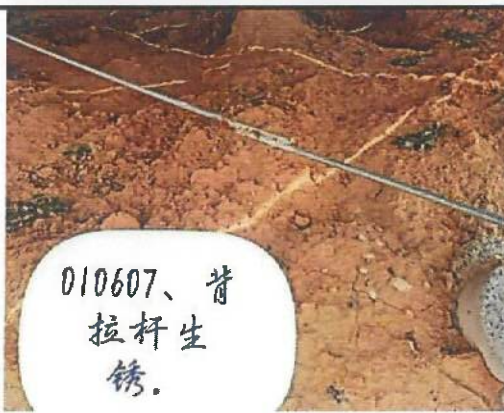
| 143 | <p>010607号码管破损。</p> | 144 | <p>010607、背拉杆生锈。</p> |

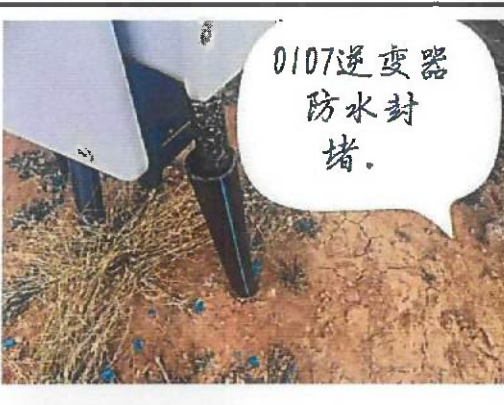
| 145 | <p>040607, 斜拉杆未露丝</p> | 146 | <p>0107逆变器防水封堵。</p> |

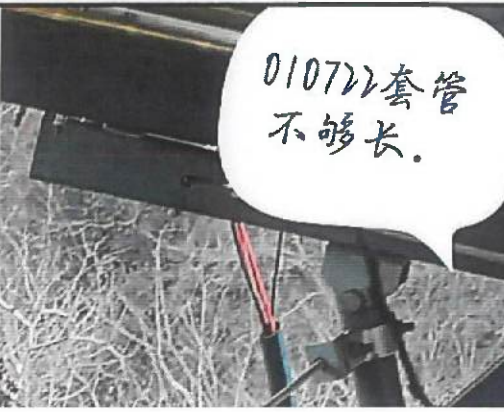
| 147 | <p>0107逆变器下方电缆没有绑扎固定。</p> | 148 | <p>010722套管不够长。</p> |

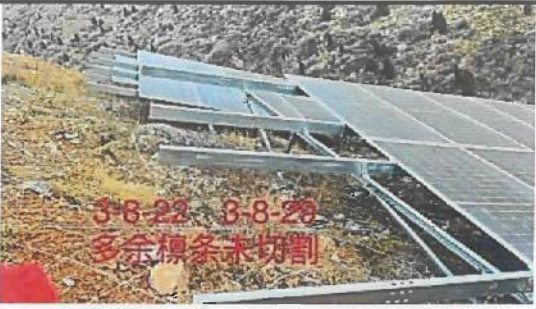
| 161 | <p>4#箱变8#逆变器电缆管未绑扎<br/>接地未连接接地网<br/>包箍生锈</p> | 162 | <p>3-8-22 3-8-28<br/>多余檩条未切割</p> |

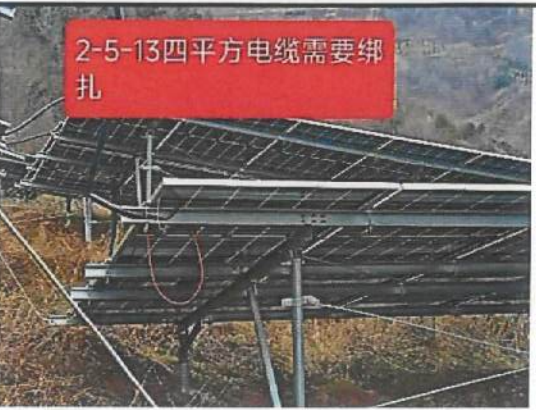
| 163 | <p>3-4-4地线接地连接螺<br/>丝生锈</p> | 164 | <p>2-5-13四平方电缆需要绑<br/>扎</p> |

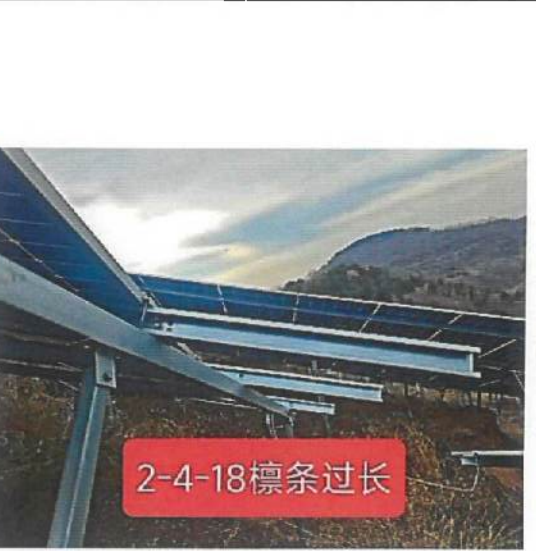
| 165 | <p>2-4-11四平方电缆需要绑<br/>扎</p> | 166 | <p>2-4-18檩条过长</p> |

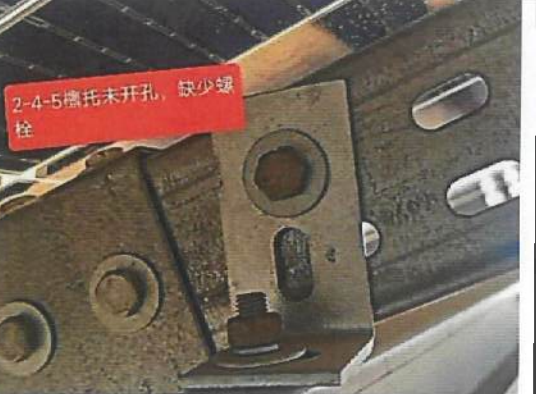
| 167 | <p>2-4-3拉杆长度不够，无法<br/>安装双螺母</p> | 168 | <p>2-4-5檩托未开孔，缺少螺<br/>栓</p> |
