# 平陆县 100MW 农光互补光伏发电项目

## 监理工程师通知单

编号: ZHJL-JLTZ-PL-192

主题: 2025 年 3 月 23 日建设单位、监理单位及总包单位在洪池地块 29 区、32 区验收过程中发现以下问题:

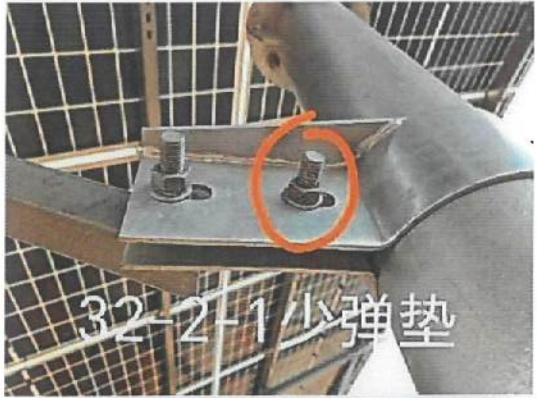
| 1 | <p>32-2-1小弹垫</p> | 2 | <p>32-2-1缝隙太大</p> |

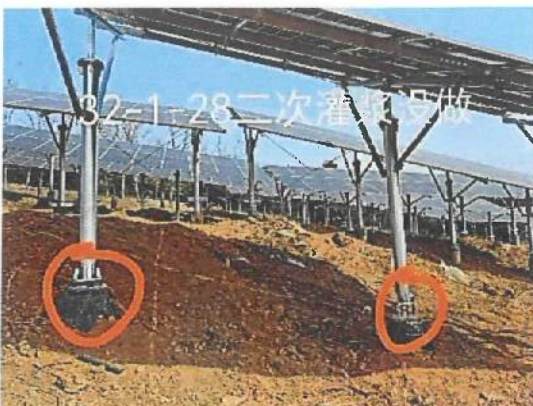
| 5 | <p>32-1-24斜槽条弯曲及撑托调整</p> | 6 | <p>32-1-28二次灌胶没做</p> |

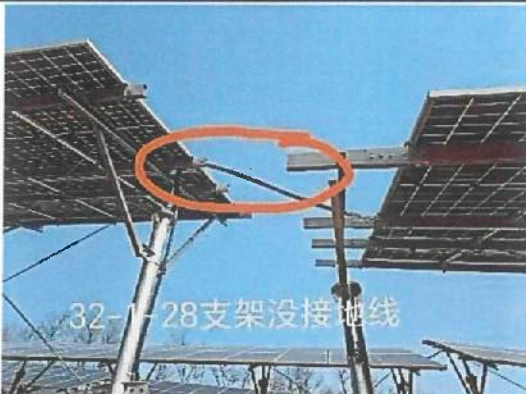
| 7 | <p>32-1-28支架没接地线</p> | 8 | <p>32-1-28少黄绿线接地</p> |

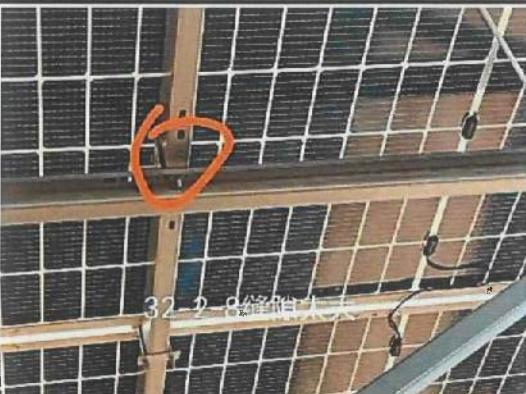
| 9 | <p>32-2-8螺栓没紧</p> | 10 | <p>32-2-17螺栓没紧</p> |

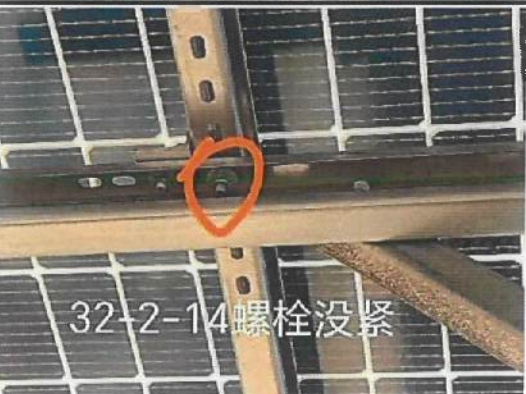
| 11 | <p>32-2-14螺栓没紧</p> | 12 | <p>32-2-24螺栓没紧</p> |

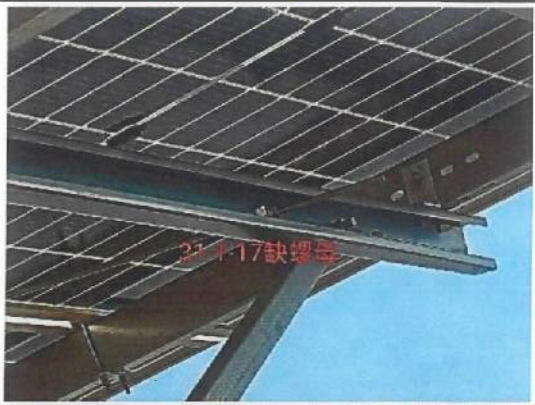
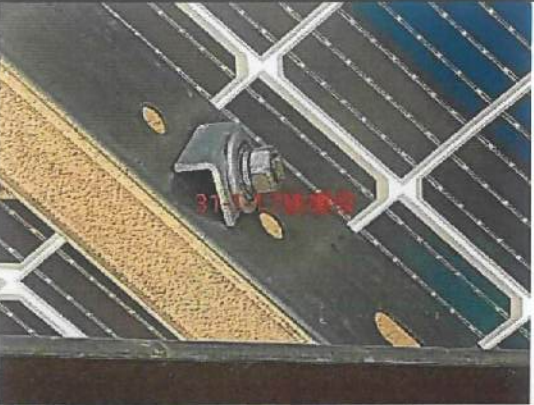
| 21 | <p>21-1-17缺螺母</p> | 22 | <p>21-1-17缺螺母</p> |

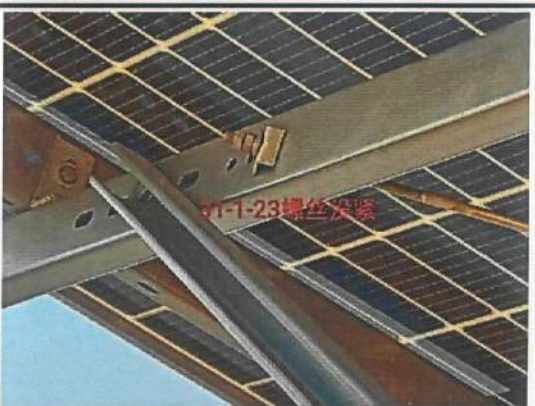
| 23 | <p>21-1-23螺栓没紧</p> | 24 | <p>21-1-26缺螺母</p> |

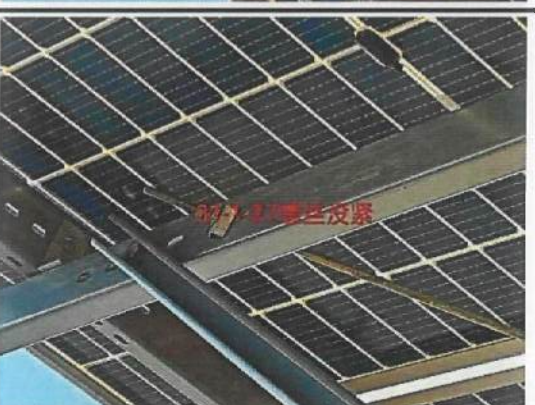
| 25 | <p>21-1-25螺栓没紧</p> | 26 | <p>21-1-28缺螺栓</p> |

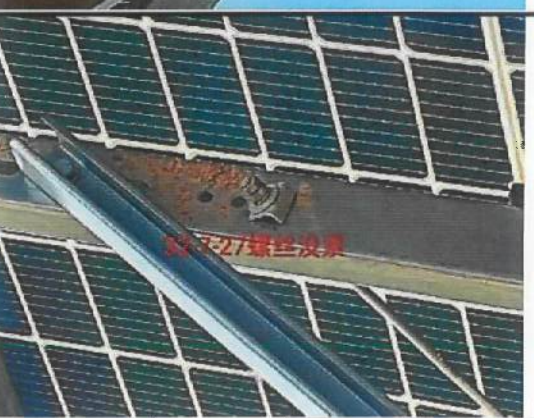
| 27 | <p>21-1-28缺螺栓和螺母</p> | 28 | <p>21-1-27螺栓没紧</p> |

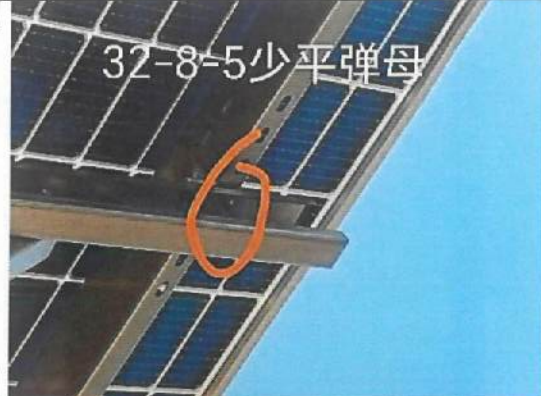
| 29 | <p>32-8-6弹垫更换</p> | 30 | <p>32-8-5少平弹母</p> |

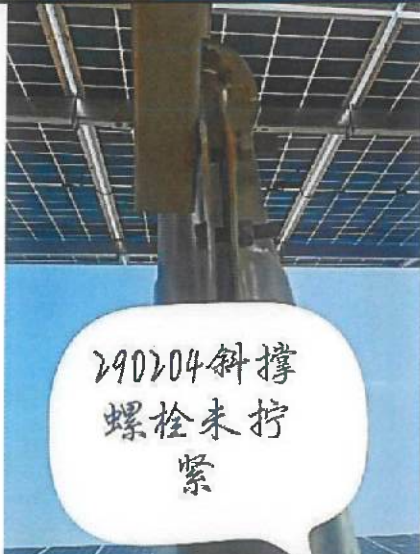
| 31 | <p>2901逆变器<br/>缺少指示<br/>标牌</p> | 32 | <p>290204斜撑<br/>螺栓未拧<br/>紧</p> |

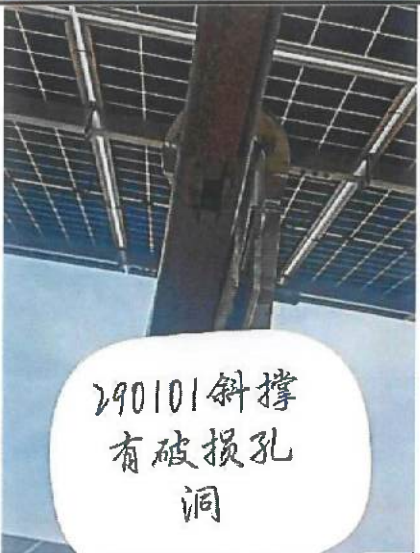
| 33 | <p>290127立<br/>柱生锈</p> | 34 | <p>290101斜撑<br/>有破损孔<br/>洞</p> |

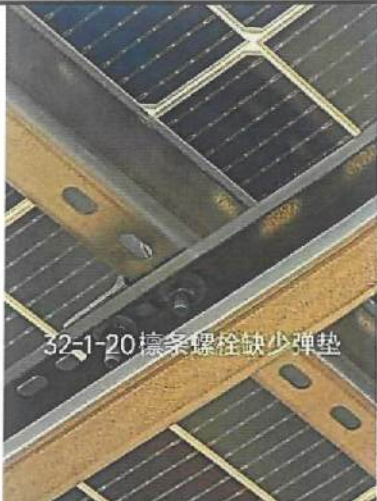
| 35 | <p>32-1-21 標条螺栓缺少平垫</p> | 36 | <p>32-1-20 標条螺栓缺少彈墊</p> |

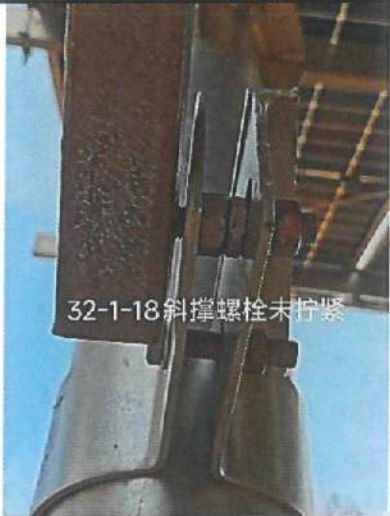
| 37 | <p>32-1-19 標条螺栓缺少彈墊</p> | 38 | <p>32-1-18 斜撐螺栓未拧紧</p> |

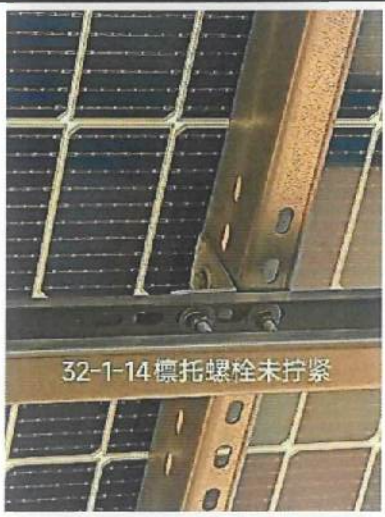
| 39 | <p>32-1-17 抱箍彈墊损坏</p> | 40 | <p>32-1-14 標托螺栓未拧紧</p> |

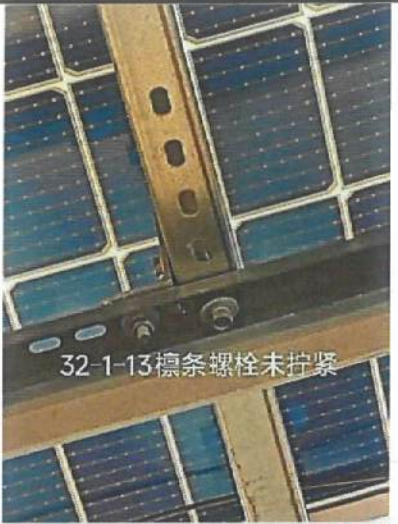
| 41 | <p>32-1-13 檩托未拧紧</p> | 42 | <p>32-1-13 檩条螺栓未拧紧</p> |

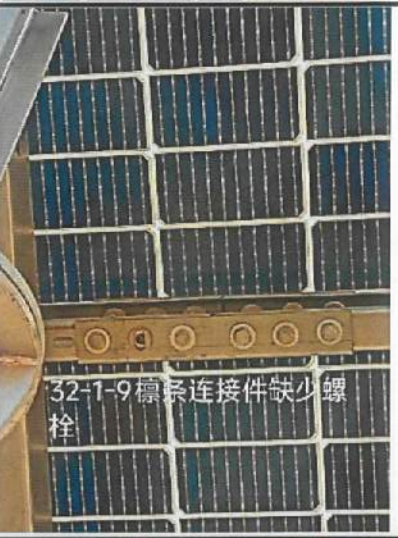
| 43 | <p>32-1-10 檩托螺栓未拧紧</p> | 44 | <p>32-1-9 檩条连接件缺少螺栓</p> |

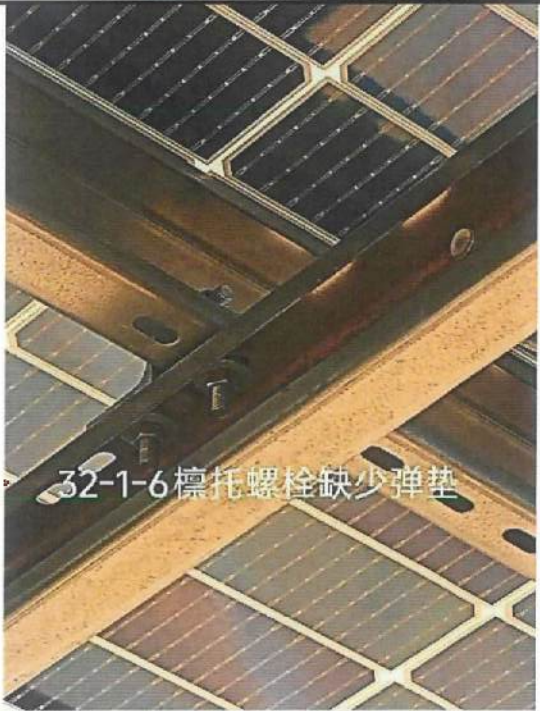
| 45 | <p>32-1-8 斜梁弯曲</p> | 46 | <p>32-1-6 檩托螺栓缺少弹垫</p> |

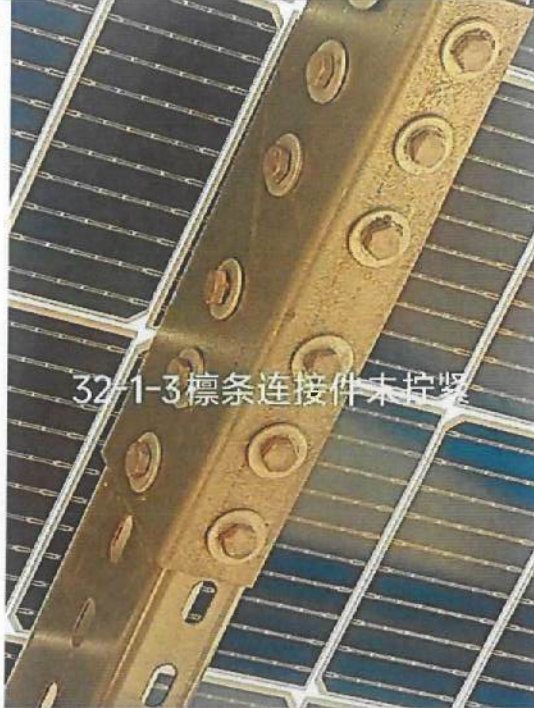
| 47 | <p>32-1-4 標托未拧紧</p> | 48 | <p>32-1-3 標条连接件未拧紧</p> |

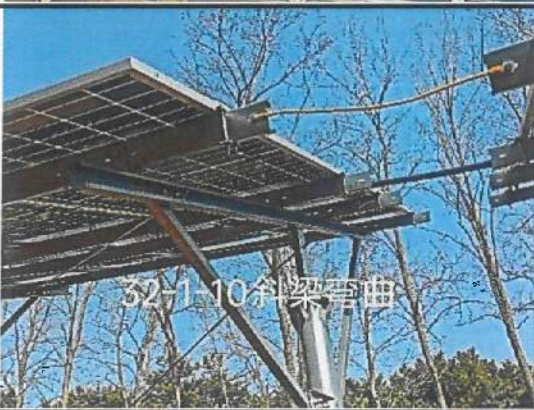
| 49 | <p>32-1-10 斜梁標条缺少连接螺栓</p> | 50 | <p>32-1-10 斜梁弯曲</p> |

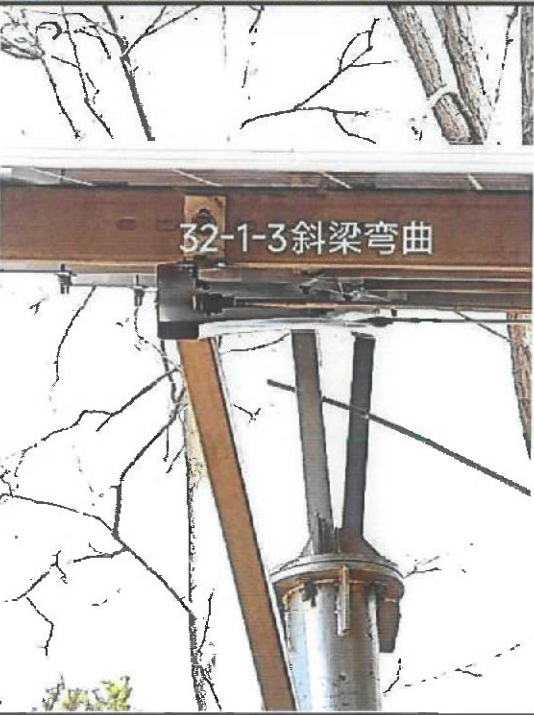
| 51 | <p>32-1-9 斜梁弯曲</p> | 52 | <p>32-1-3 斜梁弯曲</p> |

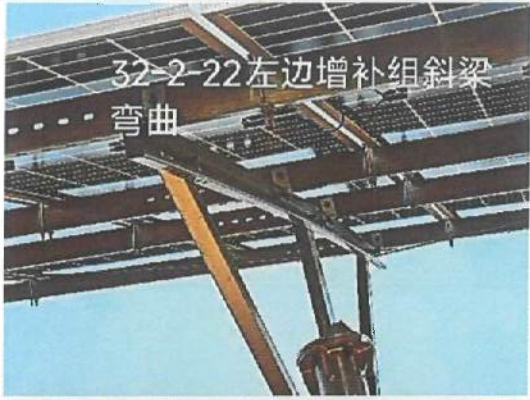
| 59 | <p>32-2-22 左边增补组斜梁弯曲</p> | 60 | <p>32-2-21 檩条连接件缺少平垫</p> |

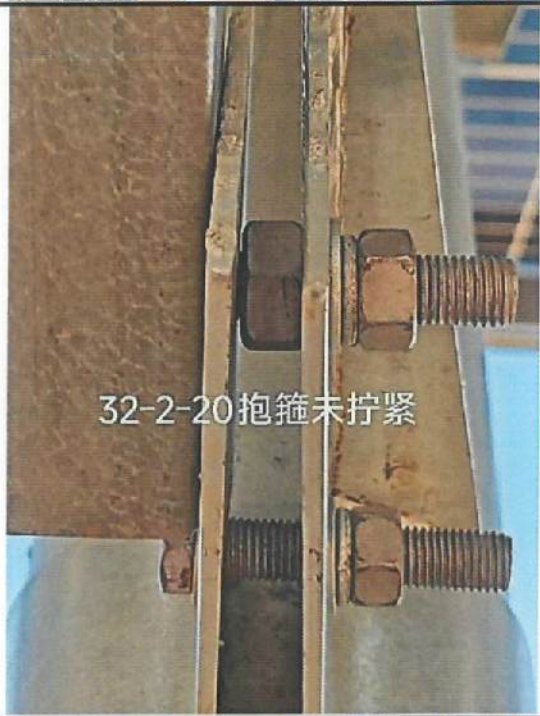
| 61 | <p>32-2-20 抱箍未拧紧</p> | 62 | <p>32-2-20 抱箍未拧紧</p> |

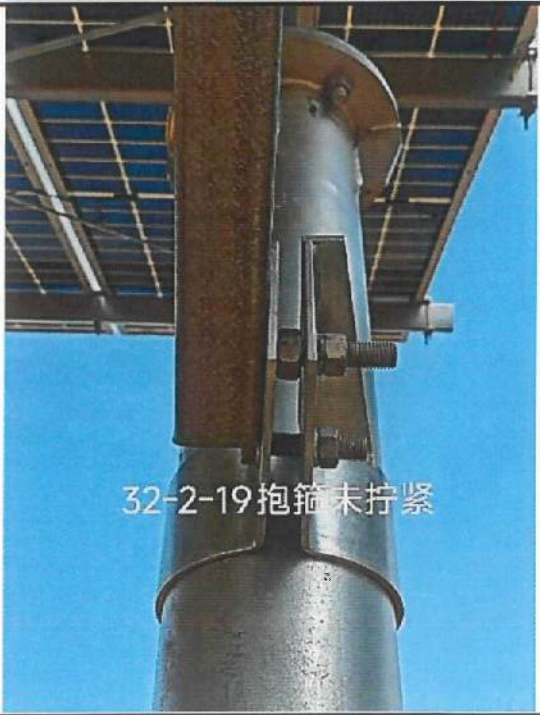
| 63 | <p>32-2-20 檩条螺栓缺少弹垫</p> | 64 | <p>32-2-19 抱箍未拧紧</p> |

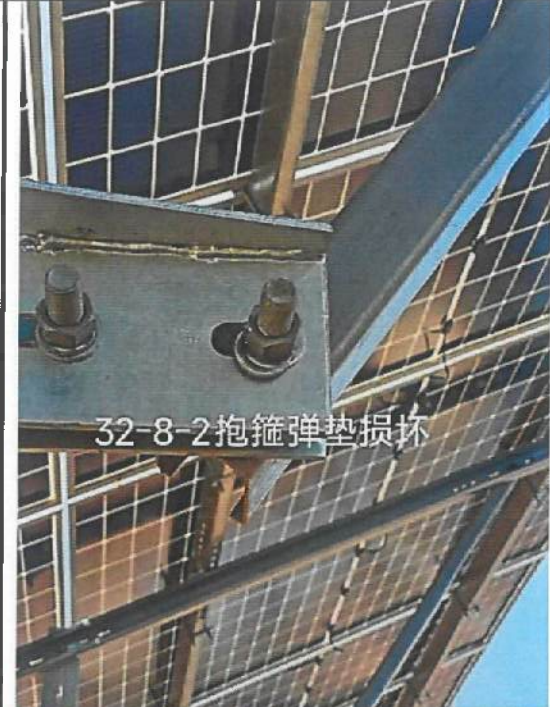
| 65 | <p>32+2-19斜撑未拧紧</p> | 66 | <p>32-8-2抱箍弹垫损坏</p> |

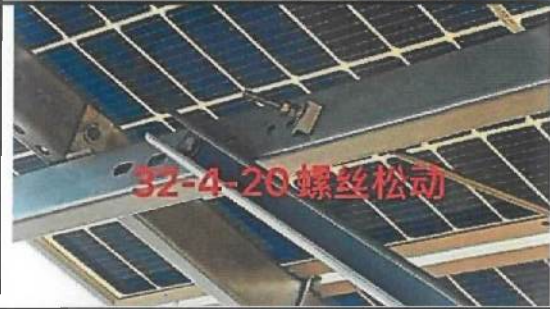
| 67 | <p>32-4-19压块间隙多处</p> | 68 | <p>32-4-20螺丝松动</p> |

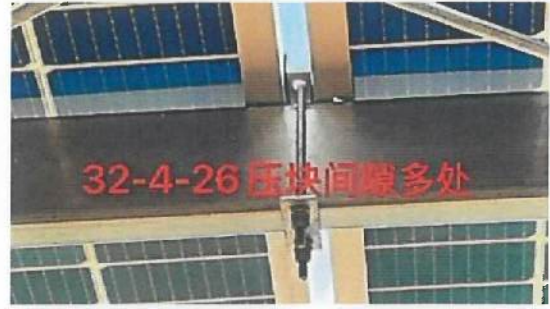
| 69 | <p>32-4-20压块未贴紧</p> | 70 | <p>32-4-26压块间隙多处</p> |

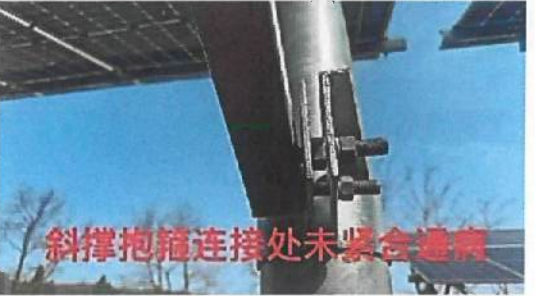
| 71 | <p>斜撑抱箍连接处未紧合</p> | 72 | <p>32-7-23横托螺丝松动</p> |

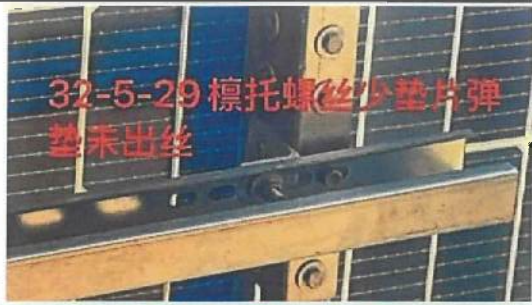
| 73 | <p>32-5-29 槽托螺丝少垫片弹<br/>垫未出丝</p> | 74 | <p>32-5-22 缺少垫片弹垫</p> |

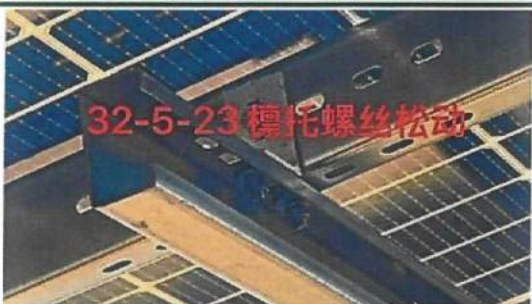
| 75 | <p>32-5-23 槽托螺丝松动</p> | 76 | <p>32-5-16 槽托螺丝松动</p> |

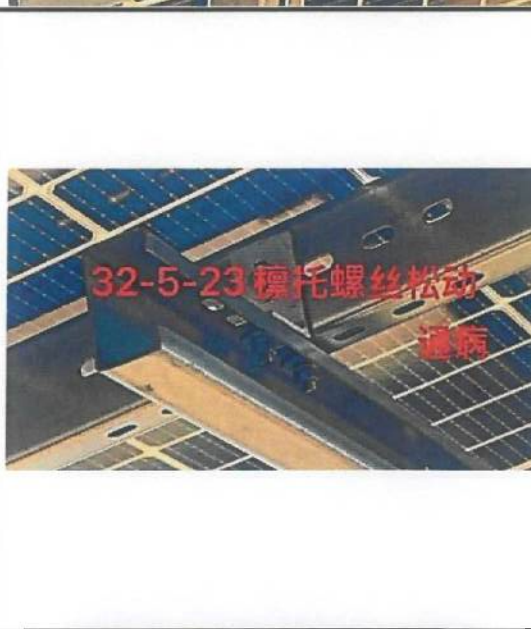
| 77 | <p>32-5-14 螺丝松动</p> | 78 | <p>32-5-23 槽托螺丝松动<br/>通病</p> |

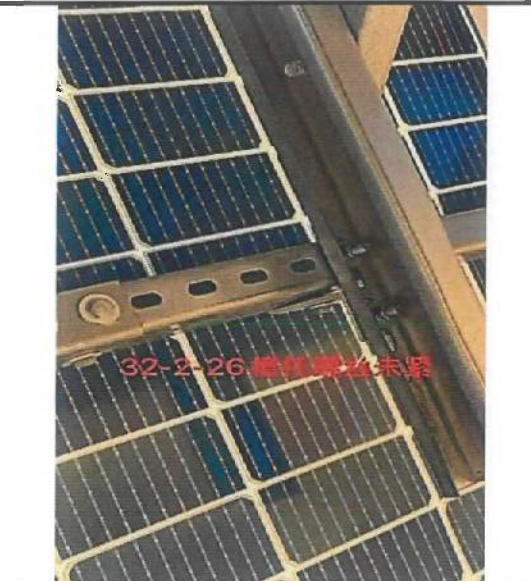
| 79 | <p>32-5-2 槽托无螺丝</p> | 80 | <p>32-2-26 槽托螺丝未紧</p> |

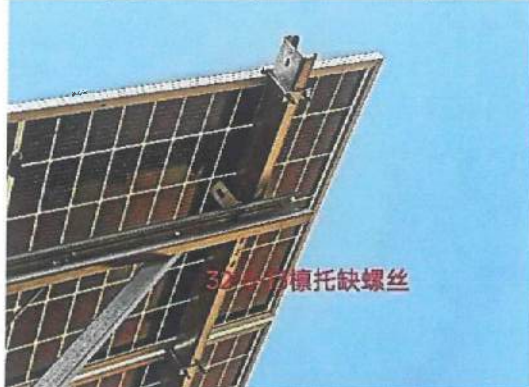
| 89 | <p>32区69号托架缺螺丝</p> | 90 | <p>32区69号托架少两颗螺丝</p> |

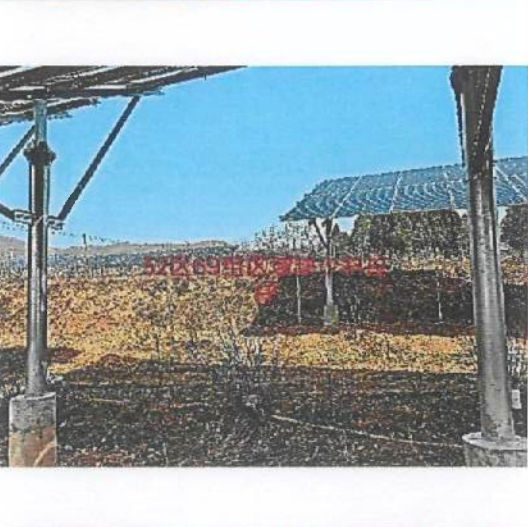
| 91 | <p>32区69号托架缺螺丝</p> | 92 | <p>52区69号托架缺螺丝</p> |

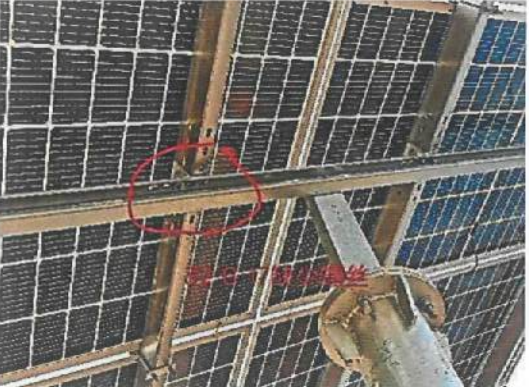
| 93 | <p>32区69号托架缺螺丝</p> | 94 | <p>32区逆变器未做标识</p> |

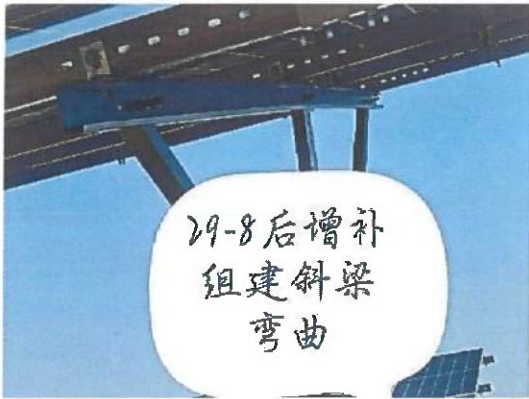
| 101 | <p>29-8后增补<br/>组建斜梁<br/>弯曲</p> | 102 | <p>29-8后增补组<br/>件，桩基螺<br/>丝没拧紧。</p> |

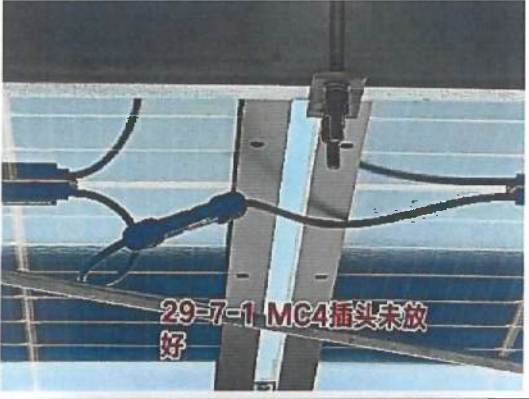
| 103 | <p>29-7-1 MC4插头未放<br/>好</p> | 104 | <p>29-7-7 左侧增补组串<br/>螺栓未紧固</p> |

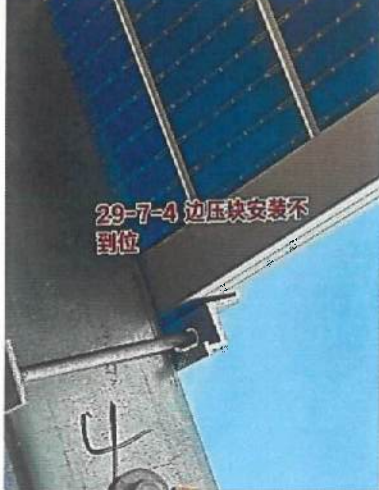
| 105 | <p>29-7-4 边压块安装不<br/>到位</p> | 106 | <p>29-7-7 左侧增补组串<br/>螺栓未紧固</p> |

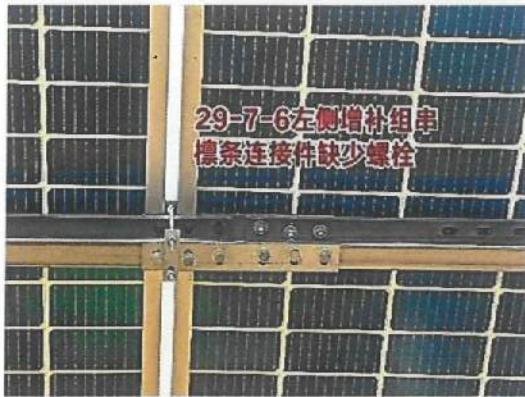
| 107 | <p>29-7-6左侧增补组串<br/>檩条连接件缺少螺栓</p> | 108 | <p>29-7-10 压块螺栓未<br/>紧固</p> |

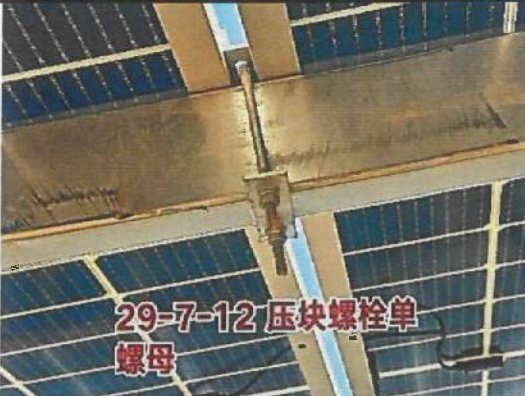
| 109 | <p>29-7-11压块螺栓未紧<br/>固</p> | 110 | <p>29-7-12 压块螺栓单<br/>螺母</p> |

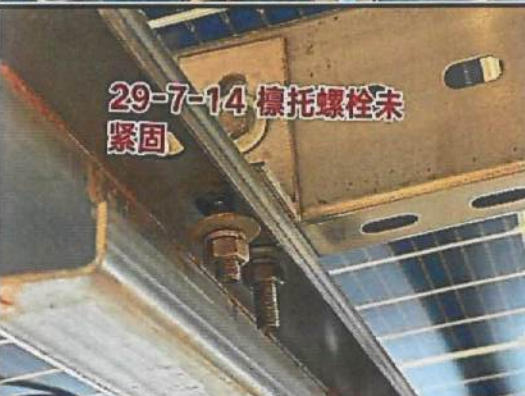
| 111 | <p>29-7-14 压块螺栓未<br/>安装</p> | 112 | <p>29-7-14 檩托螺栓未<br/>紧固</p> |

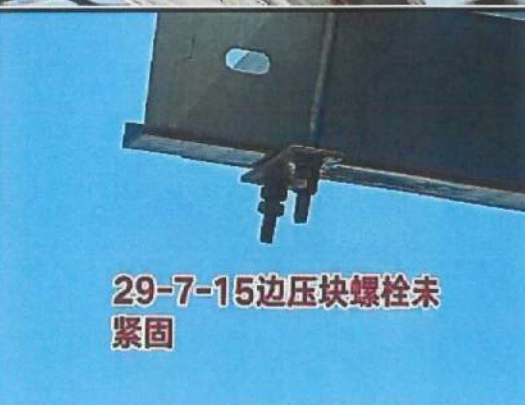
| 113 | <p>29-7-15 檩条螺栓平<br/>垫生锈</p> | 114 | <p>29-7-15边压块螺栓未<br/>紧固</p> |

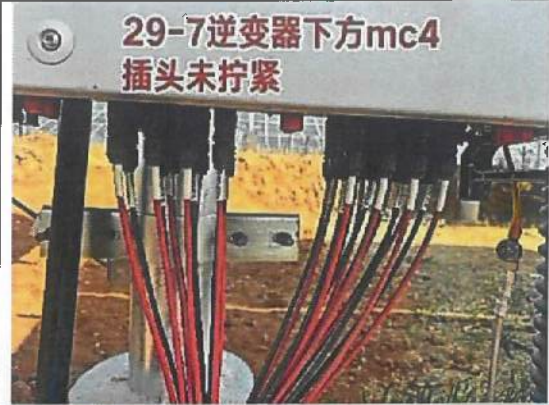
| 115 | <p>29-7逆变器无标识</p> | 116 | <p>29-7逆变器下方mc4<br/>插头未拧紧</p> |

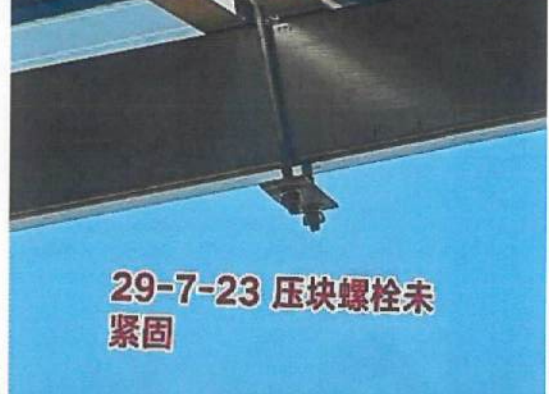
| 117 | <p>29-7-18 压块螺栓单<br/>螺母</p> | 118 | <p>29-7-23 压块螺栓未<br/>紧固</p> |

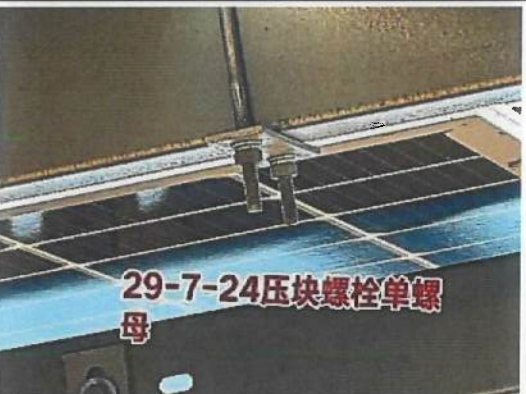
| 119 | <p>29-7-24压块螺栓单螺<br/>母</p> | 120 | <p>29-6-5 檩条连接件缺<br/>螺栓</p> |

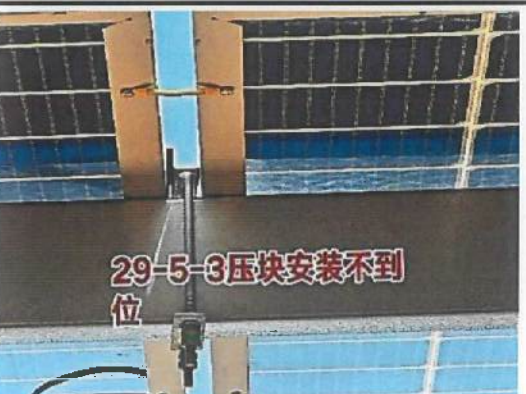
| 121 | <p>29-5-3压块安装不到<br/>位</p> | 122 | <p>29-6逆变器无标识</p> |

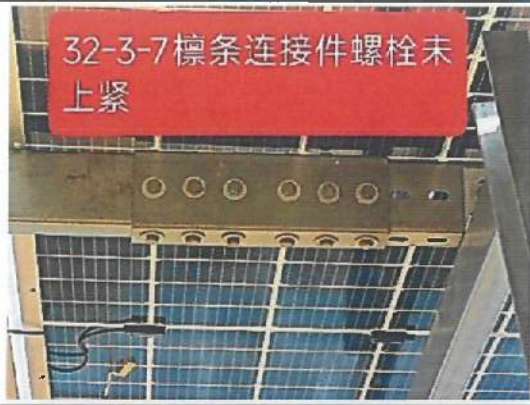
| 131 | <p>32-3-7 檩条连接件螺栓未上紧</p> | 132 | <p>32-3-15 檩条连接处螺栓未上紧</p> |

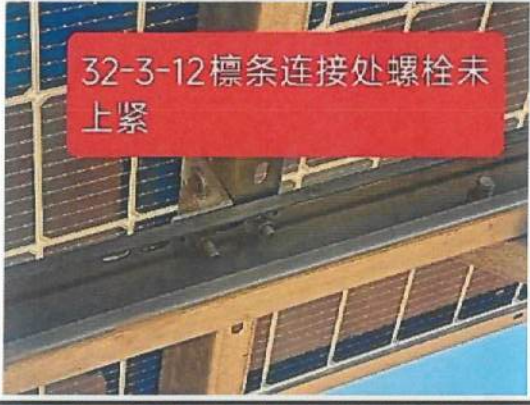
| 133 | <p>32-3-12 檩条连接处螺栓未上紧</p> | 134 | <p>32-3-18 檩条连接处螺栓未上紧</p> |

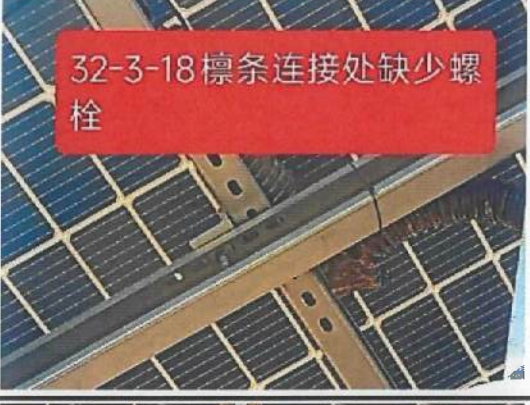
| 135 | <p>32-3-18 檩条连接处缺少螺栓</p> | 136 | <p>32-3-23 檩条连接处螺栓未上紧</p> |

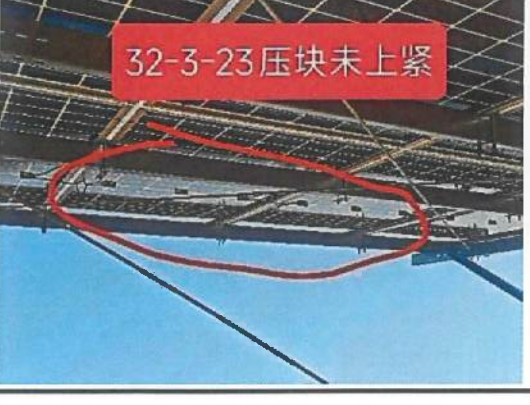
| 137 | <p>32-3-23 压块未上紧</p> | 138 | <p>32-3-22 拉杆螺母未上紧</p> |

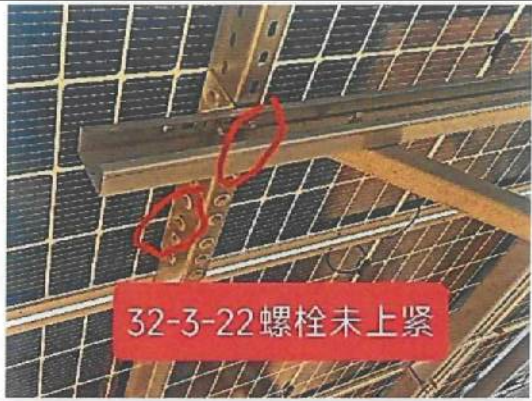
| 139 | <p>32-3-22 螺栓未上紧</p> | 140 | <p>32-3-22 缺少弹垫</p> |

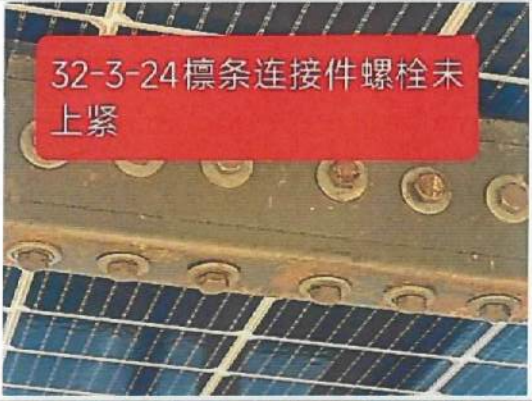
| 141 | <p>32-3-24 檩条连接件螺栓未上紧</p> | 142 | <p>32-3-22 压块缺少螺母</p> |

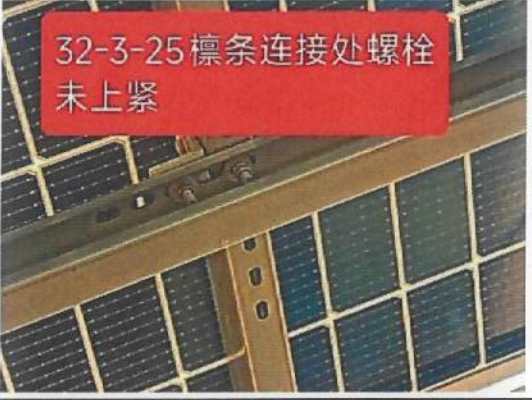
| 143 | <p>32-3-25 檩条连接处螺栓未上紧</p> | 144 | <p>32-3-24 檩条连接处螺栓未上紧</p> |

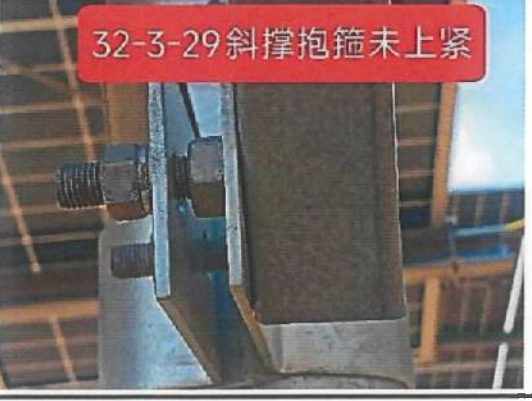
| 145 | <p>32-3-29 斜撑抱箍未上紧</p> | 146 | <p>32-3-25 檩条连接处螺栓未上紧</p> |

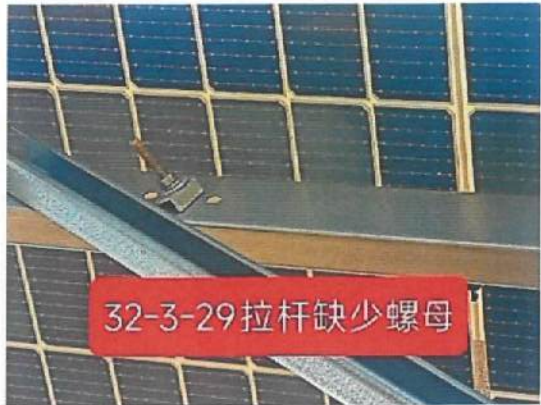
| 147 | <p>32-4-1 檩条连接件螺栓未上紧</p> | 148 | <p>32-3-29 拉杆缺少螺母</p> |

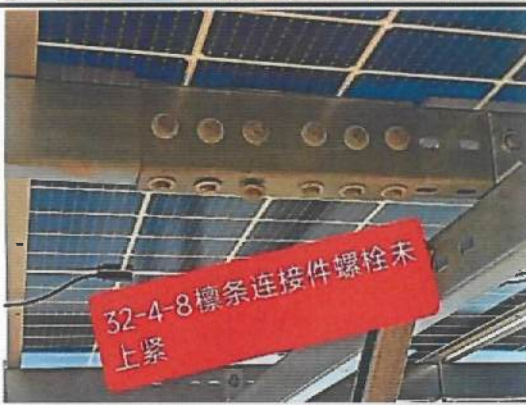
| 149 | <p>32-4-8 檩条连接件螺栓未上紧</p> | 150 | <p>32-4-1 檩条连接处螺栓未上紧</p> |

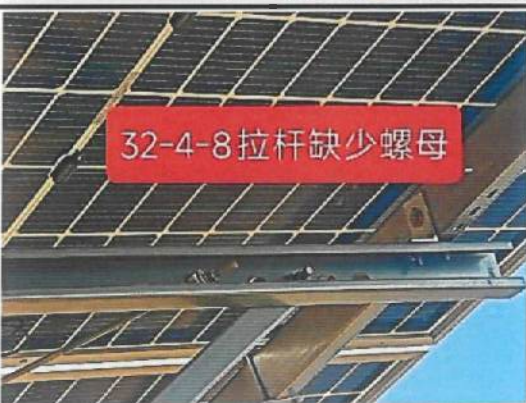
| 151 | <p>32-4-8 拉杆缺少螺母</p> | 152 | <p>32-4-8 压块缺少螺母</p> |

请贵单位按照上述问题立即消缺整改。

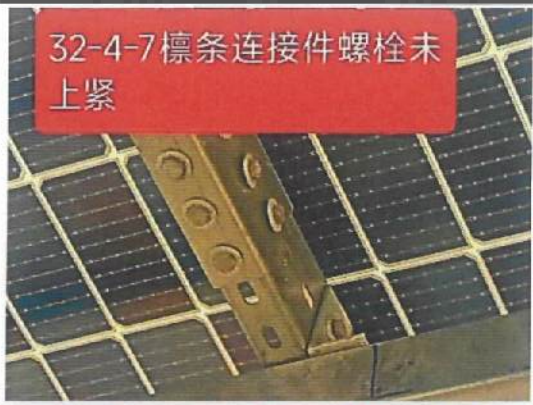
| 153 | <p>32-4-7 檩条连接件螺栓未上紧</p> | 154 | <p>32-4-7 拉杆缺少螺母</p> |

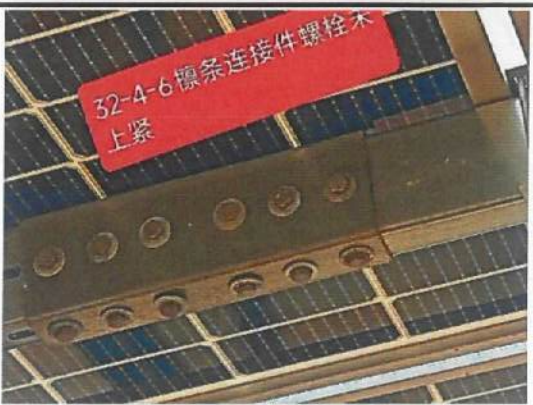
| 155 | <p>32-4-6 檩条连接件螺栓未上紧</p> | 156 | <p>32-4-7 檩条连接处螺栓未上紧</p> |

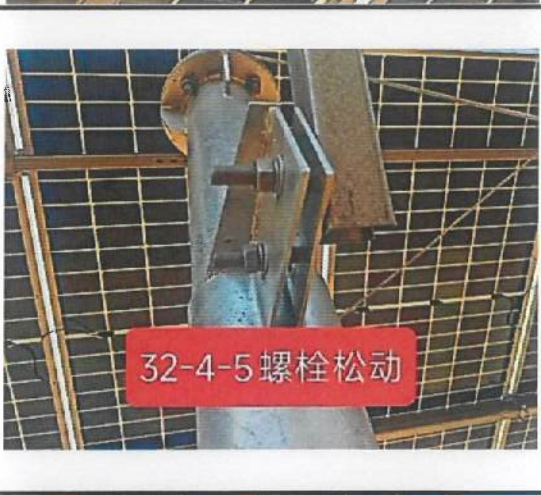
| 157 | <p>32-4-6 螺栓未上紧</p> | 158 | <p>32-4-5 螺栓松动</p> |

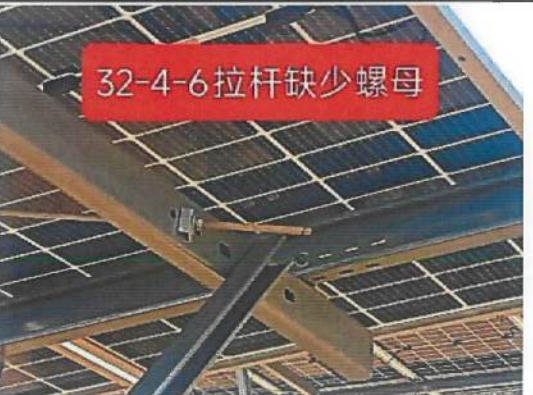
| 159 | <p>32-4-6 拉杆缺少螺母</p> | 160 | <p>32-4-9 檩托安装不到位</p> |

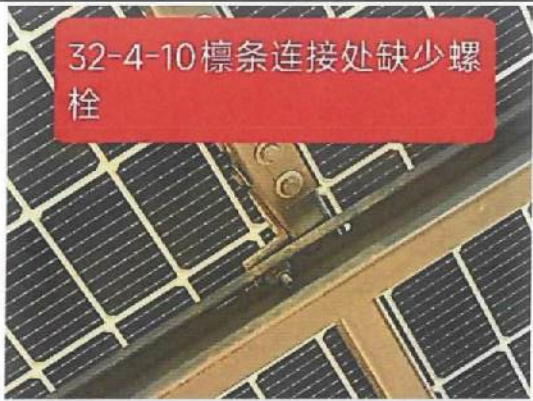
| 161 | <p>32-4-10 檩条连接处缺少螺栓</p> | 162 | <p>32-4-10 檩条连接处缺少垫片</p> |

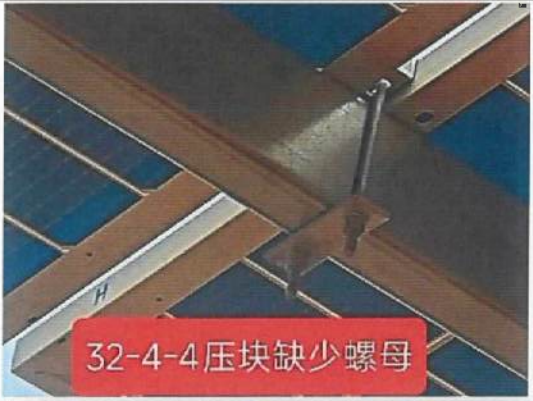
| 163 | <p>32-4-4 压块缺少螺母</p> | 164 | <p>32-4-12 压块缺少螺母</p> |

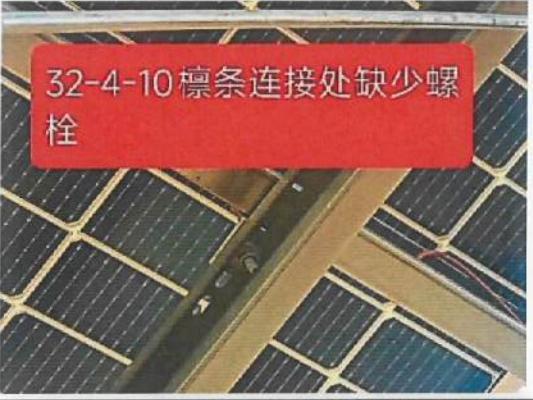
| 165 | <p>32-4-10 檩条连接处缺少螺栓</p> | 166 | <p>32-4-12 檩条连接件缺少垫片</p> |

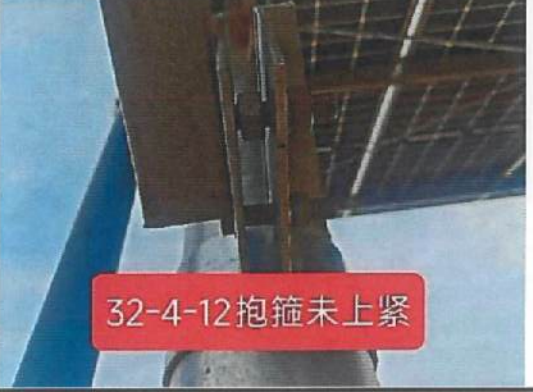
| 167 | <p>32-4-12 抱箍未上紧</p> | | |
