# 平陆县 100MW 农光互补光伏发电项目

## 监理工程师通知单

编号: ZHJL-JLTZ-PL-153

2024年11月11日、12日建设单位、监理单位及总包单位对上苏20、24、28区光伏区验收过程中发现以下问题:

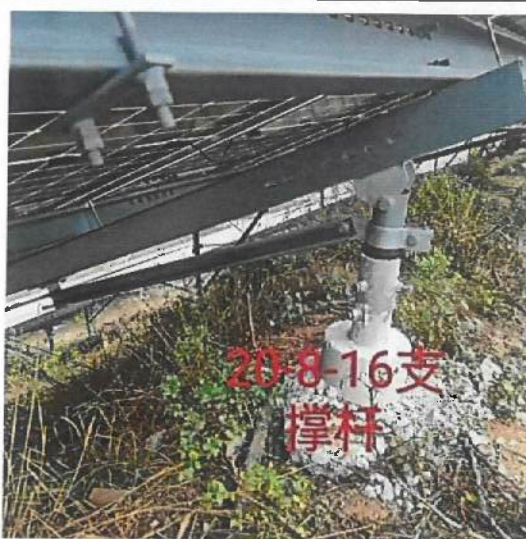
| 49 | <p>20-8-16支<br/>撑杆</p> | 50 | <p>20-8-27支<br/>撑杆</p> |

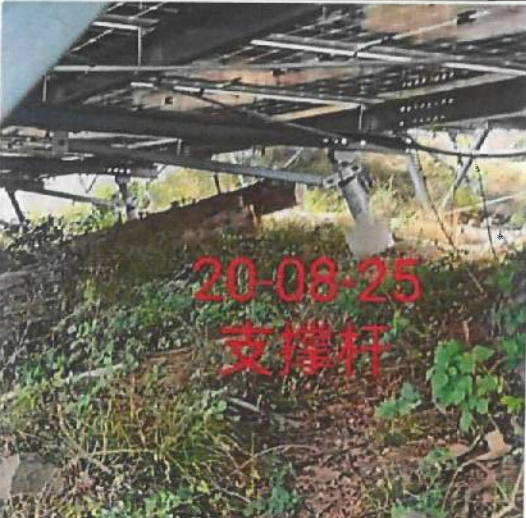
| 51 | <p>20-08-25<br/>支撑杆</p> | 52 | <p>20-8-17支<br/>撑杆</p> |

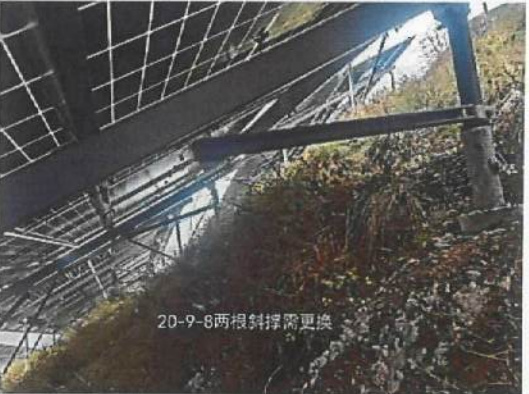
| 57 | <p>20-9-8两根斜撑需更换</p> | 58 | <p>20-9-10相串3根斜撑需更换</p> |

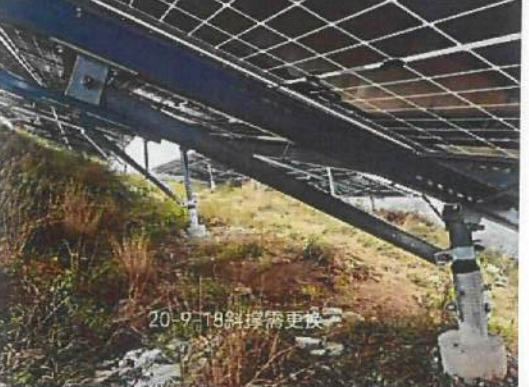
| 59 | <p>20-9-18斜撑需更换</p> | 60 | <p>20-9-19斜撑需调整更换</p> |

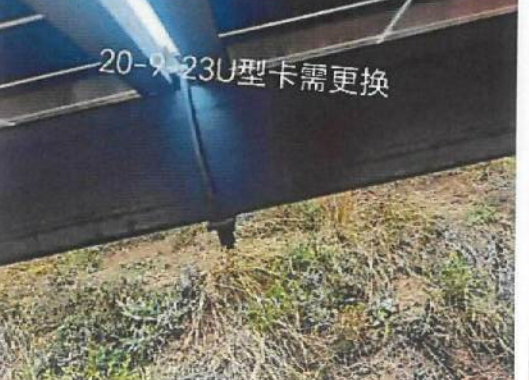
| 61 | <p>20-9-23U型卡需更换</p> | 62 | <p>20-9-25下斜撑需更换</p> |

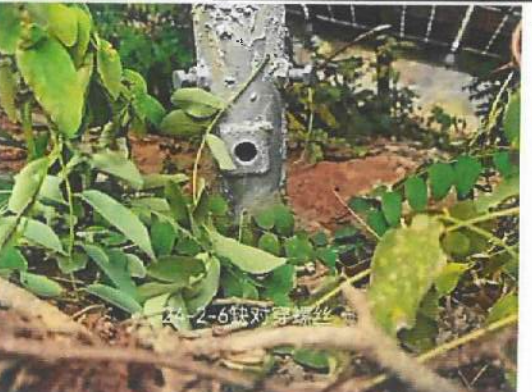
| 81 | <p>24-2-6铁对穿螺丝</p> | 82 | <p>28-06-09斜撑角度不够</p> |

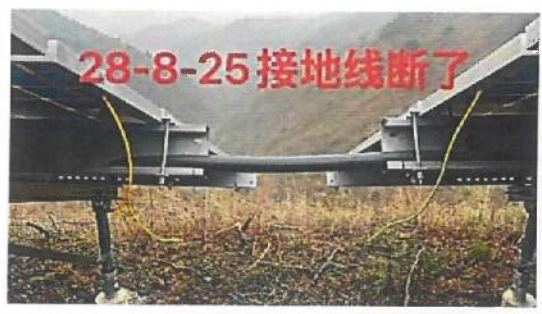
| 87 | <p>28-8-25接地线断了</p> | 88 | <p>38-7-4缺少斜撑</p> |

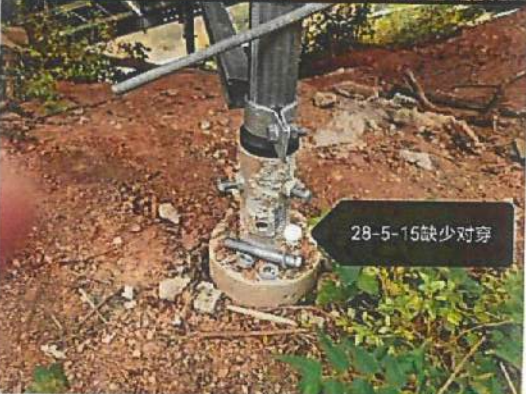
| 91 | <p>28-5-15缺少对穿</p> | 92 | <p>28方阵4号逆变器区域多处接地未地埋</p> |

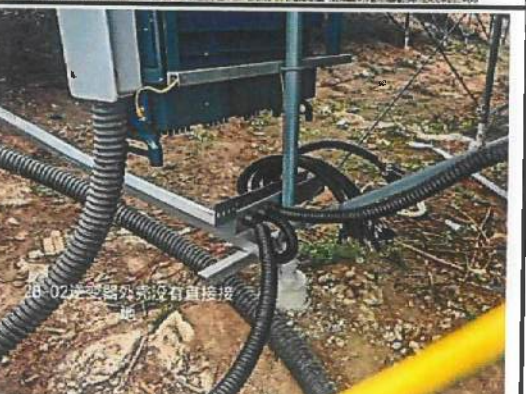
| 95 | <p>28-02逆变器外壳没有直接接地</p> | 96 | <p>28-02-06旁边的组件没有找见号码管</p> |
